OUTSIDE TERMINAL
Circuit 1
- Cargo line -

INSIDE TERMINAL
Circuit 1
- Cargo line -

INSIDE TERMINAL
Circuit 1
- Diesel pump suction line -

INSIDE TERMINAL
Circuit 2
- Diesel pump discharge line -

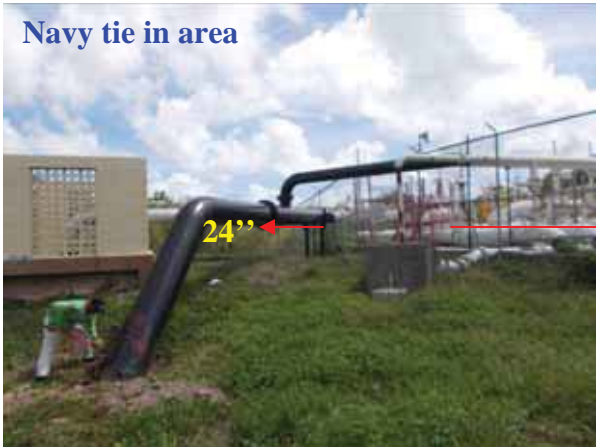
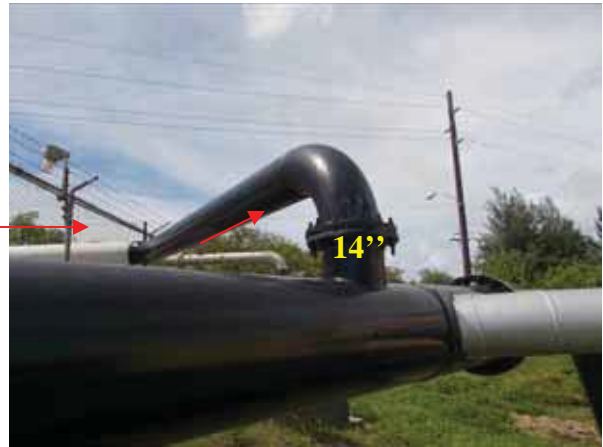
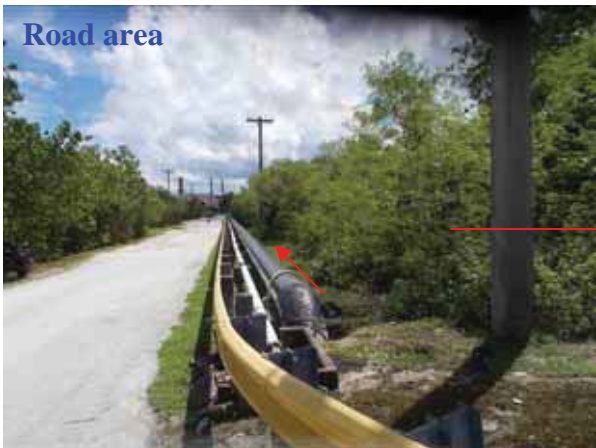
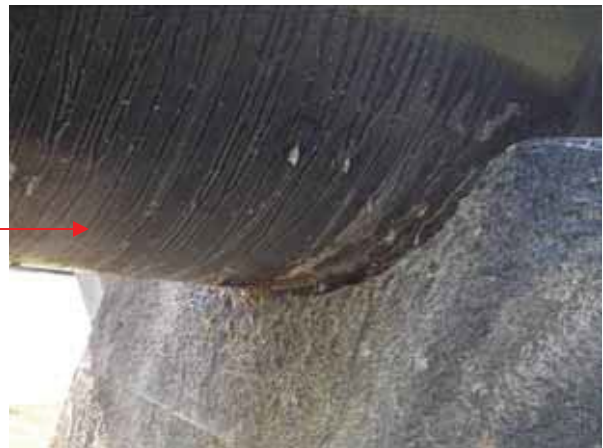
LINE SERVICE	DRAWING REFERENCE
14" & 24" Residual Fuel Oil No. 6 (RFO no. 6)	ISO drawing no. 1 to 6
DESCRIPTION	LOCATION
Circuit 1 – Cargo line	Outside Terminal – Navy tie in area <i>*Please refer Appendix 3 for detail location</i>
FINDING	RECOMMENDATIONS
<ol style="list-style-type: none"> 1. General view of 14" and 24" RFO pipeline. 2. Excessive in contact between piping and pedestal support. 	<ol style="list-style-type: none"> 1. Nil. 2. Consideration to modify existing support and to install rounded/angle bar or others material to give single contact point between piping and support. Single contact point is to prevent moisture or water sitting against the piping surface and promote to corrosion.

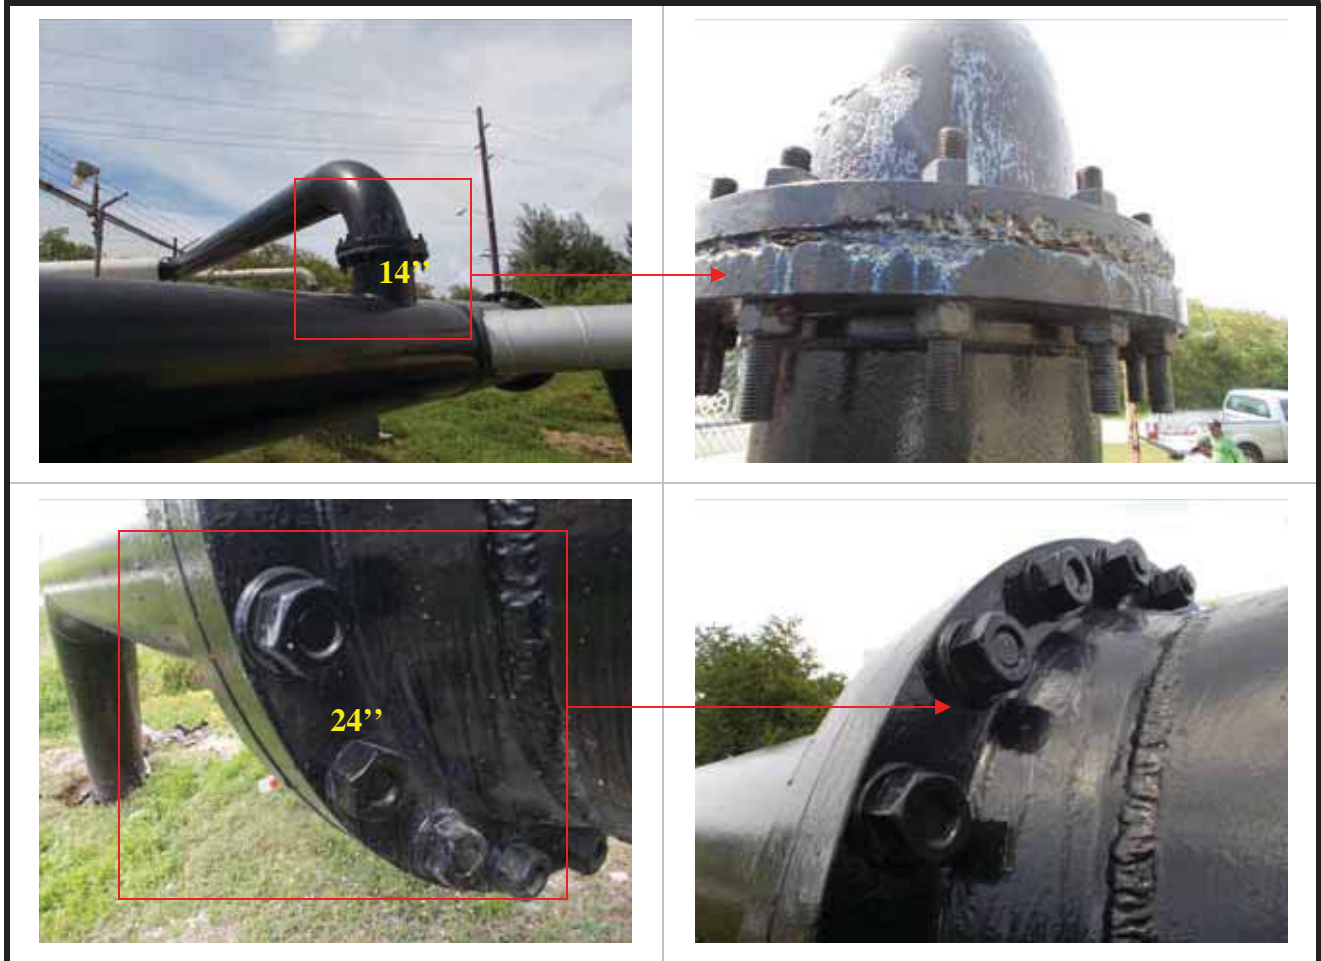
LINE SERVICE	DRAWING REFERENCE
24" Residual Fuel Oil No. 6 (RFO no. 6)	ISO drawing no. 1
DESCRIPTION	LOCATION
Circuit 1 - Cargo line	Outside Terminal – Navy tie in area <i>*Please refer Appendix 3 for detail location</i>
FINDING	RECOMMENDATIONS
<ol style="list-style-type: none"> 1. Crevice corrosion was noted between 14" of flanges. 2. Stud bolts of 24" flanges was noted not extend out through their nuts. 	<ol style="list-style-type: none"> 1. To monitor for leaking or to dismantle the flange to check for corrosion at raise face and replace with new gasket. 2. To replace with longer stud bolts of the same material, specification and diameter and to ensure both side of nuts engage the bolts at least one complete thread as per ASME B31.3, <i>Section 335.2.3, bolts should extend completely through their nuts and any which fail to do so are considered acceptable if the lack of complete engagement is not more than one thread.</i>

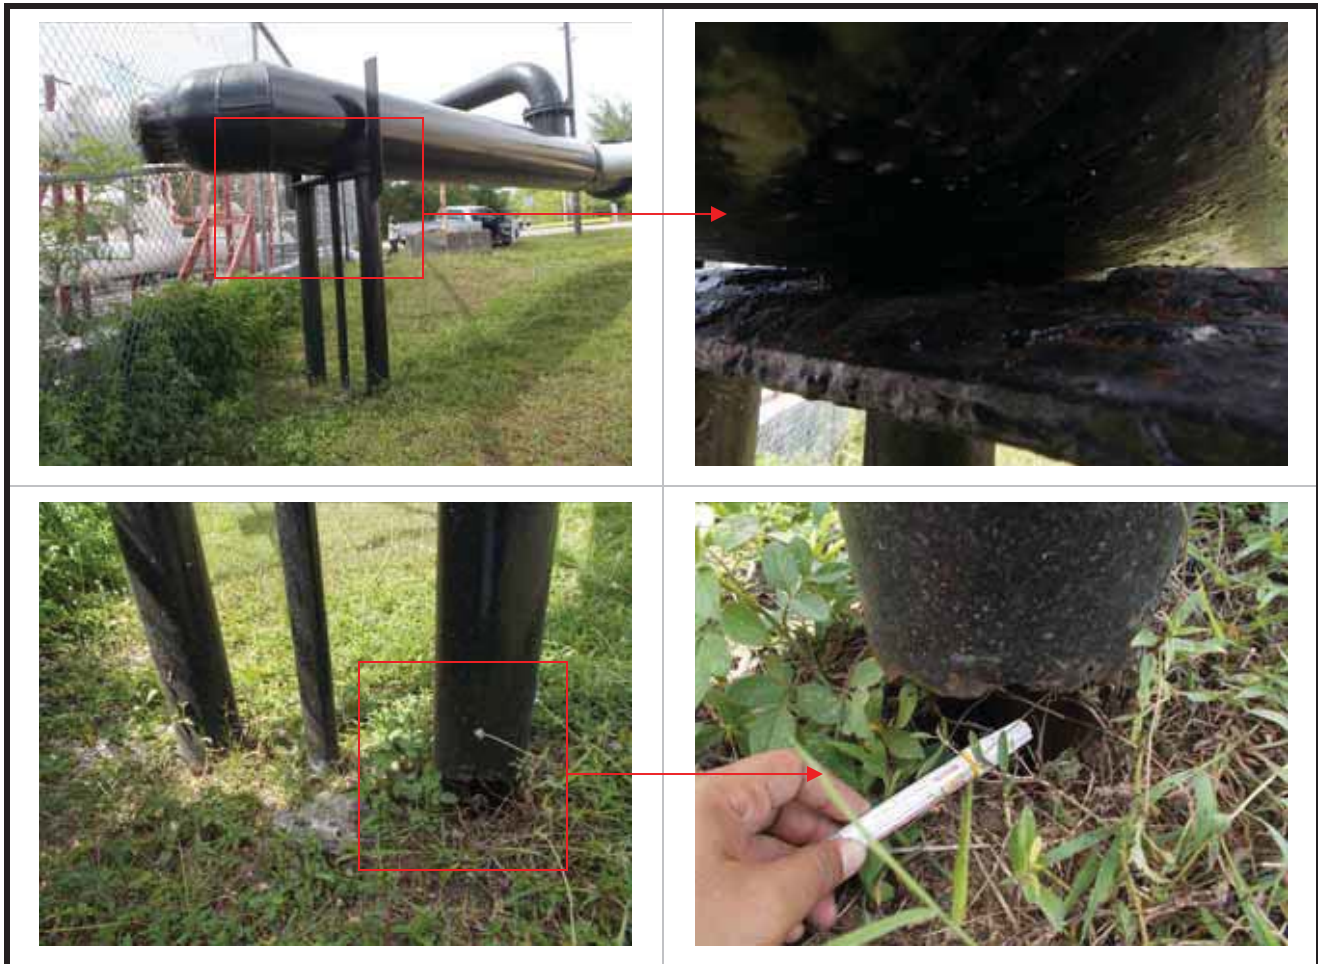
LINE SERVICE	DRAWING REFERENCE
24" Residual Fuel Oil No. 6 (RFO no. 6)	ISO drawing no. 1
DESCRIPTION	LOCATION
Circuit 1 - Cargo line	Outside Terminal – Navy tie in area <i>*Please refer Appendix 3 for detail location</i>
FINDING	RECOMMENDATIONS
H type support was observed deteriorated, severe corrosion (through hole) was noted at bottom section of the support legs.	To be repaired as per approve procedure and to monitor periodically for soil to air interface corrosion.

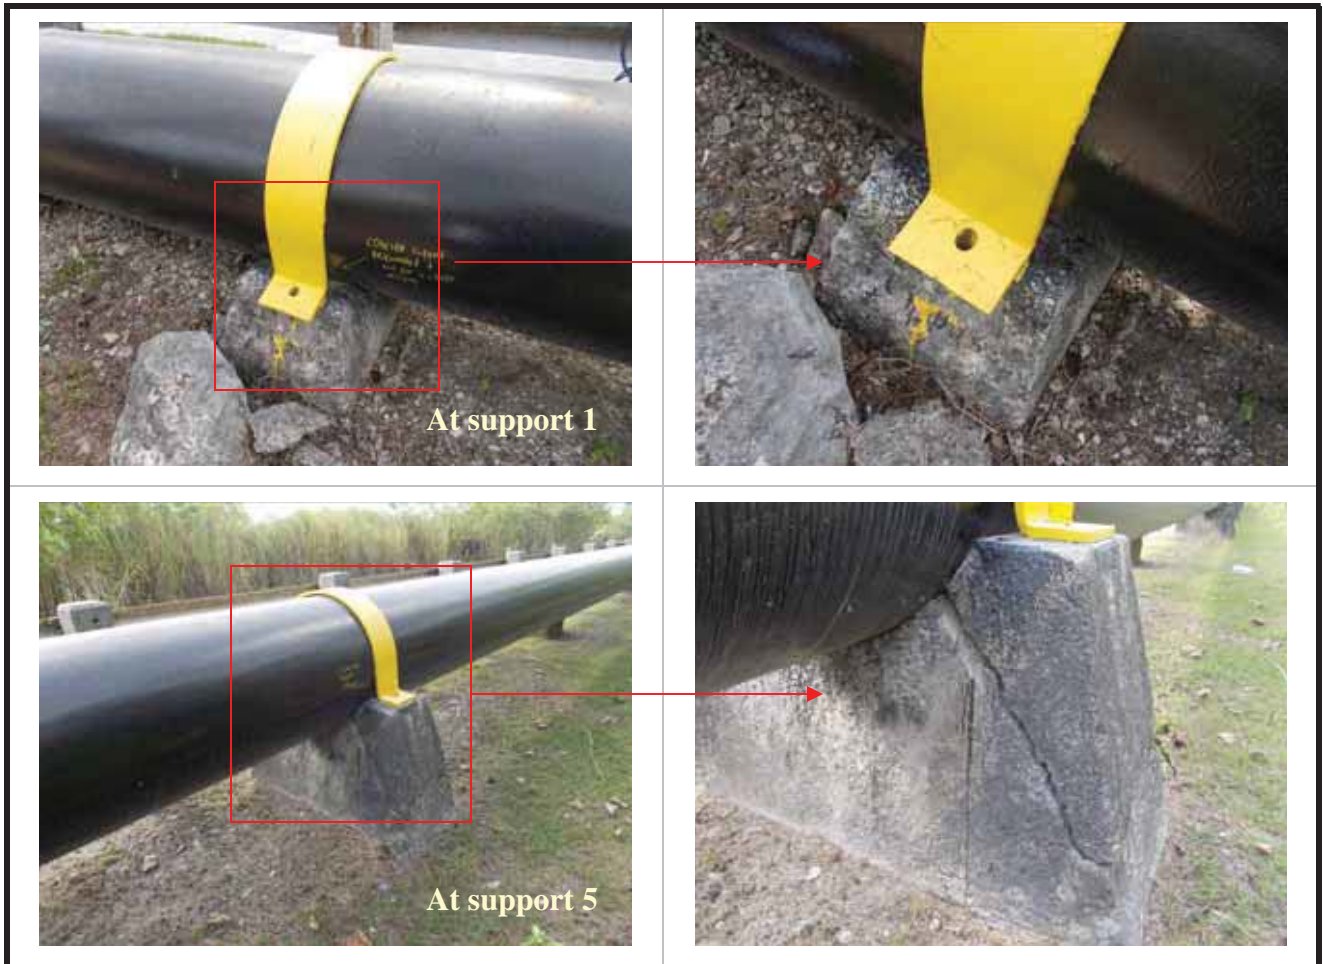
LINE SERVICE	DRAWING REFERENCE
24" Residual Fuel Oil No. 6 (RFO no. 6)	ISO drawing no. 2
DESCRIPTION	LOCATION
Circuit 1 - Cargo line	Outside Terminal – Road area <i>*Please refer Appendix 3 for detail location</i>
FINDING	RECOMMENDATIONS
Pedestals support was noted deteriorated (cracked).	To be repaired as per approve procedure. Consideration to replace/modified the existing support to give single contact point between piping and support to prevent water seep/accumulate underneath and promote to corrosion.

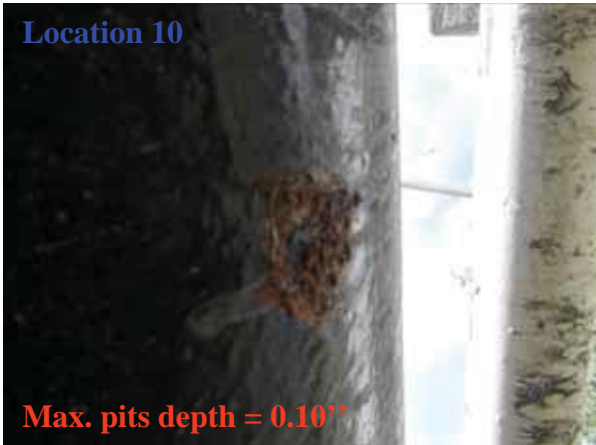
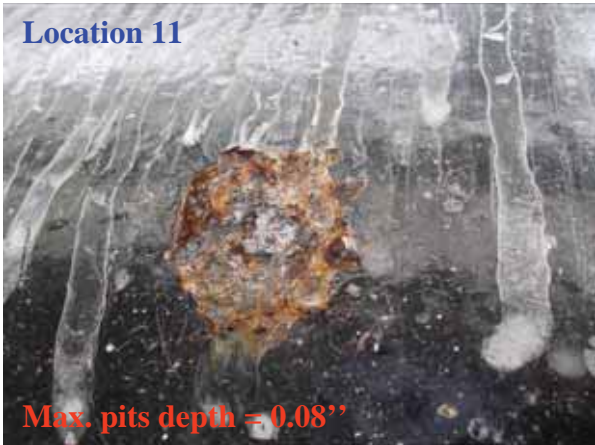
<p>Location 10</p>

<p>Max. pits depth = 0.10''</p>	<p>Location 11</p>

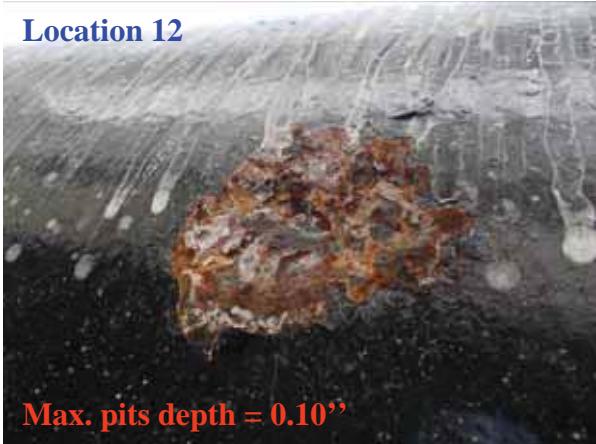
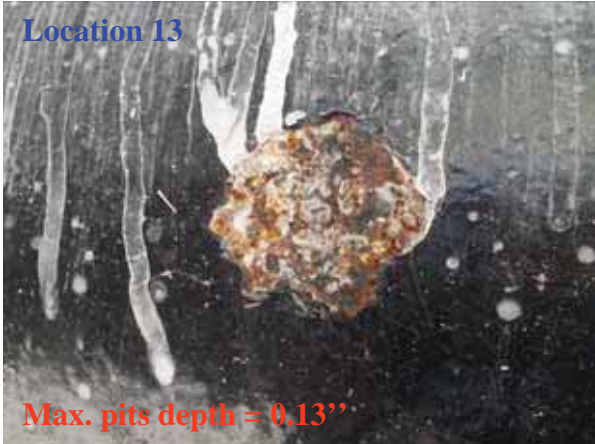
<p>Max. pits depth = 0.08''</p>
<p>Location 12</p>

<p>Max. pits depth = 0.10''</p>	<p>Location 13</p>

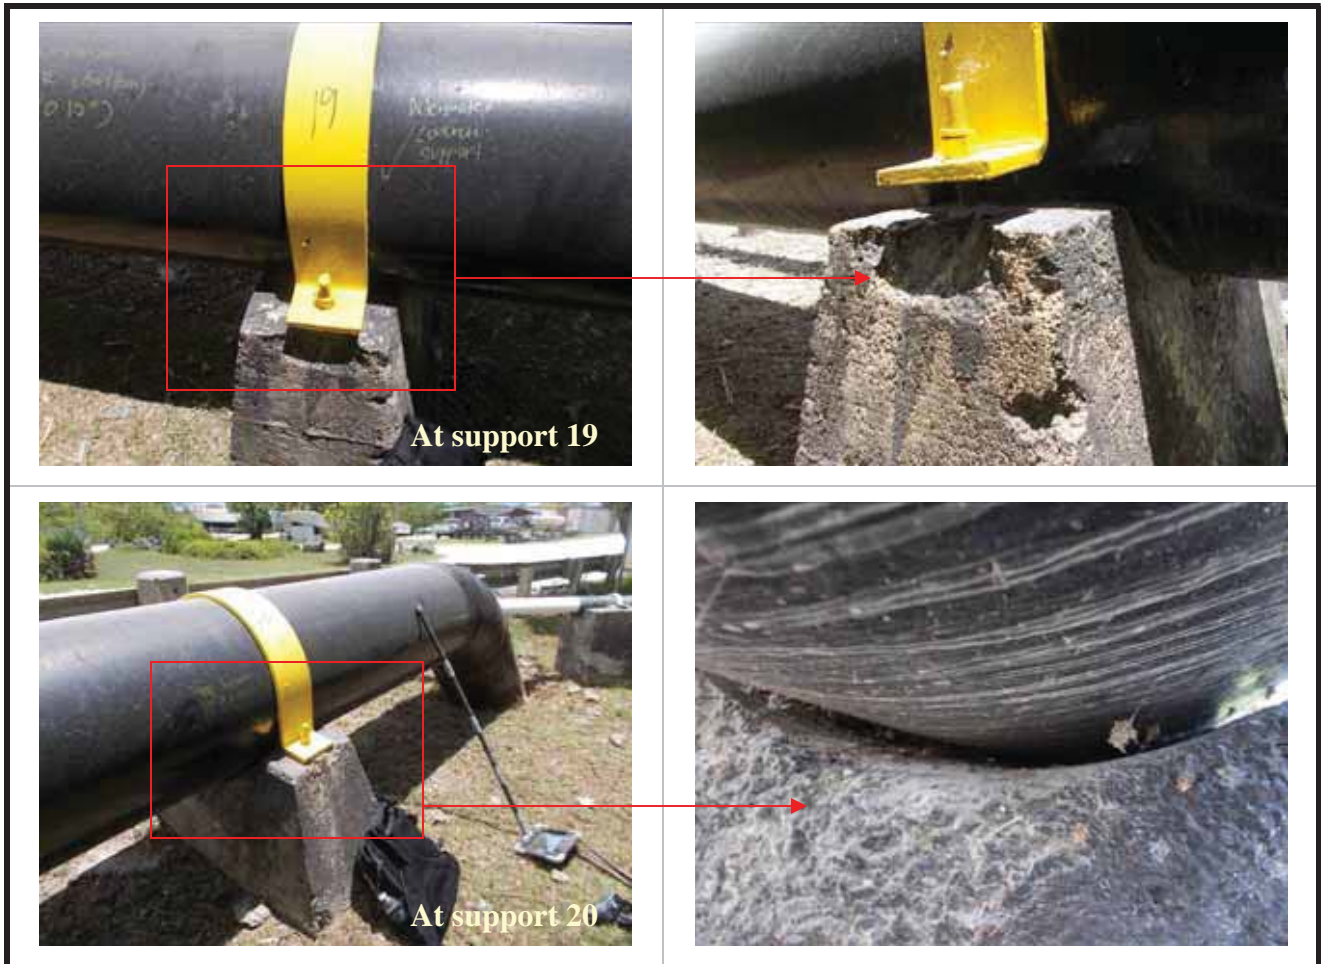
LINE SERVICE	DRAWING REFERENCE
24" Residual Fuel Oil No. 6 (RFO no. 6)	ISO drawing no. 5
DESCRIPTION	LOCATION
Circuit 1 - Cargo line	Outside Terminal – Road area <i>*Please refer Appendix 3 for detail location</i>
FINDING	RECOMMENDATIONS
<ol style="list-style-type: none"> 1. Pedestals support was noted deteriorated 2. Gap was noted between piping and support. 	<ol style="list-style-type: none"> 1. To be repaired as per approve procedure. Consideration to replace/modified the existing support to give single contact point between piping and support to prevent water seep/accumulate underneath and promote to corrosion. 2. To install rounded or angle bar to close the gap.

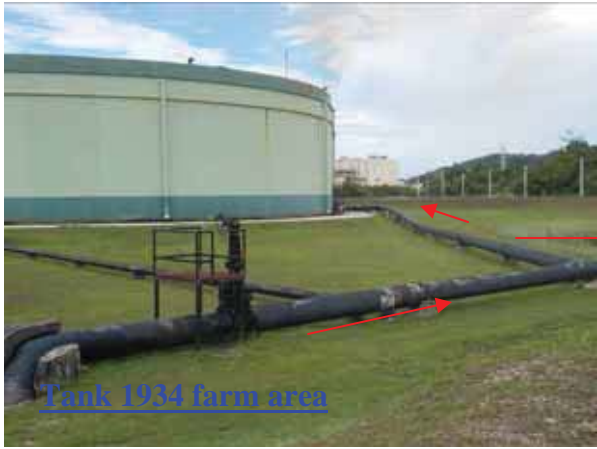
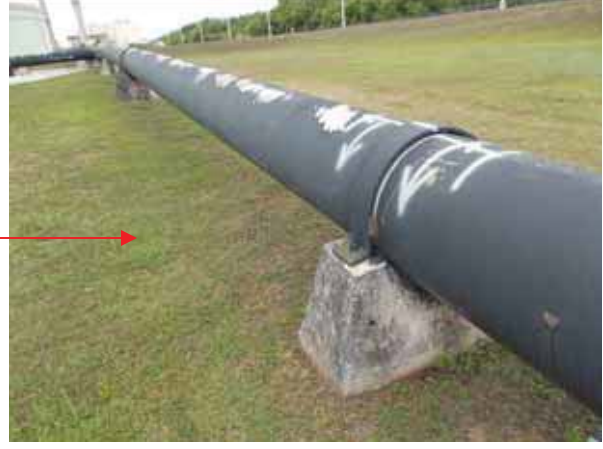
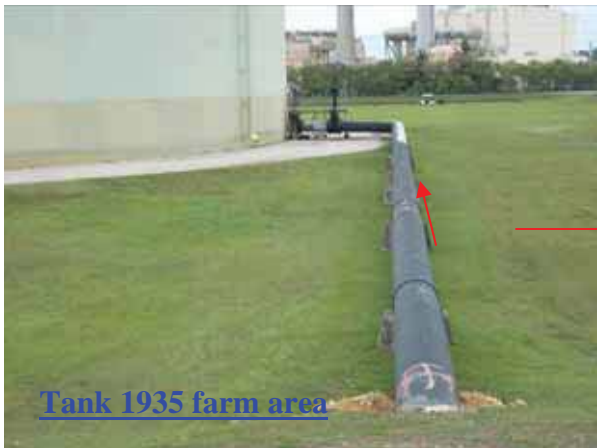
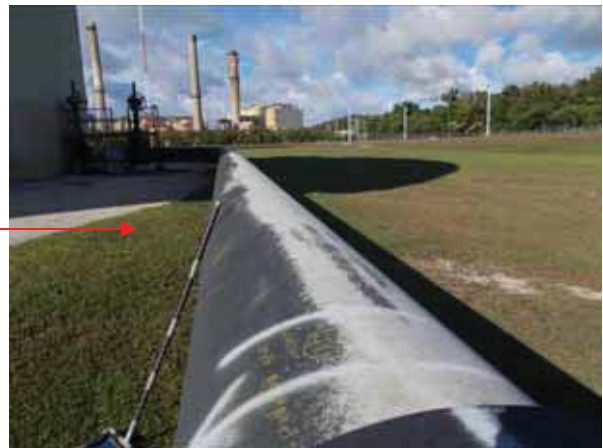
LINE SERVICE	DRAWING REFERENCE
24" Residual Fuel Oil No. 6 (RFO no. 6)	ISO drawing no. 7 & 8
DESCRIPTION	LOCATION
Circuit 1 – Cargo line	Inside Terminal – Tank 1934 & 1935 Farm Area <i>*Please refer Appendix 3 for detail location</i>
FINDING	RECOMMENDATIONS
<ol style="list-style-type: none"> 1. General view of 24" RFO pipeline inside terminal. 2. Discoloration was noted all along of piping. 3. Excessive in contact between piping and pedestal support. 	<ol style="list-style-type: none"> 1. Nil. 2. To perform surface preparation and follows by maintenance painting as per client's specification. 3. Consideration to modify existing support and to install rounded/angle bar or others material to give single contact point between piping and support. Single contact point is to prevent moisture or water sitting against the piping surface and promote to corrosion.

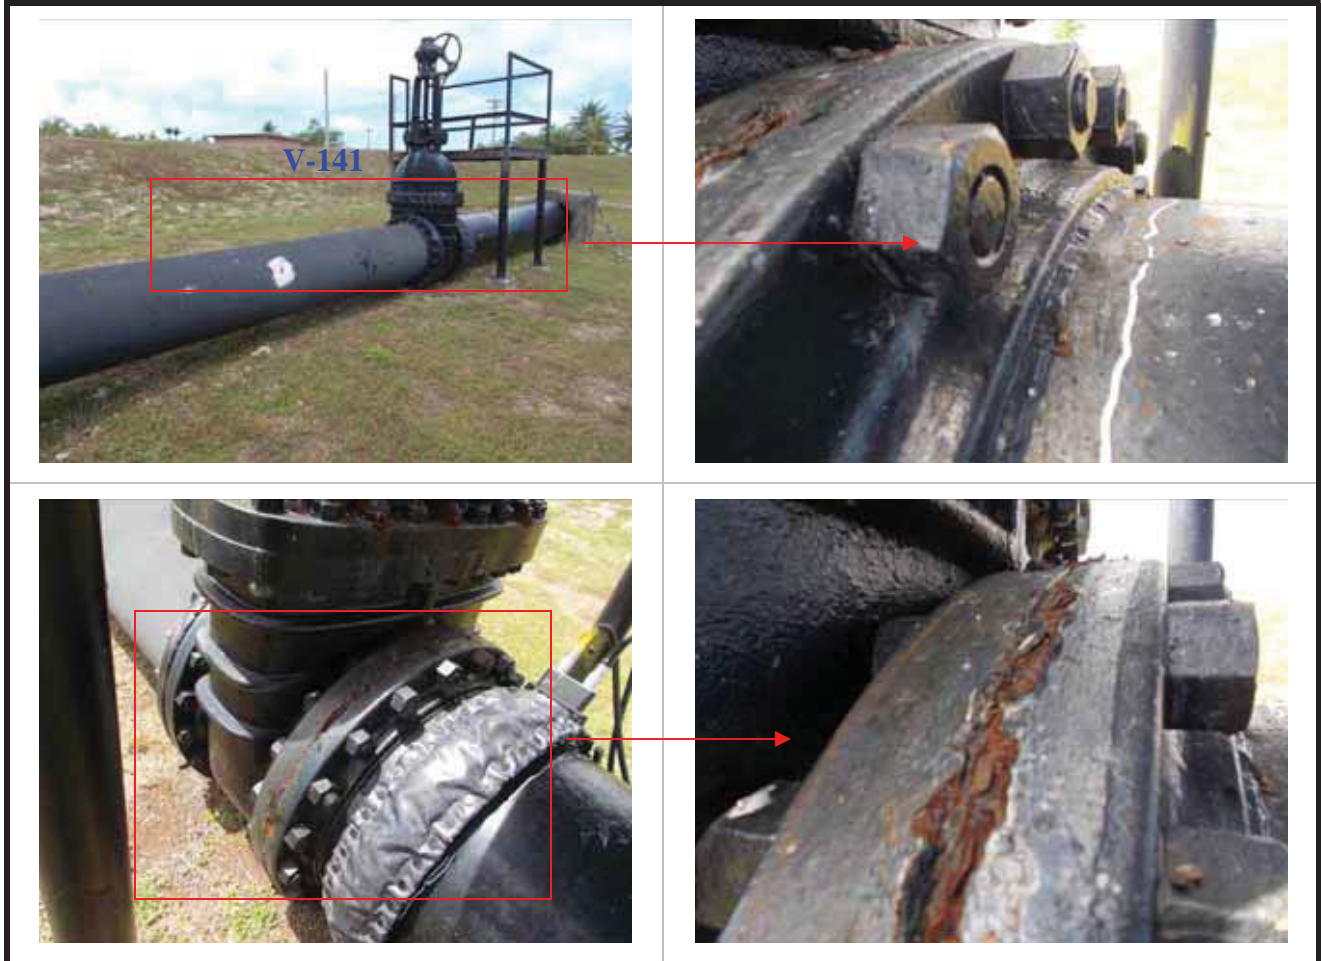
LINE SERVICE	DRAWING REFERENCE
24" Residual Fuel Oil No. 6 (RFO no. 6)	ISO drawing no. 7
DESCRIPTION	LOCATION
Circuit 1 – Cargo line	Inside Terminal – Tank 1934 Farm Area <i>*Please refer Appendix 3 for detail location</i>
FINDING	RECOMMENDATIONS
<ol style="list-style-type: none"> 1. Piping was observed too close with ground level and V-141 was noted in contact with soil. 2. Crevice corrosion was noted between flanges of valve. 3. Stud bolts of flange was noted not extend out through their nut. 	<ol style="list-style-type: none"> 1. To ensure the gap 6 inch between piping and soil surface as per API 570 and piping in contact with soil should be insulated. 2. To perform surface preparation and follows by maintenance painting as per client's specification. 3. To replace with longer stud bolt with the same material and specification.

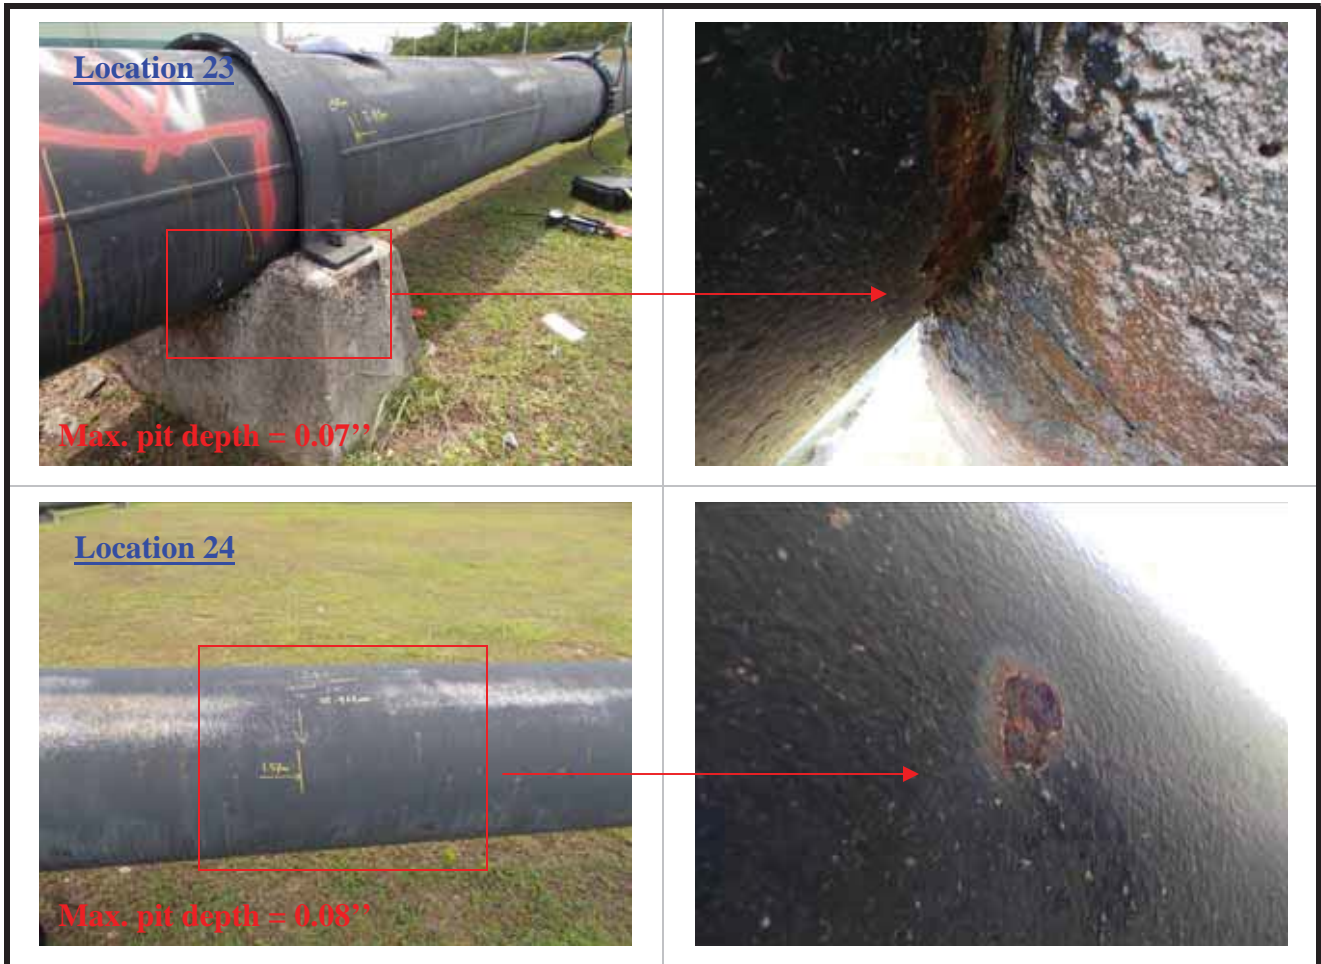
LINE SERVICE	DRAWING REFERENCE
24" Residual Fuel Oil No. 6 (RFO no. 6)	ISO drawing no. 7
DESCRIPTION	LOCATION
Circuit 1 – Cargo line	Inside Terminal – Tank 1934 Farm Area <i>*Please refer Appendix 3 for detail location</i>
FINDING	RECOMMENDATIONS
Localized corrosion/pits was noted at bottom section of piping, marked as 23 and 24 in ISO drawing. <i>*Please refer Appendix 2 for 1/2 remaining life calculation at pits area.</i>	To perform surface preparation and follows by maintenance painting as per client's specification.

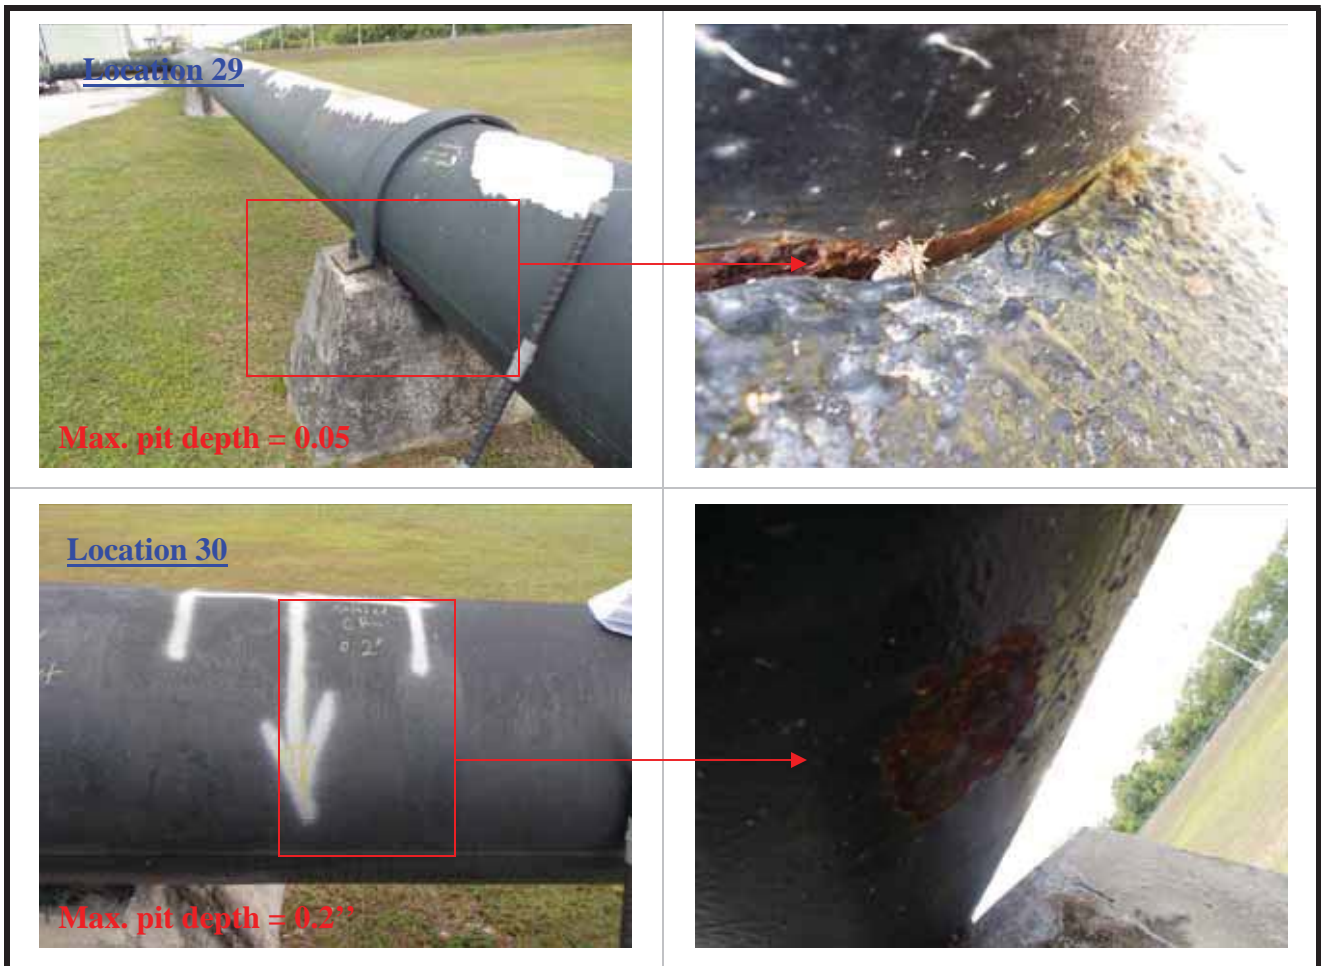
LINE SERVICE	DRAWING REFERENCE
24" Residual Fuel Oil No. 6	ISO drawing no. 7
DESCRIPTION	LOCATION
Circuit 1 – Cargo line	Inside Terminal – Tank 1934 Farm Area <i>*Please refer Appendix 3 for detail location</i>
FINDING	RECOMMENDATIONS
<p>1. Corrosion was noted at contact area between piping and support, marked as location 29 in ISO drawing.</p> <p>2. Severe localized corrosion/pits was noted at bottom section of piping, marked as 30 in ISO drawing.</p> <p><i>*Please refer Appendix 2 for 1/2 remaining life calculation at pits area.</i></p>	<p>1. To lift the piping and perform surface preparation and follows by maintenance painting as per client's specification.</p> <p>2. Consideration to perform permanent repair at this area with remove the corrosion, restore with weld metal deposited/insert weld patch, follow by NDE and re-painting as per client's specification.</p> <p>Note:-Pits depth measurement at contact area between piping and support based on estimation due to inaccessible area.</p>

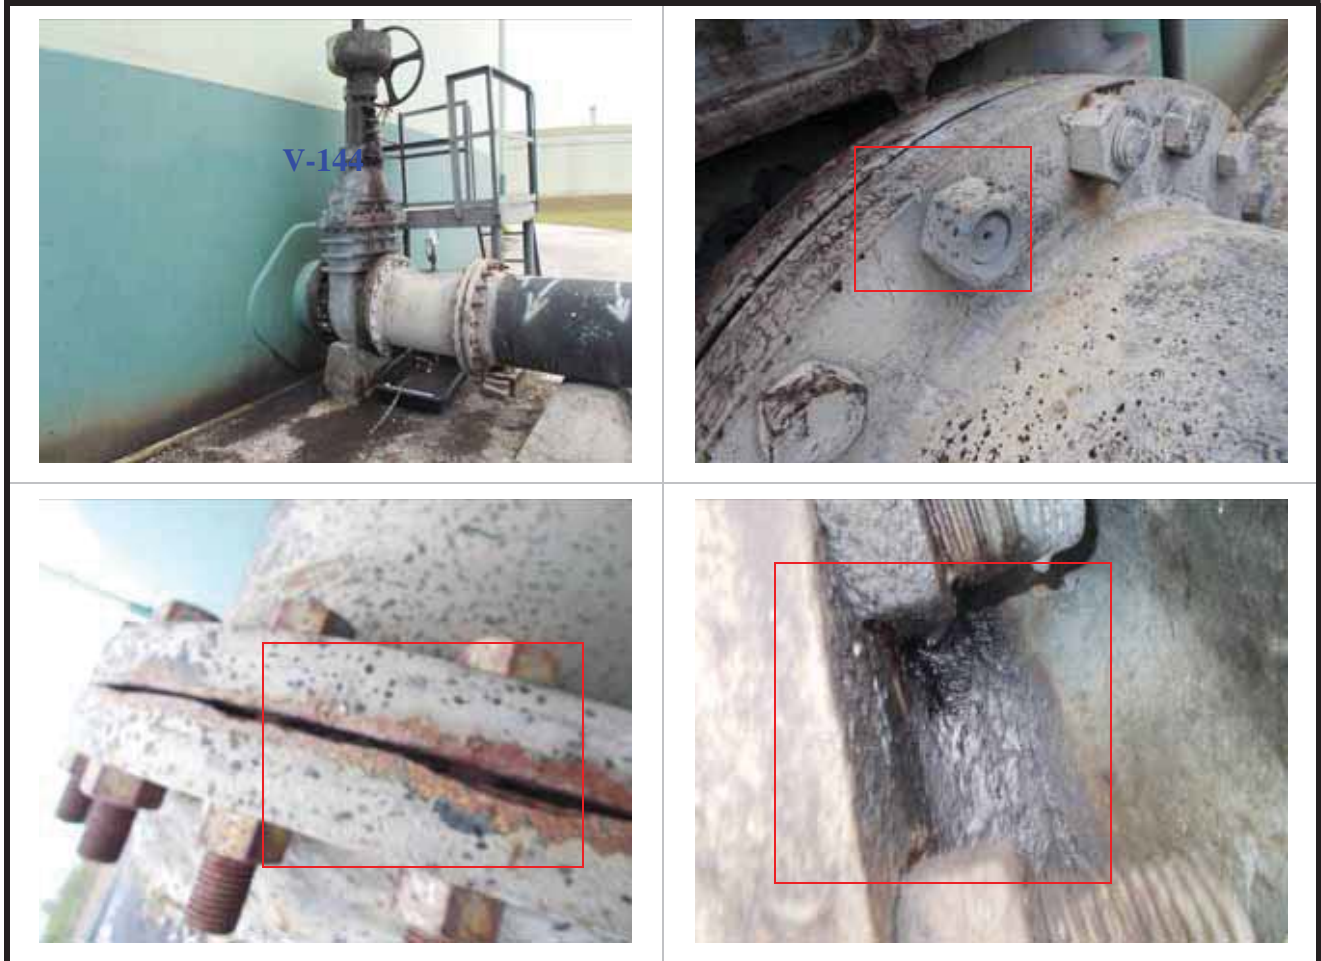
LINE SERVICE	DRAWING REFERENCE
24" Residual Fuel Oil No. 6 (RFO no. 6)	ISO drawing no. 7
DESCRIPTION	LOCATION
Circuit 1 – Cargo line	Inside Terminal – Tank 1934 Farm Area <i>*Please refer Appendix 3 for detail location</i>
FINDING	RECOMMENDATIONS
<ol style="list-style-type: none"> 1. Stud bolts of flanges was observed not extend out from their nuts. 2. Product stain sign of leak and crevice corrosion was noted at flanges area. 	<ol style="list-style-type: none"> 1. To replace with longer stud bolt with the same material and specification. 2. Consideration to dismantle the valve and check for corrosion at raise face and replace with new gasket.

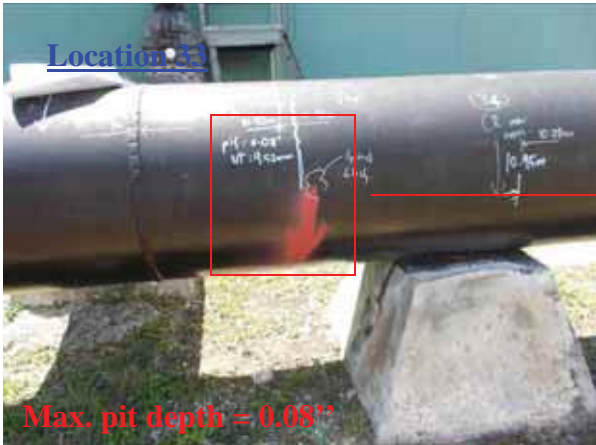
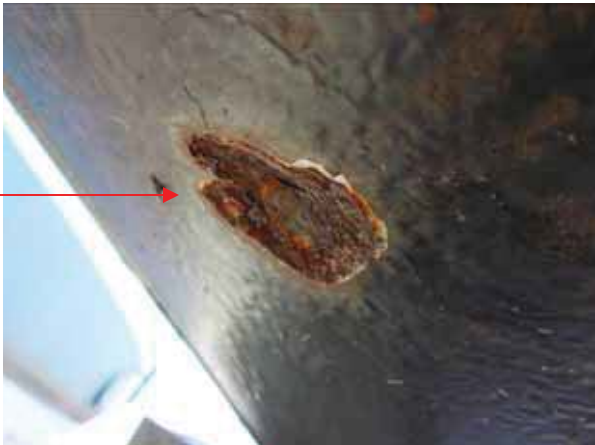
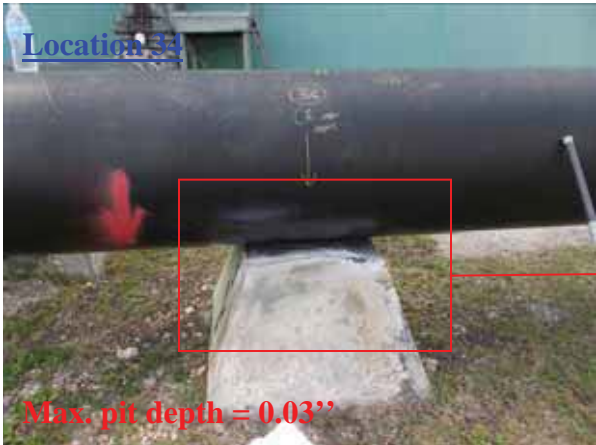
<p>Location 33</p> <p>Max. pit depth = 0.08"</p>

<p>Location 34</p> <p>Max. pit depth = 0.03"</p>	 
<p>LINE SERVICE</p>	<p>DRAWING REFERENCE</p>
<p>24" Residual Fuel Oil No. 6 (RFO no. 6)</p>	<p>ISO drawing no. 7</p>
<p>DESCRIPTION</p>	<p>LOCATION</p>
<p>Circuit 1 – Cargo line</p>	<p>Inside Terminal – Tank 1934 Farm Area <i>*Please refer Appendix 3 for detail location</i></p>
<p>FINDING</p>	<p>RECOMMENDATIONS</p>
<p>1. Localized corrosion/pits was noted at bottom section of piping, marked as 33 in ISO drawing. 2. Corrosion was noted at contact area between piping and support, marked as location 34 in ISO drawing. <i>*Please refer Appendix 2 for ½ remaining life calculation at pits area.</i></p>	<p>1. To perform surface preparation and follows by maintenance painting as per client's specification. 2. To lift the piping and perform surface preparation and follows by maintenance painting as per client's specification. Note:-Pits depth measurement at contact area between piping and support based on estimation due to inaccessible area.</p>

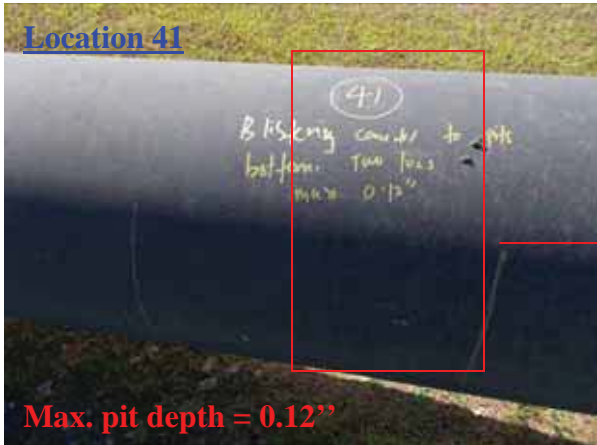
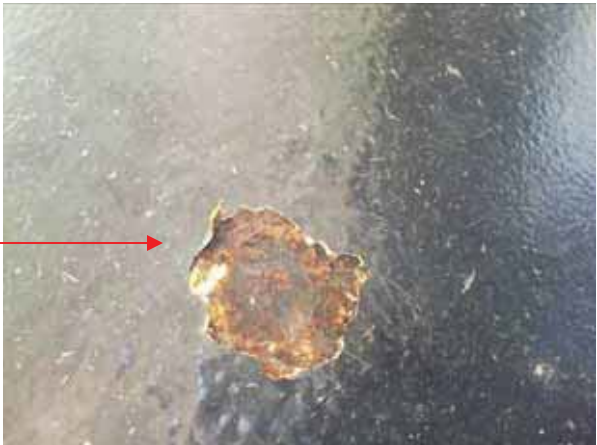
<p><u>Location 41</u></p>

<p>Max. pit depth = 0.12''</p>

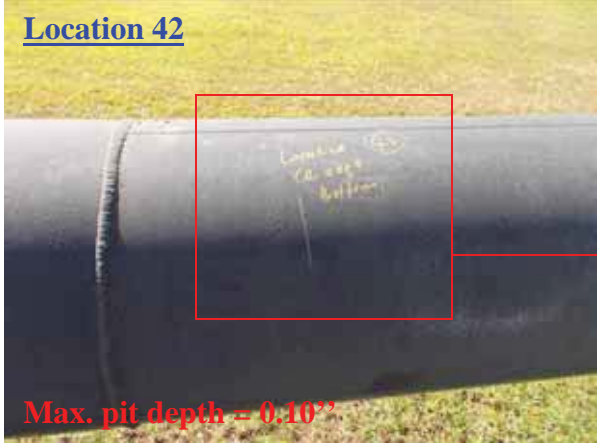
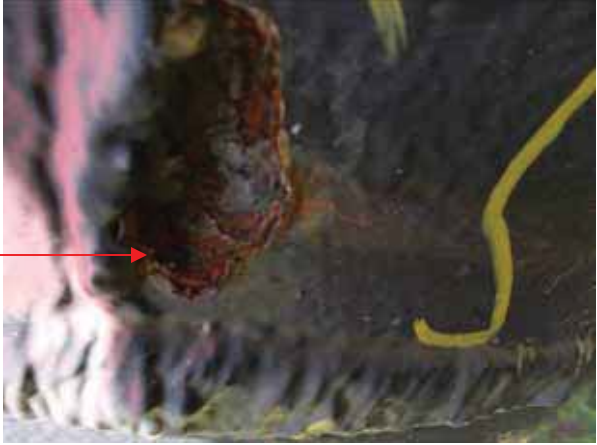
<p><u>Location 42</u></p>

<p>Max. pit depth = 0.10''</p>

<p>LINE SERVICE</p>	<p>DRAWING REFERENCE</p>
<p>24" Residual Fuel Oil No. 6 (RFO no. 6)</p>	<p>ISO drawing no. 8</p>
<p>DESCRIPTION</p>	<p>LOCATION</p>
<p>Circuit 1 – Cargo line</p>	<p>Inside Terminal – Tank 1935 farm area <i>*Please refer Appendix 3 for detail location</i></p>
<p>FINDING</p>	<p>RECOMMENDATIONS</p>
<p>Localized corrosion/pits was noted at bottom section of piping, marked as locations 41 and 42 in ISO drawing. <i>*Please refer Appendix 2 for 1/2 remaining life calculation at pits area.</i></p>	<p>To perform surface preparation and follows by maintenance painting as per client's specification.</p>

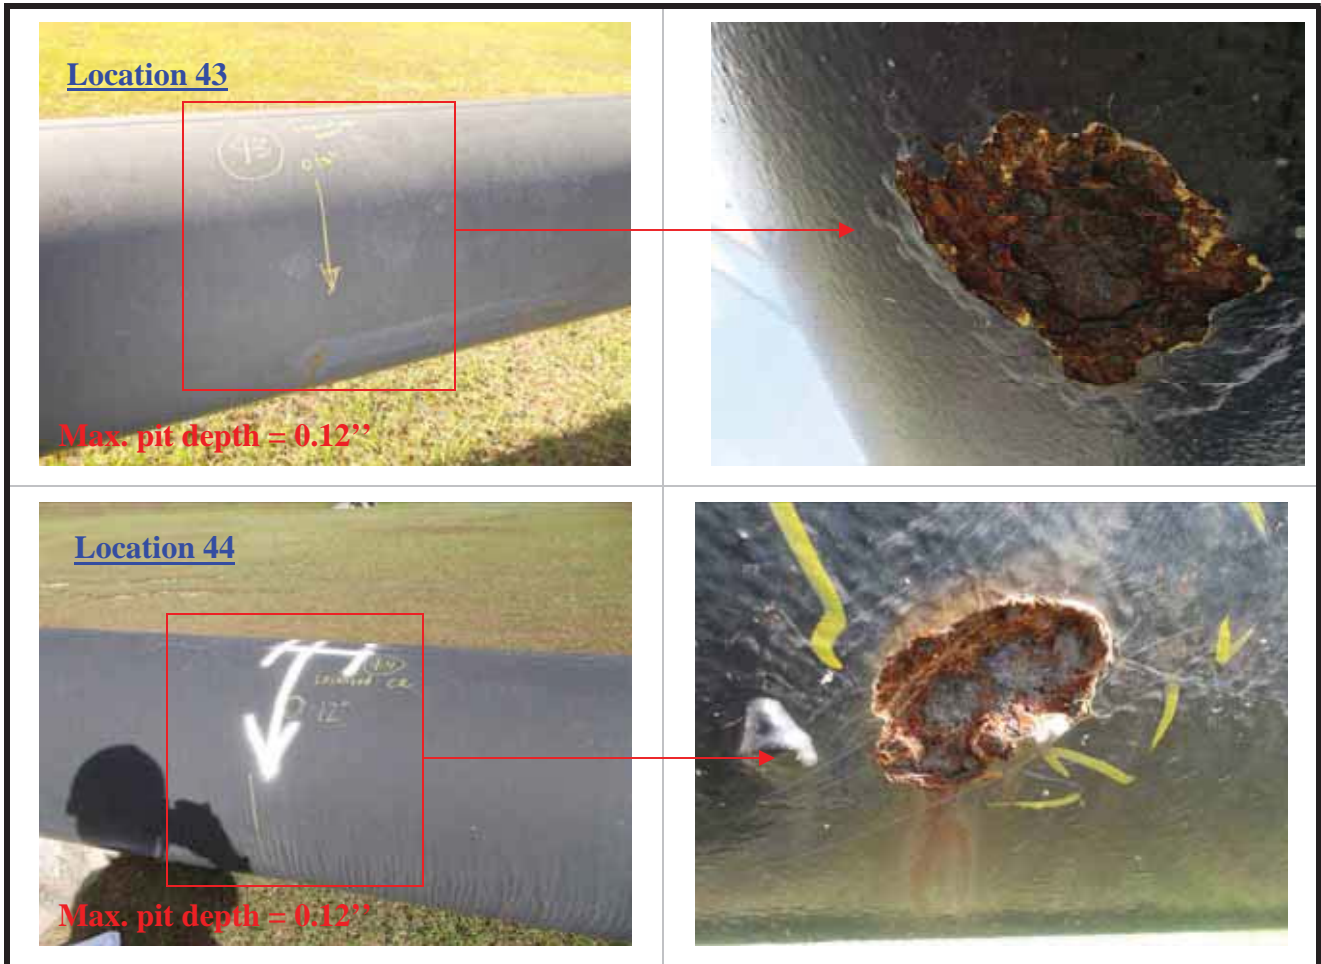
LINE SERVICE	DRAWING REFERENCE
24" Residual Fuel Oil No. 6 (RFO no. 6)	ISO drawing no. 8
DESCRIPTION	LOCATION
Circuit 1 – Cargo line	Inside Terminal – Tank 1935 farm area <i>*Please refer Appendix 3 for detail location</i>
FINDING	RECOMMENDATIONS
Localized corrosion/pits was noted at bottom section of piping, marked as locations 43 and 44 in ISO drawing. <i>*Please refer Appendix 2 for 1/2 remaining life calculation at pits area.</i>	To perform surface preparation and follows by maintenance painting as per client's specification.

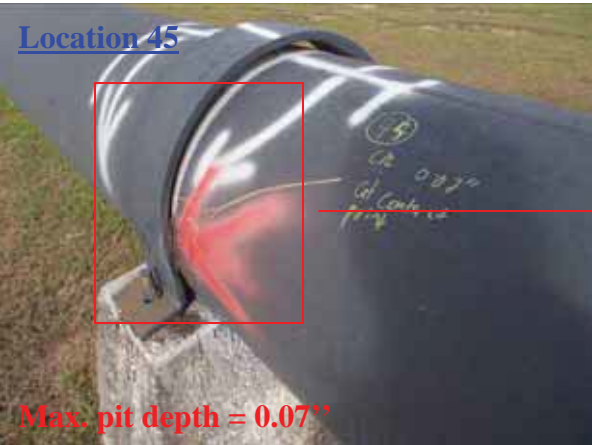
<p><u>Location 45</u></p>

<p>Max. pit depth = 0.07"</p>	 
<p><u>Location 46</u></p>   <p>Max. pit depth = 0.05</p>	 
<p>LINE SERVICE</p>	<p>DRAWING REFERENCE</p>
<p>24" Residual Fuel Oil No. 6 (RFO no. 6)</p>	<p>ISO drawing no. 8</p>
<p>DESCRIPTION</p>	<p>LOCATION</p>
<p>Circuit 1 – Cargo line</p>	<p>Inside Terminal – Tank 1935 farm area <i>*Please refer Appendix 3 for detail location</i></p>
<p>FINDING</p>	<p>RECOMMENDATIONS</p>
<p>1. Corrosion was noted at contact area between piping and u-bolt clamp area, marked as location 45 in ISO drawing. 2. Localized corrosion/pits was noted at bottom section of piping, marked as location 46 in ISO drawing. <i>*Please refer Appendix 2 for ½ remaining life calculation at pits area.</i></p>	<p>1. To perform surface preparation and follows by maintenance painting as per client's specification, to ensure the u-bolt clamp installed with clearance to prevent abrasion during product loading/unloading and lead to corrosion. 2. To perform surface preparation and follows by maintenance painting as per client's specification.</p>

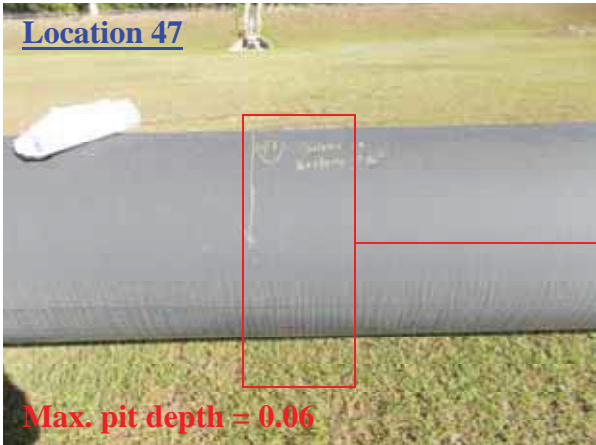
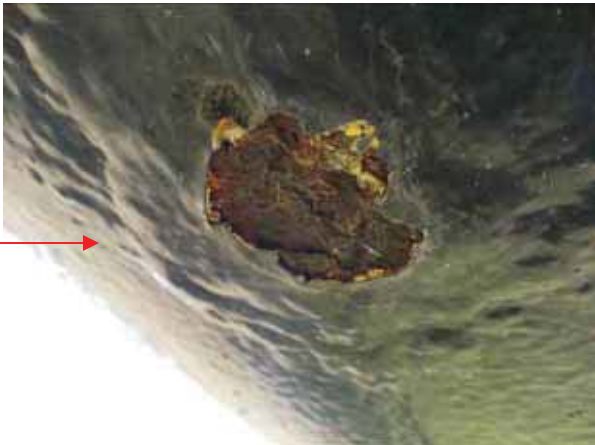
<p>Location 47</p>

<p>Max. pit depth = 0.06</p>

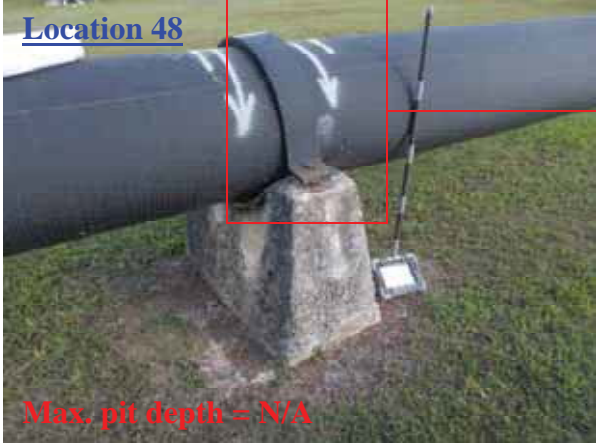
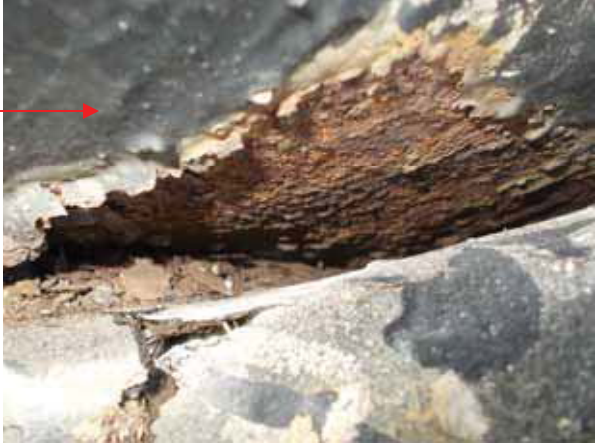
<p>Location 48</p>

<p>Max. pit depth = N/A</p>

<p>LINE SERVICE</p>	<p>DRAWING REFERENCE</p>
<p>24" Residual Fuel Oil No. 6 (RFO no. 6)</p>	<p>ISO drawing no. 8</p>
<p>DESCRIPTION</p>	<p>LOCATION</p>
<p>Circuit 1 – Cargo line</p>	<p>Inside Terminal – Tank 1935 farm area <i>*Please refer Appendix 3 for detail location</i></p>
<p>FINDING</p>	<p>RECOMMENDATIONS</p>
<p>1. Localized corrosion/pits was noted at bottom section of piping, marked as location 47 in ISO drawing. 2. Corrosion was noted at contact area between piping and support, marked as location 48 in ISO drawing. <i>*Please refer Appendix 2 for ½ remaining life calculation at pits area.</i></p>	<p>1. To perform surface preparation and follows by maintenance painting as per client's specification. 2. To lift the piping and perform surface preparation and follows by maintenance painting as per client's specification. Note:-Pits depth measurement at contact area between piping and support based on estimation due to inaccessible area.</p>

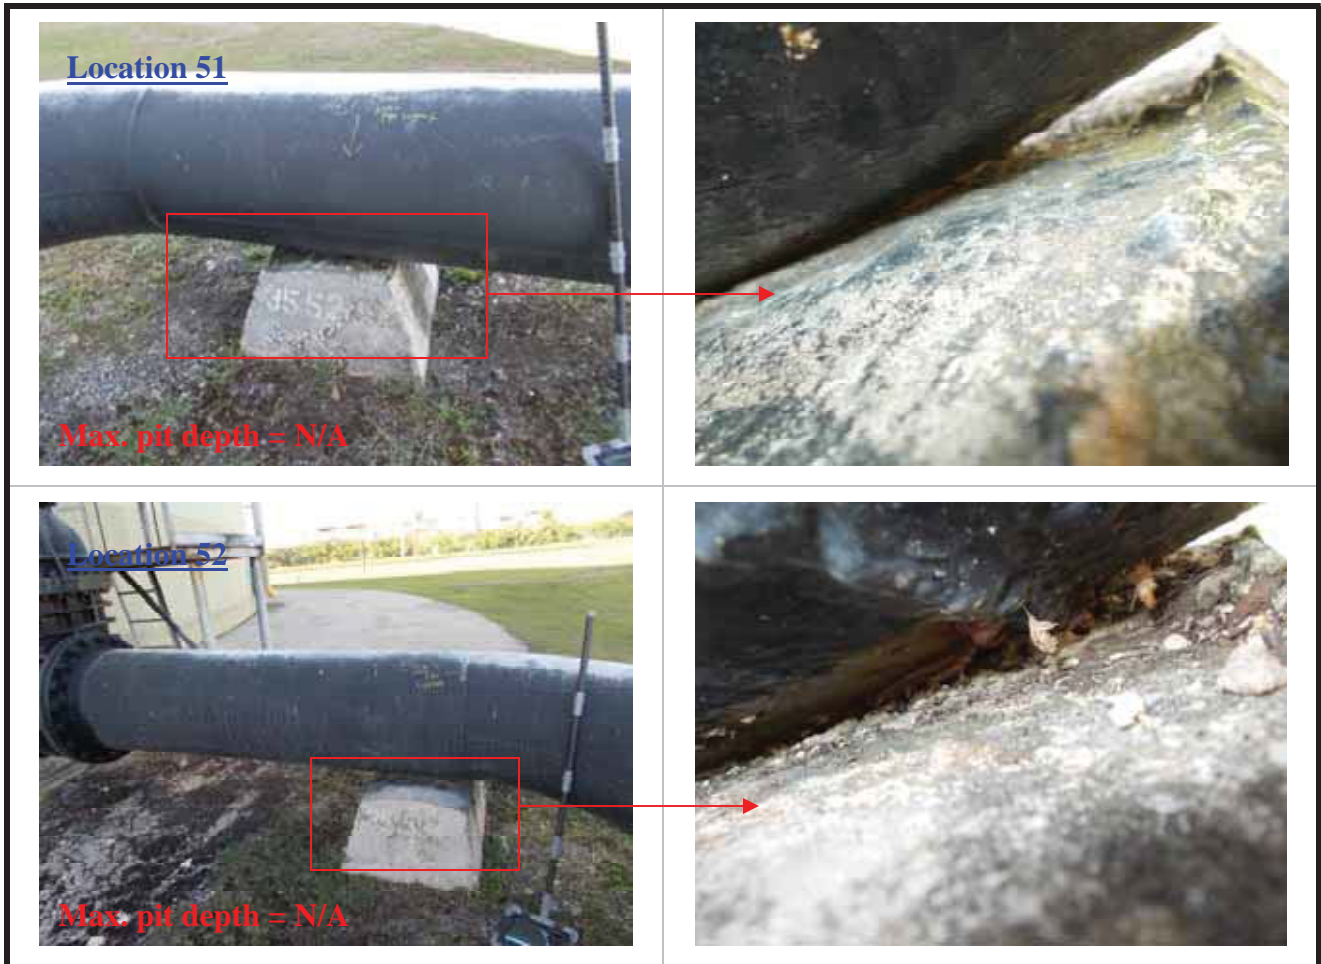
LINE SERVICE	DRAWING REFERENCE
24" Residual Fuel Oil No. 6 (RFO no. 6)	ISO drawing no. 8
DESCRIPTION	LOCATION
Circuit 1 – Cargo line	Inside Terminal – Tank 1935 farm area <i>*Please refer Appendix 3 for detail location</i>
FINDING	RECOMMENDATIONS
Corrosion was noted at contact area between piping and support, marked as locations 51 and 52 in ISO drawing. <i>*Please refer Appendix 2 for ½ remaining life calculation at pits area.</i>	To lift the piping and perform surface preparation and follows by maintenance painting as per client's specification. Note:-Pits depth measurement at contact area between piping and support based on estimation due to inaccessible area.
