OUTSIDE TERMINAL
Circuit 1
- Cargo line -

INSIDE TERMINAL
Circuit 1
- Cargo line -

INSIDE TERMINAL
Circuit 1
- Diesel pump suction line -

INSIDE TERMINAL
Circuit 2
- Diesel pump discharge line -

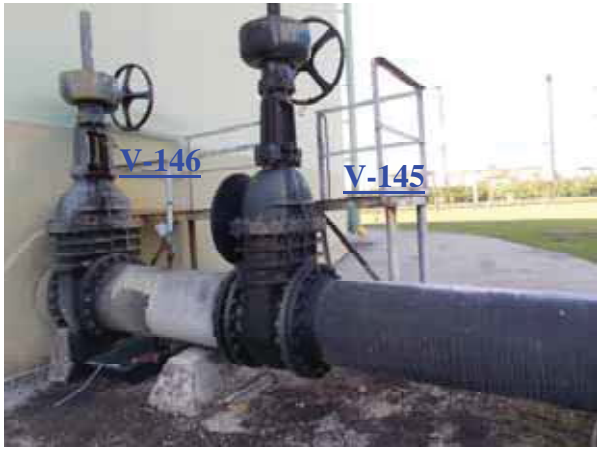
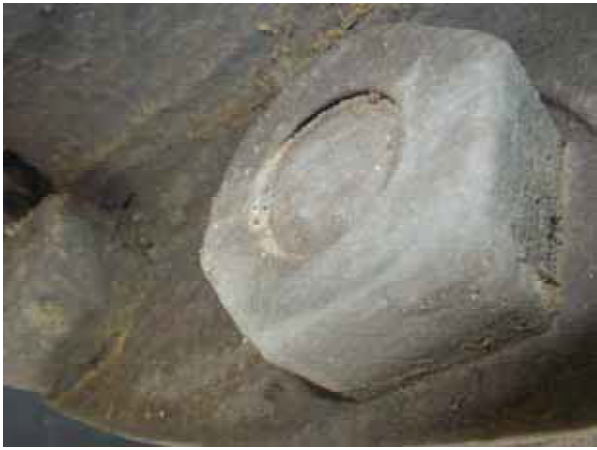
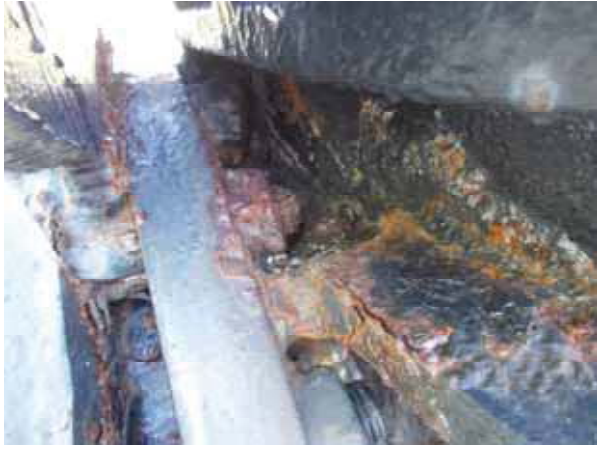
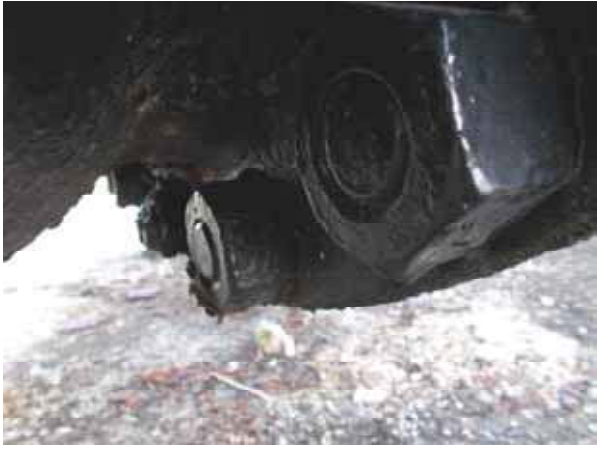
<p>LINE SERVICE</p>	<p>DRAWING REFERENCE</p>
<p>24" Residual Fuel Oil No. 6 (RFO no. 6)</p>	<p>ISO drawing no. 8</p>
<p>DESCRIPTION</p>	<p>LOCATION</p>
<p>Circuit 1 – Cargo line</p>	<p>Inside Terminal – Tank 1935 farm area <i>*Please refer Appendix 3 for detail location</i></p>
<p>FINDING</p>	<p>RECOMMENDATIONS</p>
<p>1. Stud bolts of flanges was observed not extend out from their nuts and corroded especially at bottom section. 2. Atmospheric corrosion was noted at some section of the Valve.</p>	<p>1. To replace with longer stud bolt with the same material and specification. 2. To perform surface preparation and follows by maintenance painting as per client's specification.</p>

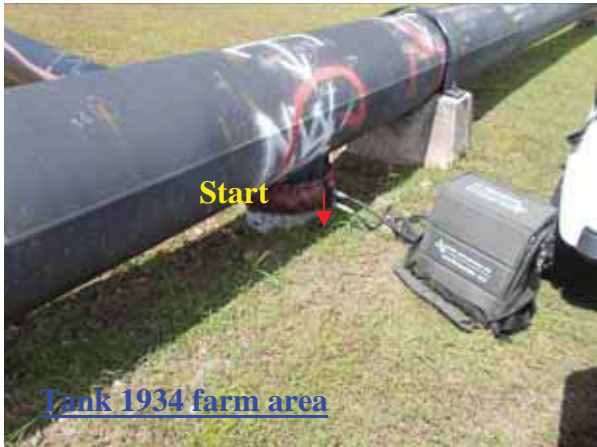
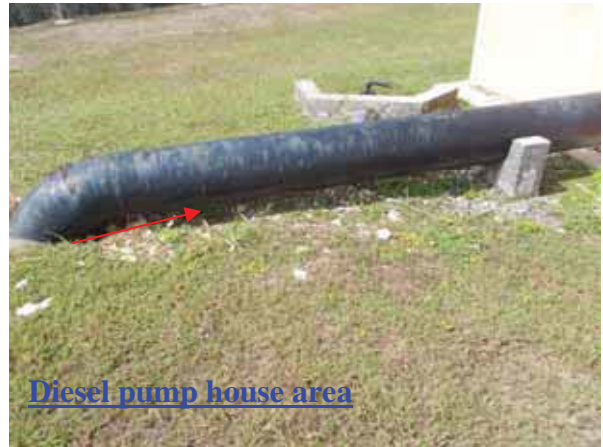
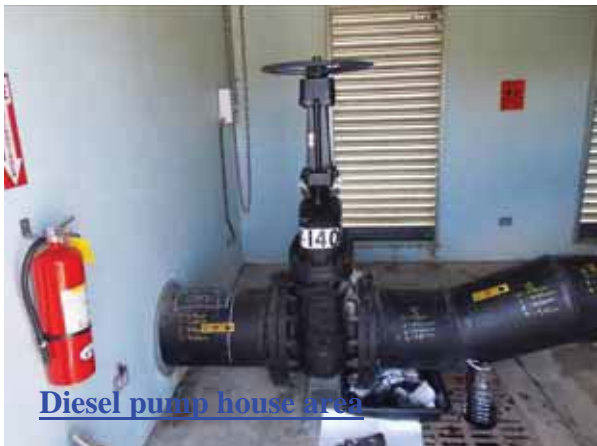
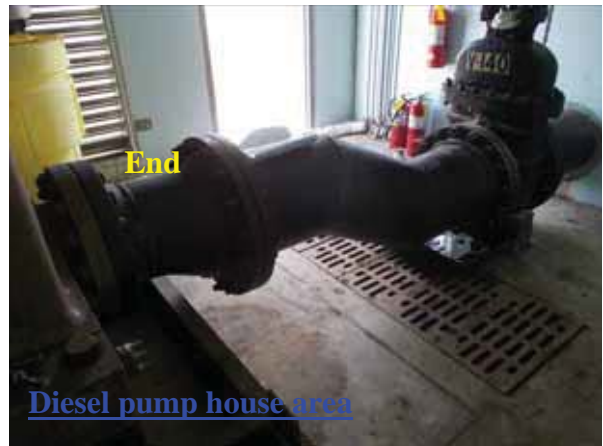
LINE SERVICE	DRAWING REFERENCE
16" Residual Fuel Oil No. 6	ISO drawing no. 7 & 9
DESCRIPTION	LOCATION
Circuit 1 – Diesel pump suction line	Inside Terminal – Close to Diesel Pump House
FINDING	RECOMMENDATIONS
General view of 16" diesel pump suction line.	Nil.

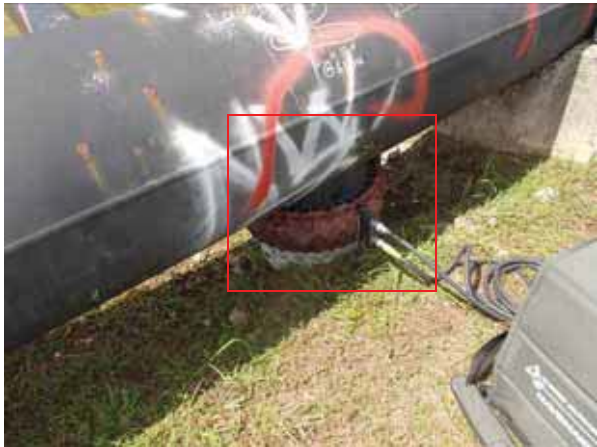
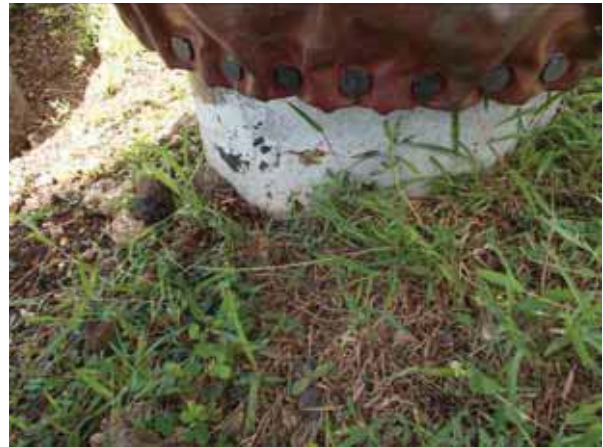
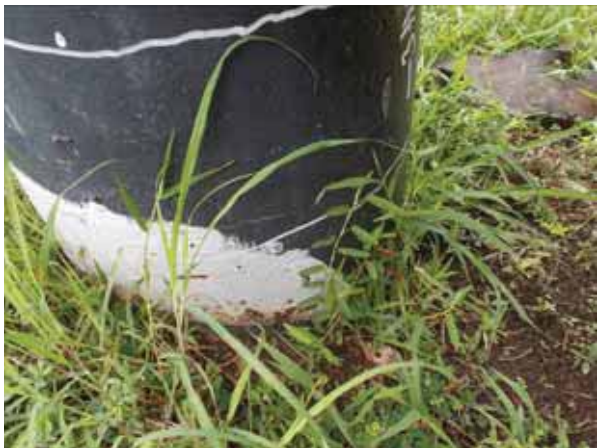
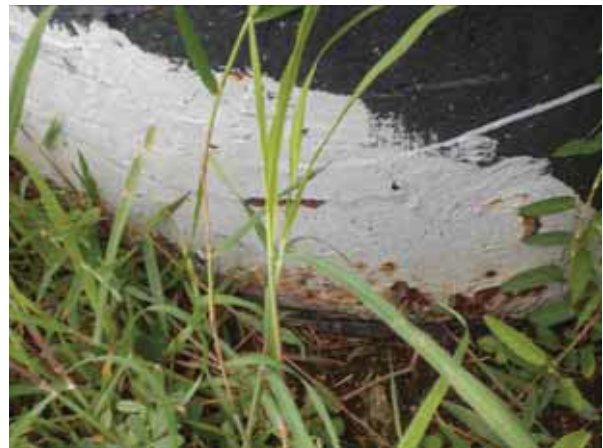
LINE SERVICE	DRAWING REFERENCE
16" Residual Fuel Oil No. 6	ISO drawing no. 7
DESCRIPTION	LOCATION
Circuit 1 – Diesel pump suction line	Inside Terminal – Tank 1934 farm area
FINDING	RECOMMENDATIONS
Paint failure with surface rust was observed at soil to air interface area.	To perform surface, apply coal tar enamel and wrap with proper procedure and suitable wrapping for buried piping up to 6 inch from soil to air interface.

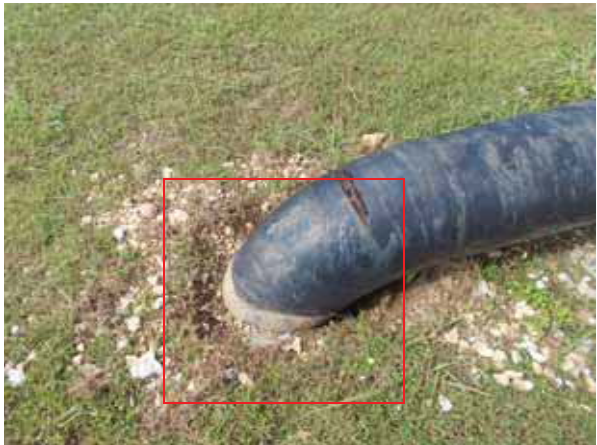
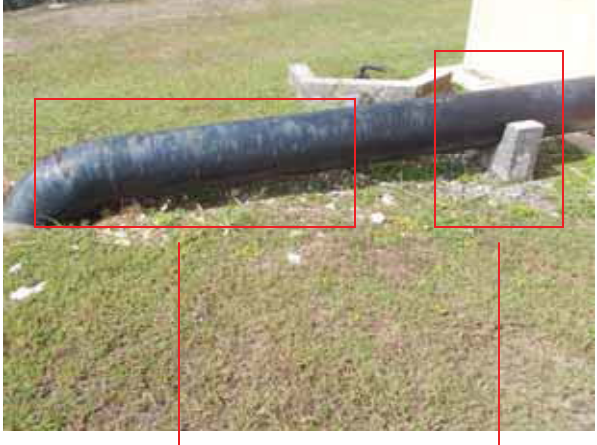
<p><u>Location 53</u></p>   <p>Max. pit depth = 0.06''</p>	<p><u>Location 54</u></p>   <p>Max. pit depth = 0.07''</p>
<p>LINE SERVICE</p>	<p>DRAWING REFERENCE</p>
<p>16" Residual Fuel Oil No. 6 (RFO no. 6)</p>	<p>ISO drawing no. 9</p>
<p>DESCRIPTION</p>	<p>LOCATION</p>
<p>Circuit 1 – Diesel pump suction line</p>	<p>Inside Terminal – Diesel pump house area</p>
<p>FINDING</p>	<p>RECOMMENDATIONS</p>
<p>1. No sign of corrosion at soil to air interface area. 2. Piping was observed too close with ground level and general corrosion was noted at bottom section of the piping, marked as locations 53 and 54 in ISO drawing.</p>	<p>1. Nil. 2. To perform surface preparation and follows by maintenance painting as per client's specification and to ensure the gap 6 inch between piping and soil surface as per API 570 and piping in contact with soil should be insulated.</p>

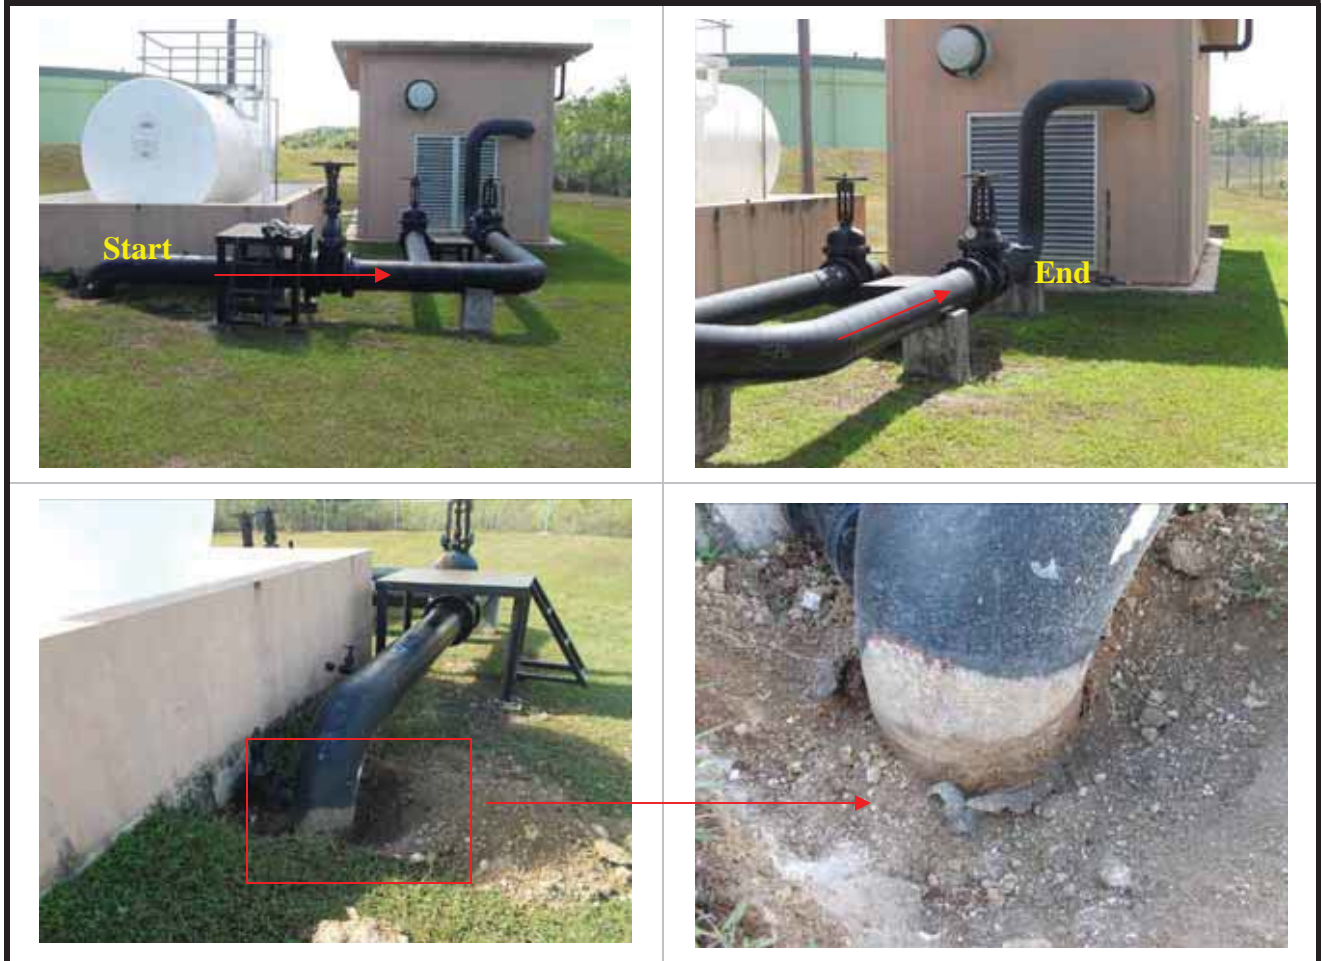
LINE SERVICE	DRAWING REFERENCE
14" Residual Fuel Oil No. 6	ISO drawing no. 10
DESCRIPTION	LOCATION
Circuit 2 - Diesel pump discharge line	Inside Terminal – Diesel pump house area <i>*Please refer Appendix 3 for detail location</i>
FINDING	RECOMMENDATIONS
Wrapping tape at buried piping was observed deteriorated, however no sign of corrosion was noted at soil to air interface area.	To replace the wrapping with suitable material for buried piping and ensure water would not ingress inside and promote to corrosion.

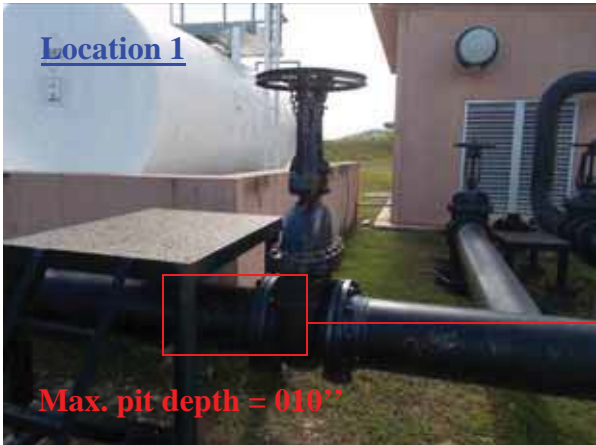
<p><u>Location 1</u></p>

<p>Max. pit depth = 010"</p>	 
<p><u>Location 2</u> At support 1</p>   <p>Max. pit depth = 013"</p>	 
<p>LINE SERVICE</p>	<p>DRAWING REFERENCE</p>
<p>14" Residual Fuel Oil No. 6</p>	<p>ISO drawing no. 10</p>
<p>DESCRIPTION</p>	<p>LOCATION</p>
<p>Circuit 2 – Diesel pump discharge line</p>	<p>Inside Terminal – Diesel pump house area <i>*Please refer Appendix 3 for detail location</i></p>
<p>FINDING</p>	<p>RECOMMENDATIONS</p>
<p>Localized corrosion/pits was noted at bottom section of piping, marked as locations 1 and 2 in ISO drawing. <i>*Please refer Appendix 2 for 1/2 remaining life calculation at pits area.</i></p>	<p>To perform surface preparation and follows by maintenance painting as per client's specification.</p>

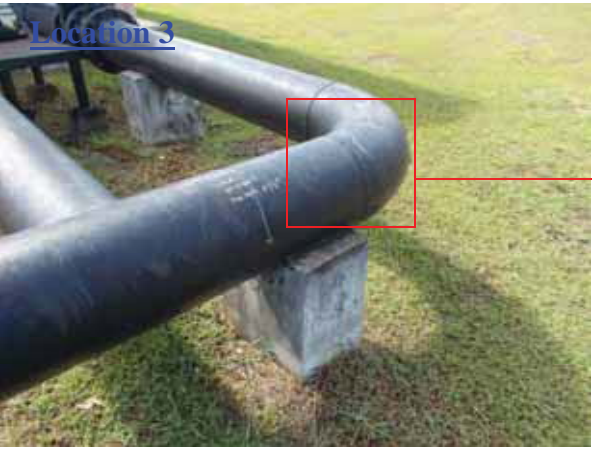
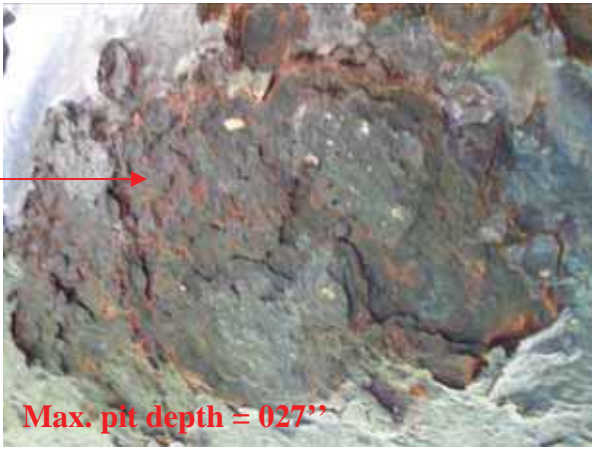
<p><u>Location 3</u></p>

<p>Max. pit depth = 027"</p>

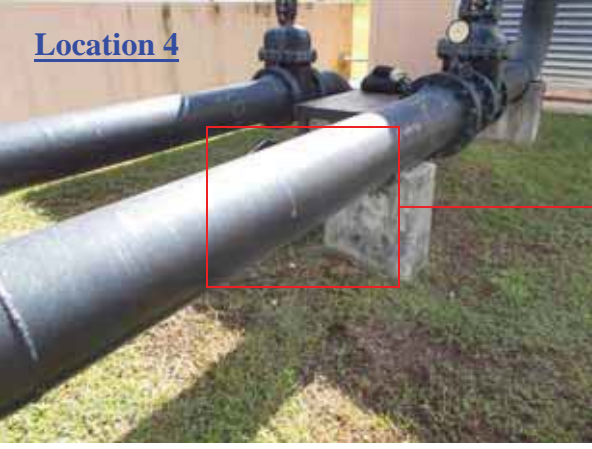
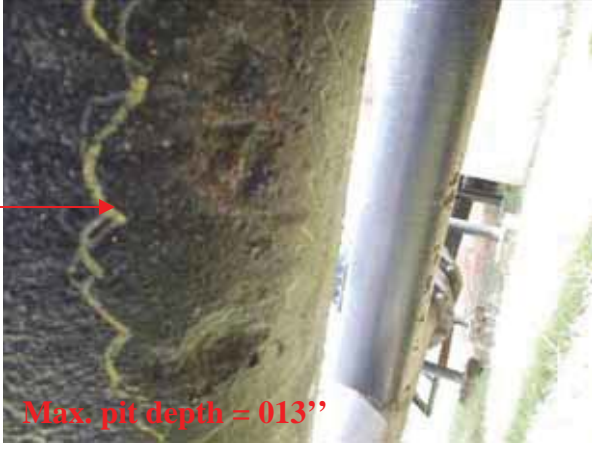
<p><u>Location 4</u></p>

<p>Max. pit depth = 013"</p>
<p>LINE SERVICE</p>	<p>DRAWING REFERENCE</p>
<p>14" Residual Fuel Oil No. 6</p>	<p>ISO drawing no. 10</p>
<p>DESCRIPTION</p>	<p>LOCATION</p>
<p>Circuit 2 – Diesel pump discharge line</p>	<p>Inside Terminal – Diesel pump house area <i>*Please refer Appendix 3 for detail location</i></p>
<p>FINDING</p>	<p>RECOMMENDATIONS</p>
<p>1. General corrosion with scaling was noted at bottom section of elbow, marked as location 3 in ISO drawing. 2. Surface rust was noted at old corrosion, marked as location 4 in ISO drawing. <i>*Please refer Appendix 2 for ½ remaining life calculation at pits area.</i></p>	<p>1. Consideration to perform permanent repair at this area with replace the corroded elbow, follow by NDE and re-painting as per client's specification. 2. To perform surface preparation and follows by maintenance painting as per client's specification.</p>

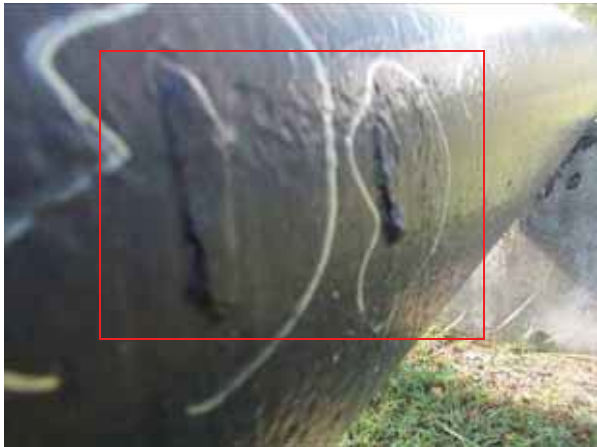
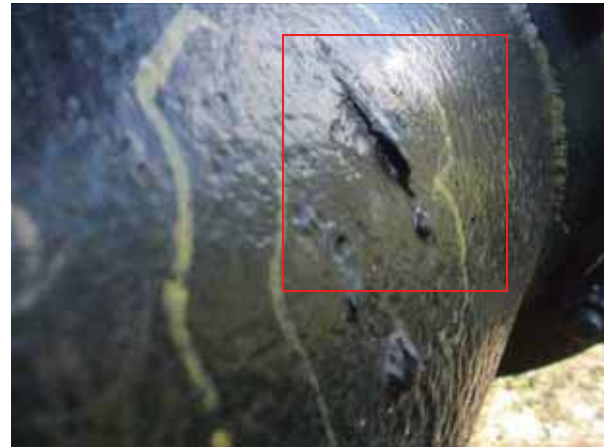
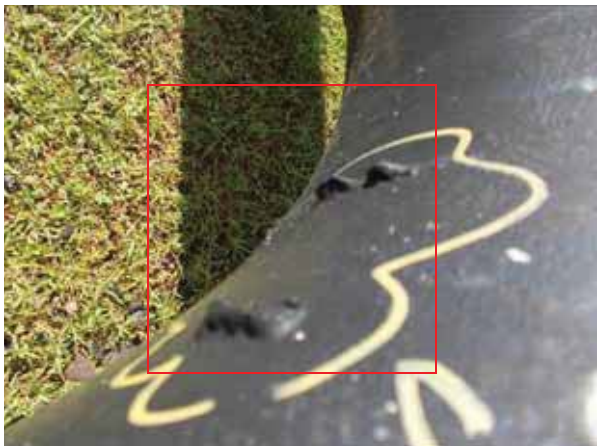
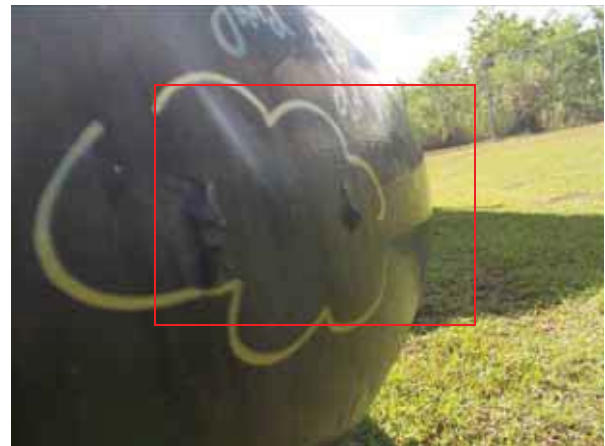
LINE SERVICE	DRAWING REFERENCE
14" Residual Fuel Oil No. 6	ISO drawing no. 10
DESCRIPTION	LOCATION
Circuit 2 – Diesel pump discharge line	Inside Terminal – Diesel pump house area <i>*Please refer Appendix 3 for detail location</i>
FINDING	RECOMMENDATIONS
Remnant tack weld was noted at some section all along the piping.	To grind flush and follows by maintenance painting as per client's specification.

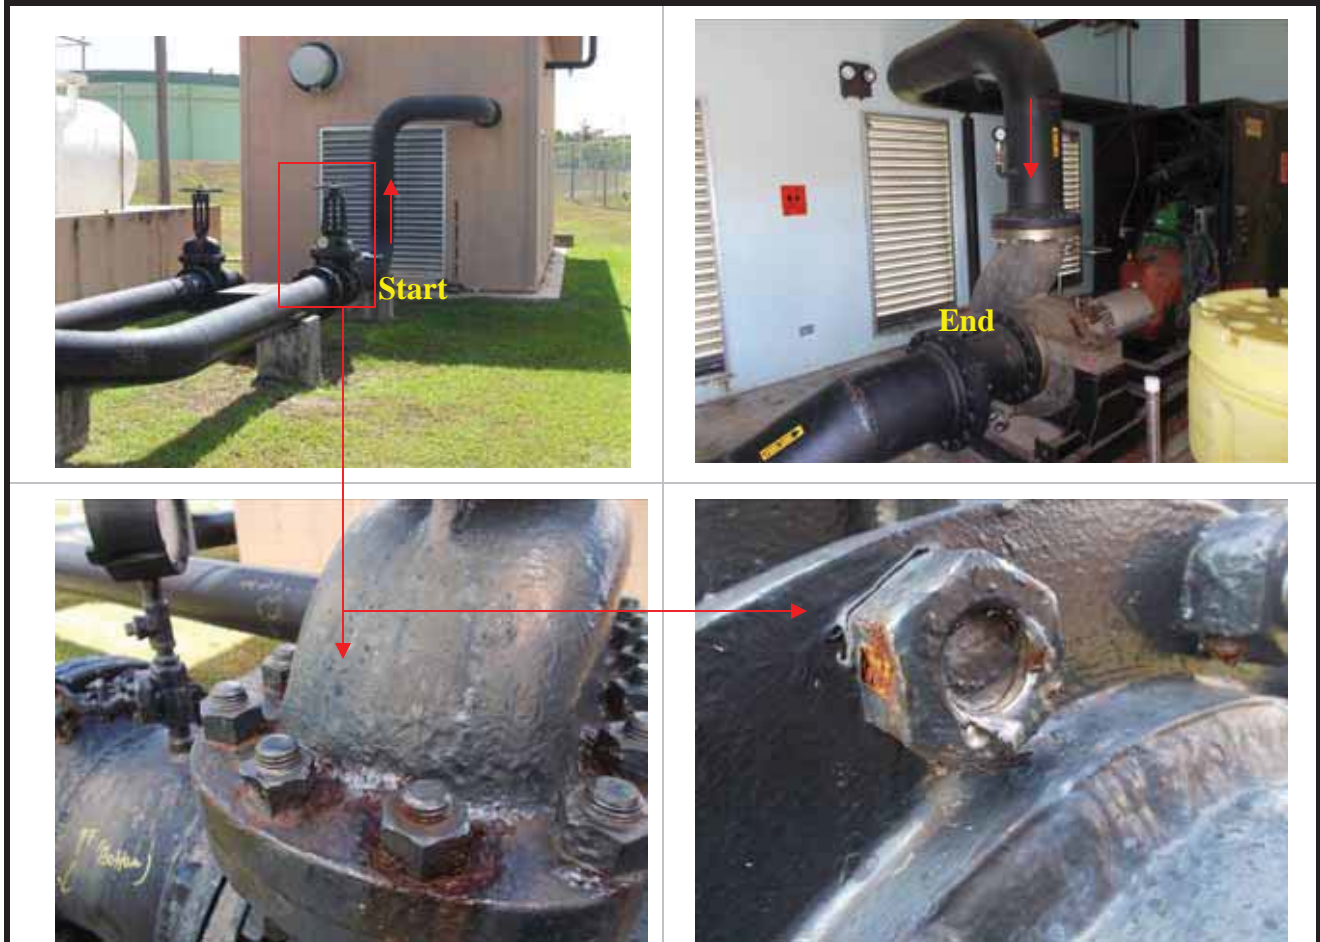
LINE SERVICE	DRAWING REFERENCE
12" Residual Fuel Oil No. 6	ISO drawing no. 10
DESCRIPTION	LOCATION
Circuit 2 – Diesel pump discharge line	Inside Terminal – Diesel pump house area <i>*Please refer Appendix 3 for detail location</i>
FINDING	RECOMMENDATIONS
<ol style="list-style-type: none"> 1. Paint failure with surface rust was observed at some section of V-139. 2. Stud bolts of the valve was noted not extend out trough their nuts. 	<ol style="list-style-type: none"> 1. To perform surface preparation and follows by maintenance painting as per client's specification. 2. To replace with longer stud bolt with the same material and specification.

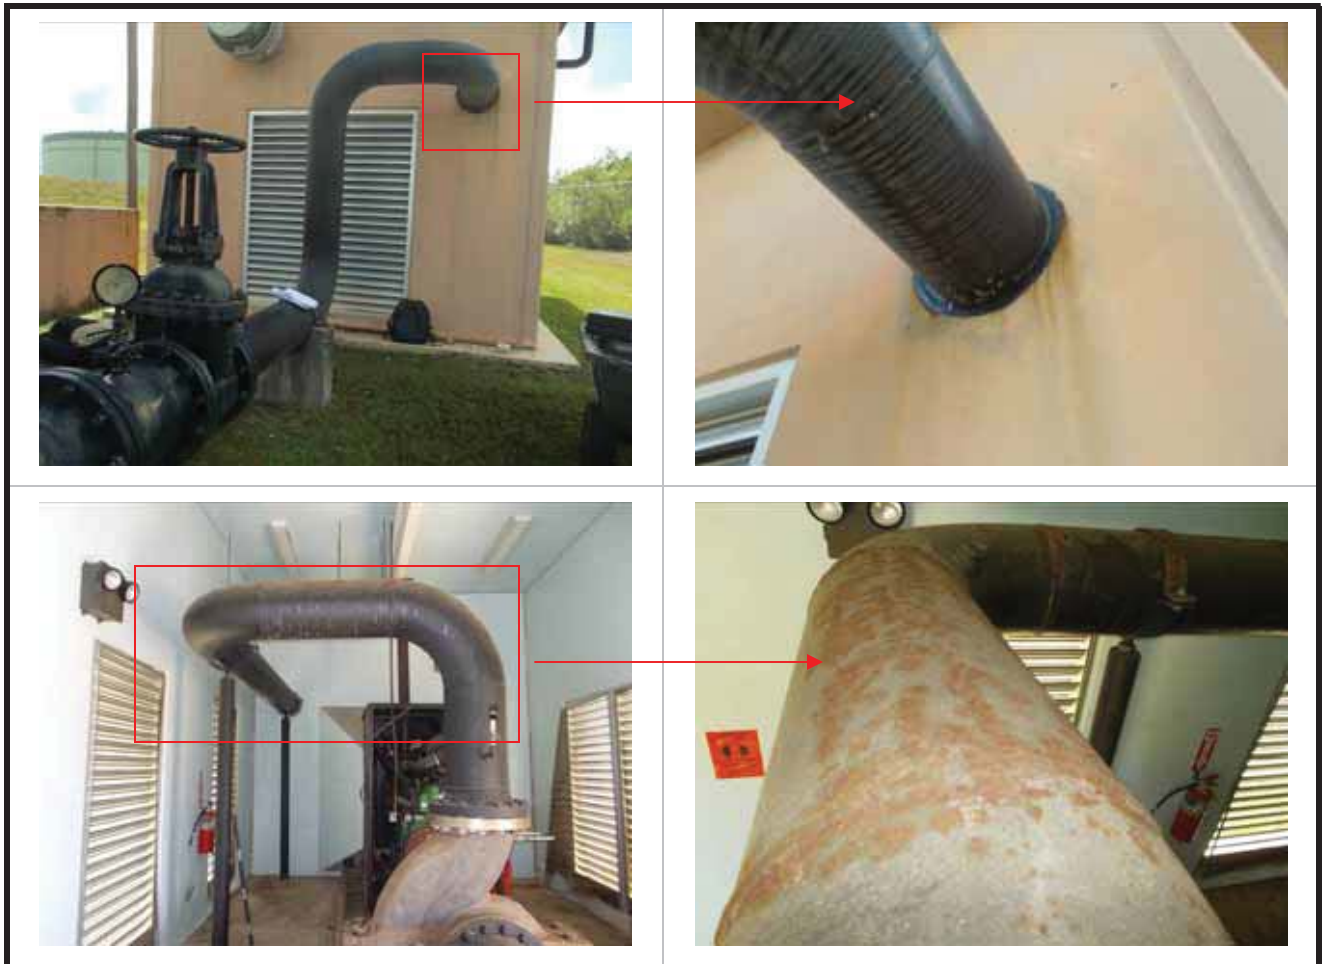
LINE SERVICE	DRAWING REFERENCE
12" Residual Fuel Oil No. 6	ISO drawing no. 10
DESCRIPTION	LOCATION
Circuit 2 – Diesel pump discharge line	Inside Terminal – Diesel pump house area <i>*Please refer Appendix 3 for detail location</i>
FINDING	RECOMMENDATIONS
<ol style="list-style-type: none"> 1. Sealant was observed intact and no sign of corrosion under sealant was noted. 2. Paint failure with surface rust was noted on top section of piping. 	<ol style="list-style-type: none"> 1. Nil. 2. To replace with longer stud bolt with the same material and specification.
