**INSIDE TERMINAL**  
**Circuit 3**  
**- Transfer line -**

**INSIDE TERMINAL**  
**Circuit 3**  
**- Fuel supply line -**

INSIDE TERMINAL  
Circuit 4  
- Tango line -

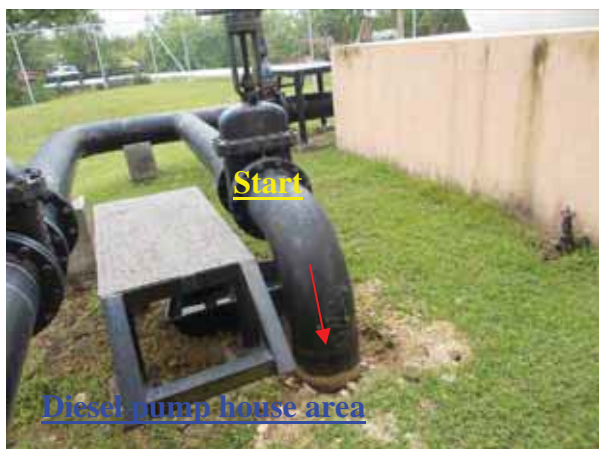
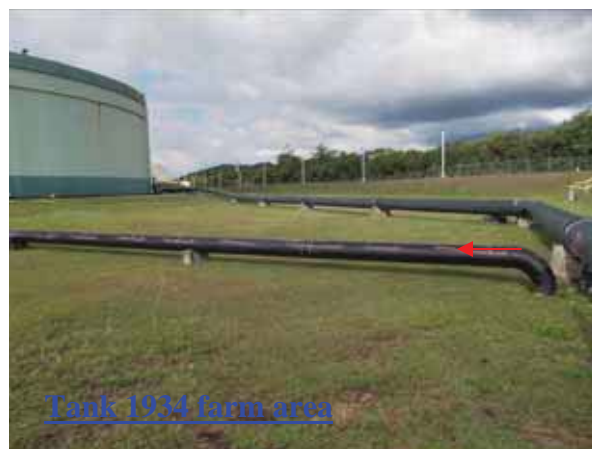
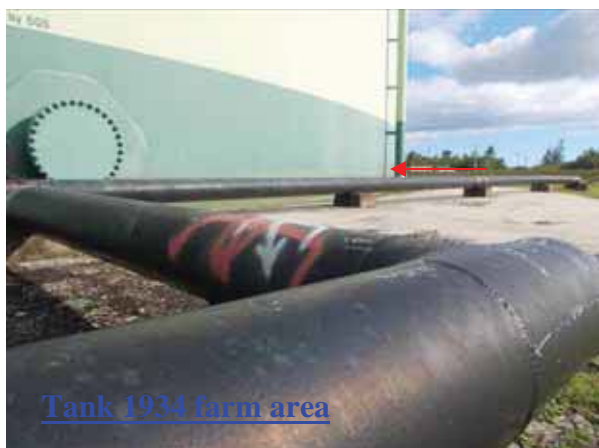
LINE SERVICE	DRAWING REFERENCE
12" Residual Fuel Oil No. 6 (RFO no. 6)	ISO drawing no. 11, 12 & 13
DESCRIPTION	LOCATION
Circuit 3 - Transfer line	Inside Terminal – Diesel pump house and tank 1934 farm area <i>*Please refer Appendix 3 for detail location</i>
FINDING	RECOMMENDATIONS
General view of 12" RFO no. 6 transfer line from diesel Pump discharge line to tank 1934.	Nil.

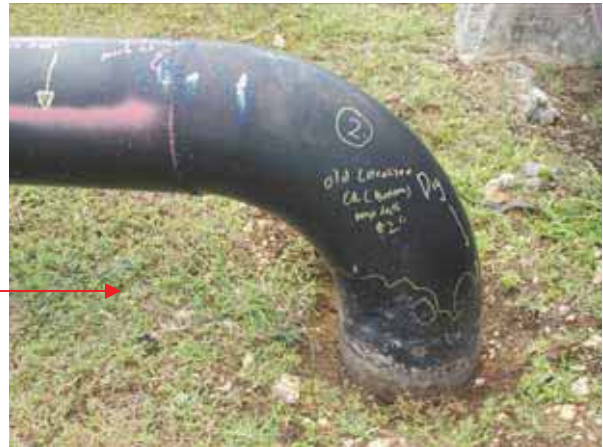
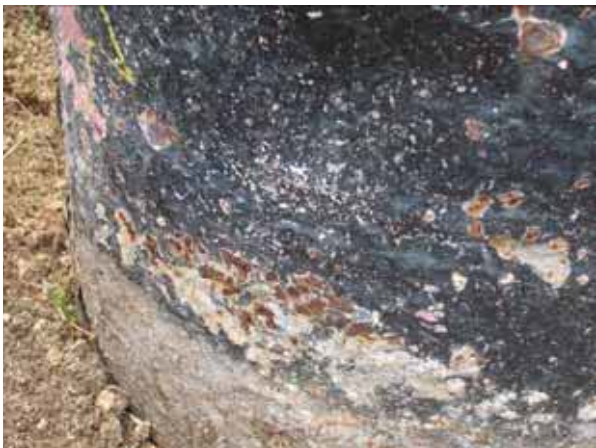
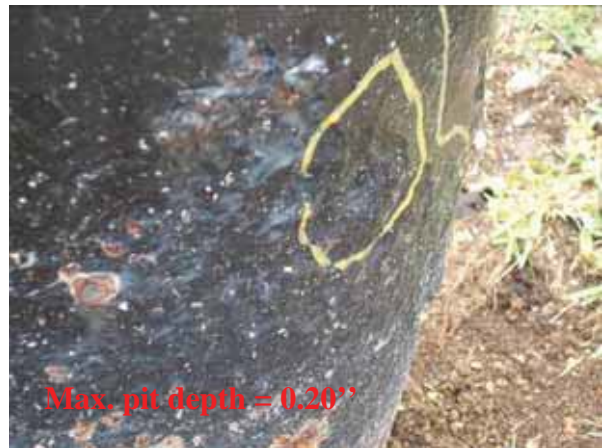
Location 2

LINE SERVICE	DRAWING REFERENCE
12" Residual Fuel Oil No. 6 (RFO no. 6)	ISO drawing no. 11
DESCRIPTION	LOCATION
Circuit 3 - Transfer line	Inside Terminal – Tank 1934 Farm Area <i>*Please refer Appendix 3 for detail location</i>
FINDING	RECOMMENDATIONS
Corrosion under wrapping was noted at soil to air interface area due to wrap failure and gives a path to water ingress inside, marked as location 2 in ISO drawing. No sign of corrosion propagate deeper after the wrapping end. <i>*Please refer Appendix 2 for ½ remaining life calculation at pits area.</i>	Consideration to perform permanent repair at this area with remove the corrosion, restore with weld metal deposited/insert weld patch, apply coal tar enamel and re-wrap with proper procedure and suitable wrapping for buried piping up to 6" from soil to air interface.

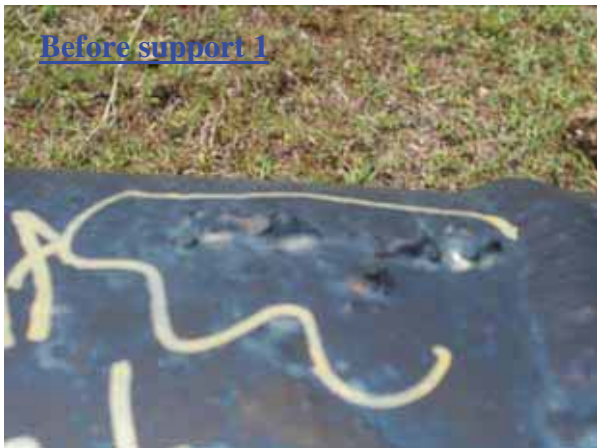
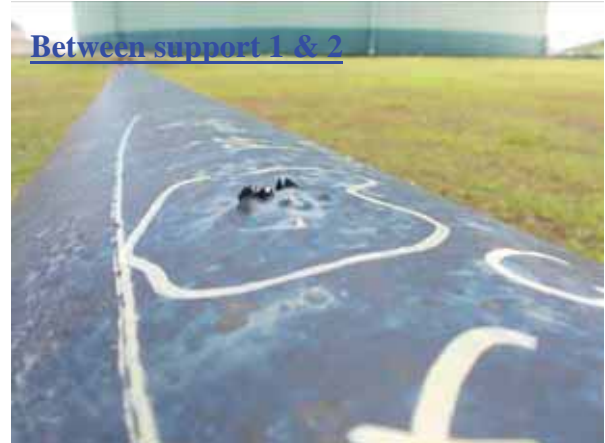
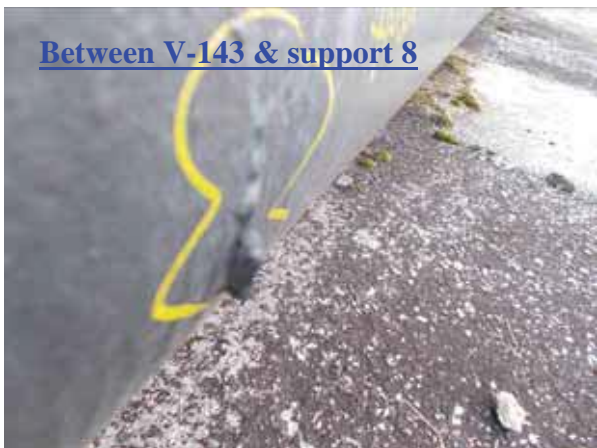
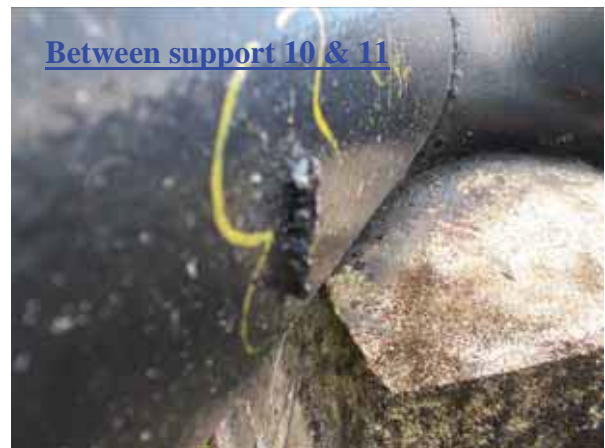
LINE SERVICE	DRAWING REFERENCE
12" Residual Fuel Oil No. 6 (RFO no. 6)	ISO drawing no. 11 & 12
DESCRIPTION	LOCATION
Circuit 3 - Transfer line	Inside Terminal – Tank 1934 Farm Area <i>*Please refer Appendix 3 for detail location</i>
FINDING	RECOMMENDATIONS
Remnant tack weld was noted on top and side section of piping.	To grind flush and follows by maintenance painting as per client's specification.

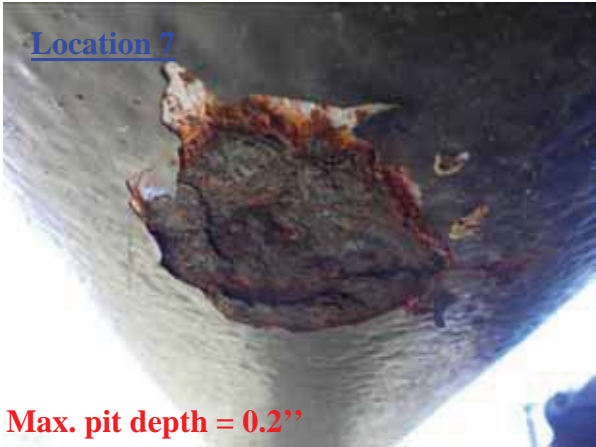
<p><b>Location 7</b></p> <p><b>Max. pit depth = 0.2"</b></p>

<p><b>Location 10</b></p> <p><b>Max. pit depth = 0.25"</b></p>
<p><b>LINE SERVICE</b></p>	<p><b>DRAWING REFERENCE</b></p>
<p>12" Residual Fuel Oil No. 6 (RFO no. 6)</p>	<p>ISO drawing no. 12</p>
<p><b>DESCRIPTION</b></p>	<p><b>LOCATION</b></p>
<p>Circuit 3 - Transfer line</p>	<p>Inside Terminal – Tank 1934 Farm Area <i>*Please refer Appendix 3 for detail location</i></p>
<p><b>FINDING</b></p>	<p><b>RECOMMENDATIONS</b></p>
<p>1. Localized corrosion with scaling/pits was noted at bottom section of piping, marked as locations 7, 8, and 9 in ISO drawing.</p> <p>2. Gap was observed between piping and support and localized corrosion with scaling/pits was noted at the area, marked as location 10 in ISO drawing.</p> <p><i>*Please refer Appendix 2 for ½ remaining life calculation at pits area.</i></p>	<p>1. To perform surface preparation and follows by maintenance painting as per client's specification for location 9. Consideration to perform permanent repair at locations 7, 8 with remove the corrosion, restore with weld metal deposited/insert weld patch, follow by NDE and re-painting as per client's specification.</p> <p>2. To lift the piping and consideration to perform permanent repair as above.</p> <p>Note:-Pits depth measurement at contact area between piping and support based on estimation due to inaccessible area.</p>

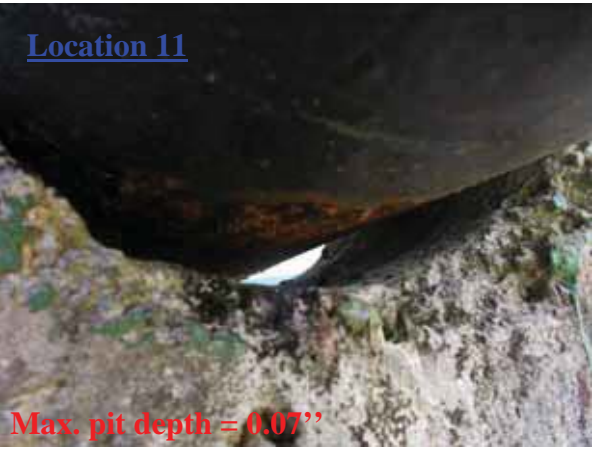
<p><u>Location 11</u></p>

<p>Max. pit depth = 0.22"</p>
<p><b>LINE SERVICE</b></p>	<p><b>DRAWING REFERENCE</b></p>
<p>12" Residual Fuel Oil No. 6 (RFO no. 6)</p>	<p>ISO drawing no. 12</p>
<p><b>DESCRIPTION</b></p>	<p><b>LOCATION</b></p>
<p>Circuit 3 - Transfer line</p>	<p>Inside Terminal – Tank 1934 Farm Area <i>*Please refer Appendix 3 for detail location</i></p>
<p><b>FINDING</b></p>	<p><b>RECOMMENDATIONS</b></p>
<p>1. Localized corrosion with scaling/pits was noted at bottom section of piping, marked as locations 12, and 13 in ISO drawing. 2. Corrosion with scaling was noted at contact area between piping and support, marked as locations 11 and 14 in ISO drawing. <i>*Please refer Appendix 2 for ½ remaining life calculation at pits area.</i></p>	<p>1. To perform surface preparation and follows by maintenance painting as per client's specification for location 13. Consideration to perform permanent repair at locations 12 with remove the corrosion, restore with weld metal deposited/insert weld patch, follow by NDE and re-painting as per client's specification. 2. To lift the piping, perform surface preparation and follows by maintenance painting as per client's specification for location 11 and permanent repair as above for location 14. Note:-Pits depth measurement at contact area between piping and support based on estimation due to inaccessible area.</p>

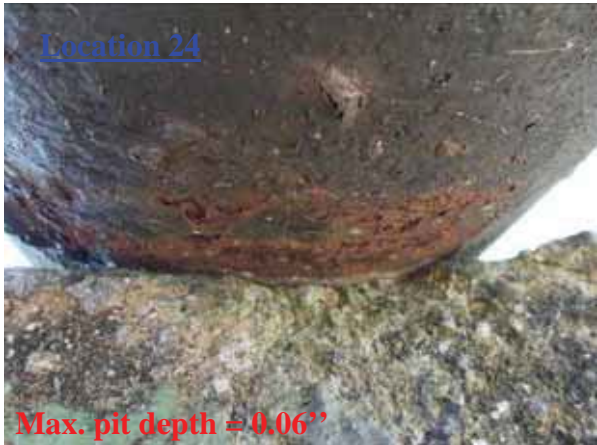
<p><u>Location 24</u></p> <p>Max. pit depth = 0.06"</p>

<p><u>Location 27</u></p> <p>Max. pit depth = 0.05"</p>
<p><b>LINE SERVICE</b></p>	<p><b>DRAWING REFERENCE</b></p>
<p>12" Residual Fuel Oil No. 6 (RFO no. 6)</p>	<p>ISO drawing no. 12 &amp; 13</p>
<p><b>DESCRIPTION</b></p>	<p><b>LOCATION</b></p>
<p>Circuit 3 - Transfer line</p>	<p>Inside Terminal – Tank 1934 Farm Area <i>*Please refer Appendix 3 for detail location</i></p>
<p><b>FINDING</b></p>	<p><b>RECOMMENDATIONS</b></p>
<p>Localized corrosion with/pits was noted at bottom section of piping, marked as locations 24, 25, 26 and 27 in ISO drawing. <i>*Please refer Appendix 2 for ½ remaining life calculation at pits area.</i></p>	<p>To perform surface preparation and follows by maintenance painting as per client's specification.</p>

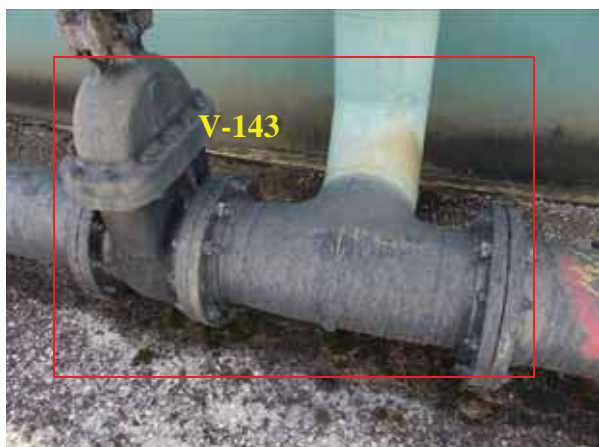
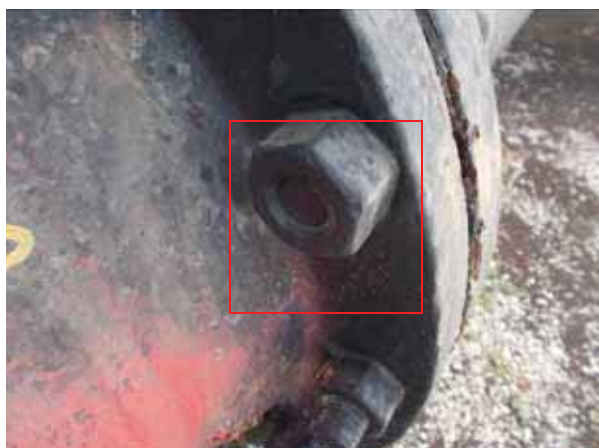
LINE SERVICE	DRAWING REFERENCE
12" Residual Fuel Oil No. 6 (RFO no. 6)	ISO drawing no. 13
DESCRIPTION	LOCATION
Circuit 3 - Transfer line	Inside Terminal – Tank 1934 Farm Area <i>*Please refer Appendix 3 for detail location</i>
FINDING	RECOMMENDATIONS
<ol style="list-style-type: none"> <li>1. Stud bolts of flange was noted not extend out through their nut.</li> <li>2. Paint failure with surface was noted at some section of V-143 valve.</li> </ol>	<ol style="list-style-type: none"> <li>1. To replace with longer stud bolt with the same material and specification.</li> <li>2. To perform surface preparation and follows by maintenance painting as per client's specification.</li> </ol>

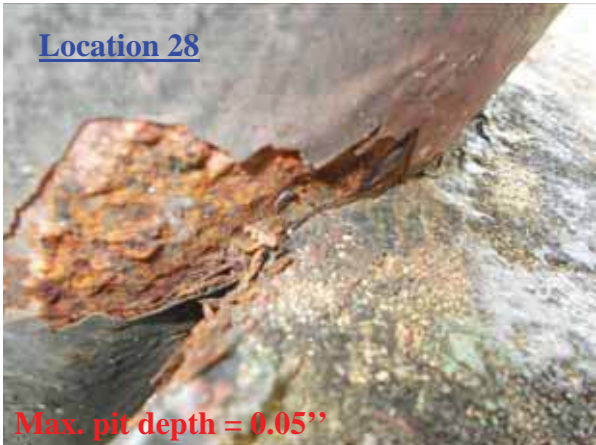
<p><u>Location 28</u></p>

<p>Max. pit depth = 0.23"</p>
<p><b>LINE SERVICE</b></p>	<p><b>DRAWING REFERENCE</b></p>
<p>12" Residual Fuel Oil No. 6 (RFO no. 6)</p>	<p>ISO drawing no. 13</p>
<p><b>DESCRIPTION</b></p>	<p><b>LOCATION</b></p>
<p>Circuit 3 - Transfer line</p>	<p>Inside Terminal – Tank 1934 Farm Area <i>*Please refer Appendix 3 for detail location</i></p>
<p><b>FINDING</b></p>	<p><b>RECOMMENDATIONS</b></p>
<p>1. Localized corrosion with scaling/pits was noted at bottom section of piping, marked as locations 29, and 31 in ISO drawing. 2. Corrosion with scaling was noted at contact area between piping and support, marked as locations 28 and 30 in ISO drawing. <i>*Please refer Appendix 2 for ½ remaining life calculation at pits area.</i></p>	<p>1. Consideration to perform permanent repair at this area with remove the corrosion, restore with weld metal deposited/insert weld patch, follow by NDE and re-painting as per client's specification. 2. To lift the piping and perform surface preparation and follows by maintenance painting as per client's specification for location 28 and permanent repair as above for location 30. Note:-Pits depth measurement at contact area between piping and support based on estimation due to inaccessible area.</p>

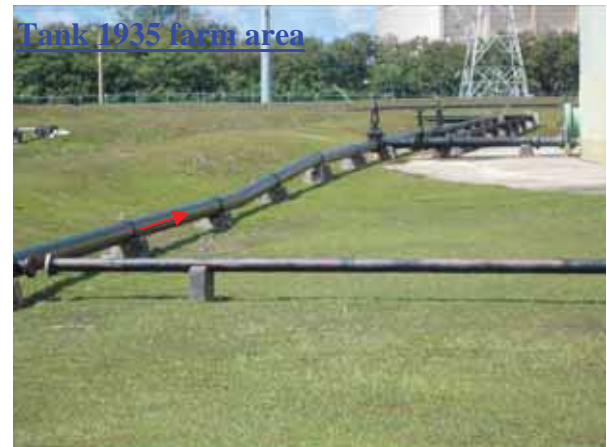
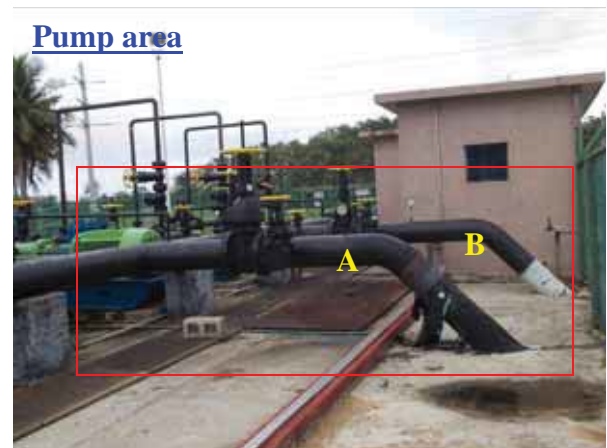
LINE SERVICE	DRAWING REFERENCE
12" Residual Fuel Oil No. 6	ISO drawing no. 14 to 18
DESCRIPTION	LOCATION
Circuit 3 - Fuel supply line	Inside Terminal – Tank 1934, 1935 farm and pump area <i>*Please refer Appendix 3 for detail location</i>
FINDING	RECOMMENDATIONS
General view of fuel supply line from tank 1934 & 1935 to pump.	Nil.

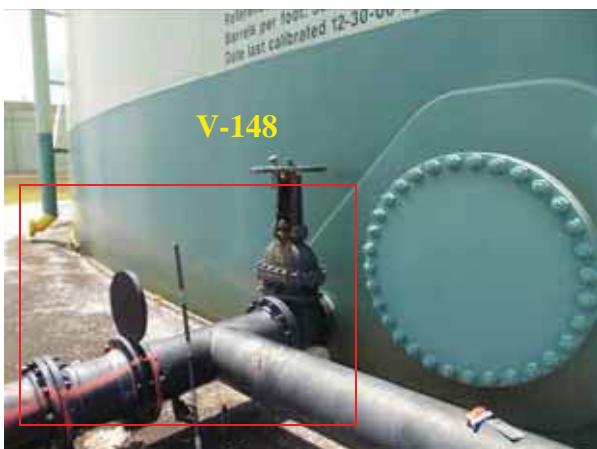
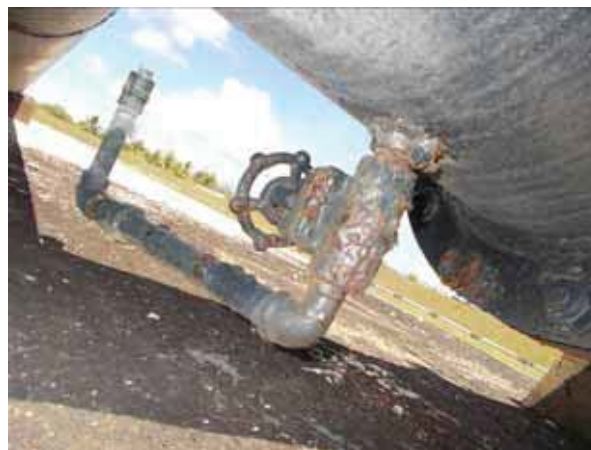
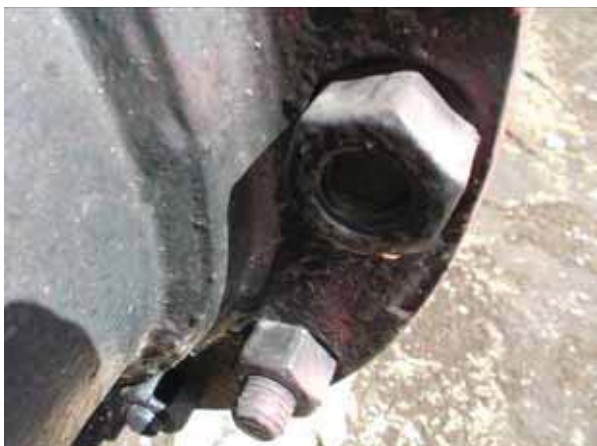
LINE SERVICE	DRAWING REFERENCE
12" Residual Fuel Oil No. 6 (RFO no. 6)	ISO drawing no. 14
DESCRIPTION	LOCATION
Circuit 3 - Transfer line	Inside Terminal – Tank 1934 Farm Area <i>*Please refer Appendix 3 for detail location</i>
FINDING	RECOMMENDATIONS
<ol style="list-style-type: none"> <li>1. General view of small bore piping (<math>\frac{3}{4}</math>" drain line).</li> <li>2. Stud bolts of flange was noted not extend out through their nut.</li> <li>3. Stud bolts of flanges was noted to be missing.</li> </ol>	<ol style="list-style-type: none"> <li>1. Consideration to perform profile Radiographic Testing (RT) for thickness measurement at small bore piping.</li> <li>2. To replace with longer stud bolt with the same material and specification.</li> <li>3. To replace the missing stud bolt with the same material and specification</li> </ol>

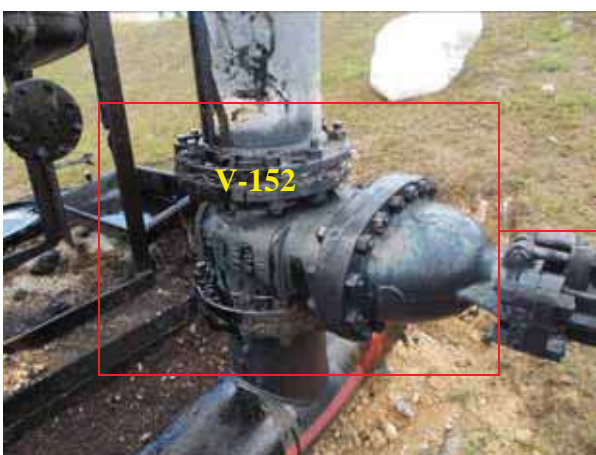
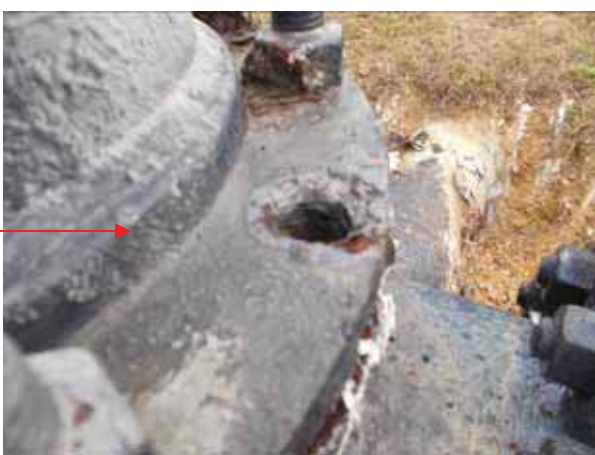
<b>LINE SERVICE</b>	<b>DRAWING REFERENCE</b>
12" Residual Fuel Oil No. 6	ISO drawing no. 14
<b>DESCRIPTION</b>	<b>LOCATION</b>
Circuit 3 - Fuel supply line	Inside Terminal – Tank 1934 Farm Area <i>*Please refer Appendix 3 for detail location</i>
<b>FINDING</b>	<b>RECOMMENDATIONS</b>
1. Stud bolts of flanges V-149 was noted not extend out through their nut. 2. Stud bolts of flanges V-152 was noted to be missing.	1. To replace with longer stud bolt with the same material and specification. 2. To replace the missing stud bolt with the same material and specification

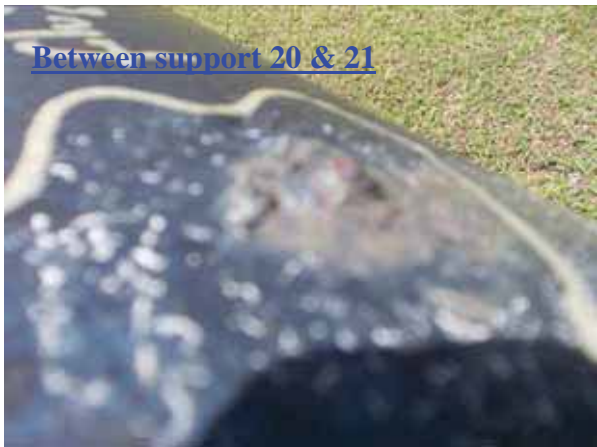
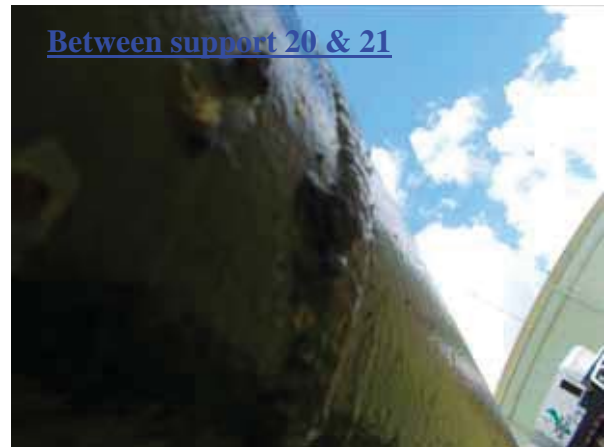
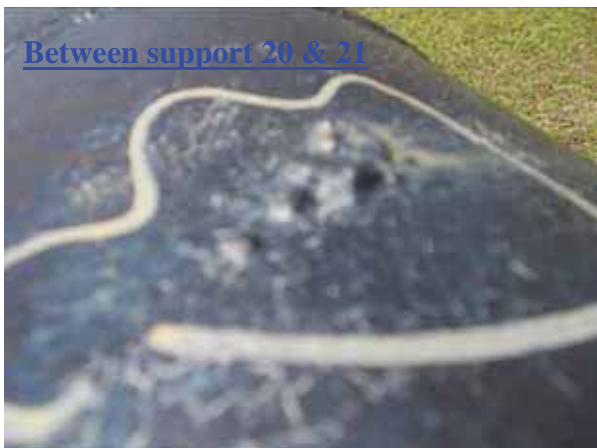
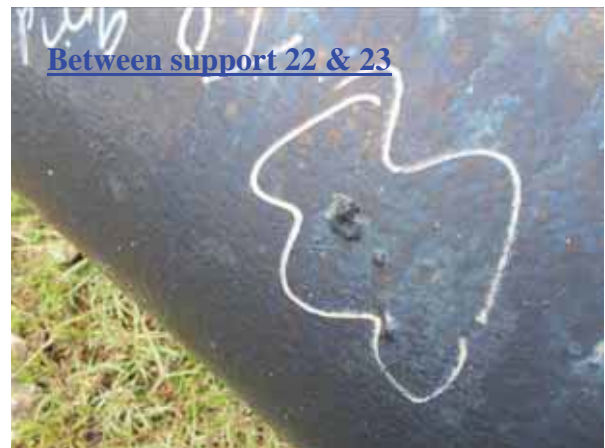
LINE SERVICE	DRAWING REFERENCE
12" Residual Fuel Oil No. 6	ISO drawing no. 14
DESCRIPTION	LOCATION
Circuit 3 - Fuel supply line	Inside Terminal – Tank 1935 Farm Area <i>*Please refer Appendix 3 for detail location</i>
FINDING	RECOMMENDATIONS
Remnant tack weld was noted at side section of piping.	To grind flush and follows by maintenance painting as per client's specification.

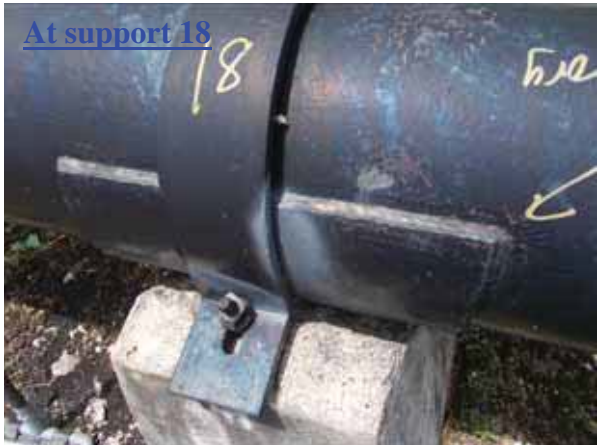
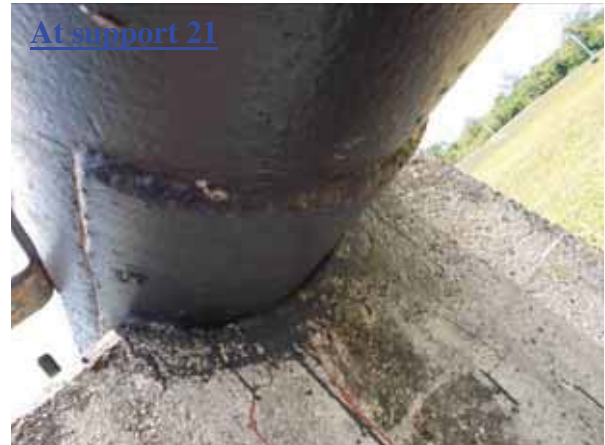
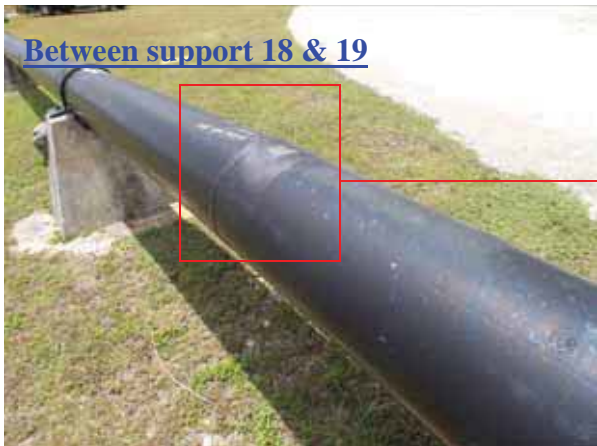
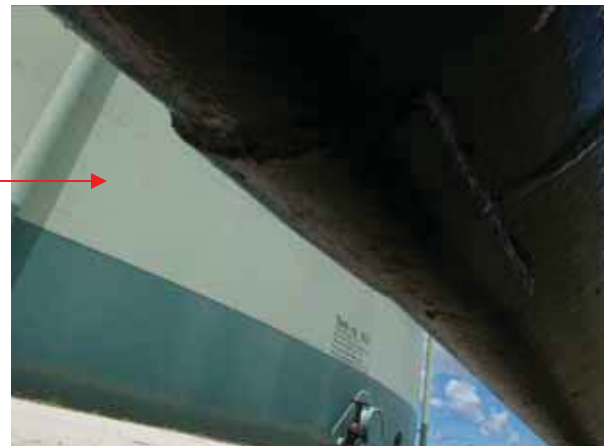
LINE SERVICE	DRAWING REFERENCE
12" Residual Fuel Oil No. 6	ISO drawing no. 14
DESCRIPTION	LOCATION
Circuit 3 - Fuel supply line	Inside Terminal – Tank 1934 Farm Area <i>*Please refer Appendix 3 for detail location</i>
FINDING	RECOMMENDATIONS
Temporary repair was noted at bottom section of piping. According to API 570 paragraph 8.1.4.1, <i>the design of temporary enclosures and repair shall be approved by piping engineer and temporary repairs should be removed and replaced with a suitable permanent repair at the next available maintenance opportunity.</i>	Consideration to perform permanent repair in accordance to API 570, restore with weld metal deposited/insert weld patch follows by NDE and painting as per client's specification.

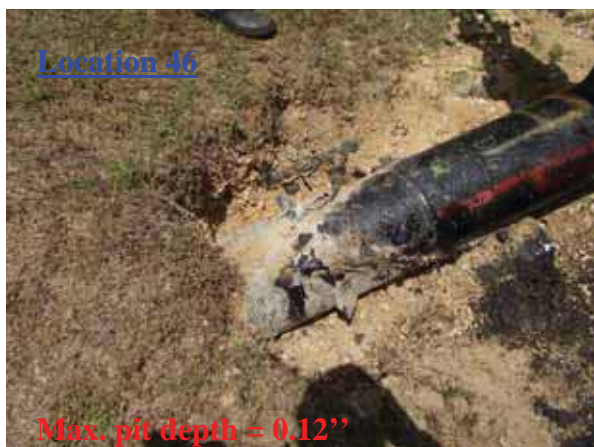
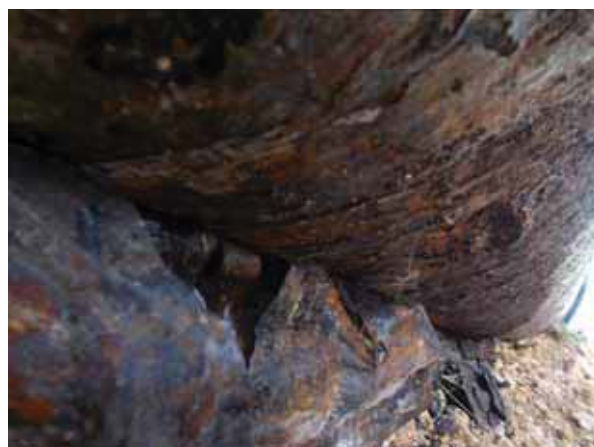
LINE SERVICE	DRAWING REFERENCE
12" Residual Fuel Oil No. 6	ISO drawing no. 15
DESCRIPTION	LOCATION
Circuit 3 - Fuel supply line	Inside Terminal – Tank 1935 Farm Area <i>*Please refer Appendix 3 for detail location</i>
FINDING	RECOMMENDATIONS
Corrosion under wrapping was noted at soil to air interface area due to wrap failure and gives a path to water ingress inside, marked as location 46 in ISO drawing. No sign of corrosion propagate deeper after the wrapping end. <i>*Please refer Appendix 2 for ½ remaining life calculation at pits area.</i>	To perform surface preparation extend to the last corrosion, apply coal tar enamel and re-wrap with proper procedure and suitable wrapping for buried piping up to 6" from soil to air interface.

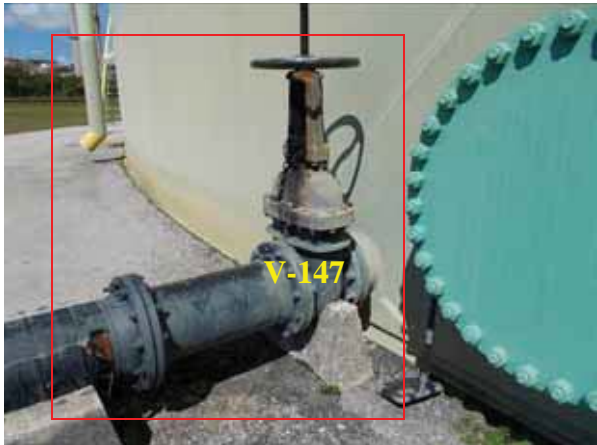
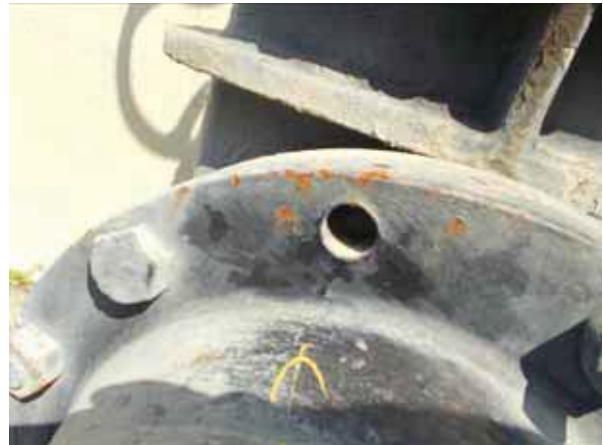
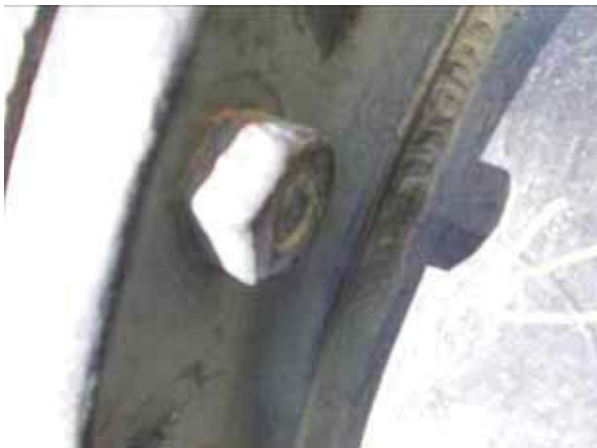
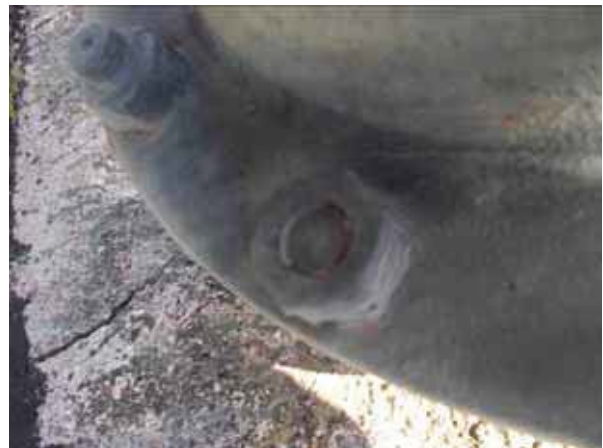
LINE SERVICE	DRAWING REFERENCE
12" Residual Fuel Oil No. 6	ISO drawing no. 15
DESCRIPTION	LOCATION
Circuit 3 - Fuel supply line	Inside Terminal – Tank 1935 Farm Area <i>*Please refer Appendix 3 for detail location</i>
FINDING	RECOMMENDATIONS
<ol style="list-style-type: none"> <li>1. Stud bolts of flange was noted not extend out through their nut.</li> <li>2. Stud bolts of flanges was noted to be missing.</li> </ol>	<ol style="list-style-type: none"> <li>1. To replace with longer stud bolt with the same material and specification.</li> <li>2. To replace the missing stud bolt with the same material and specification</li> </ol>

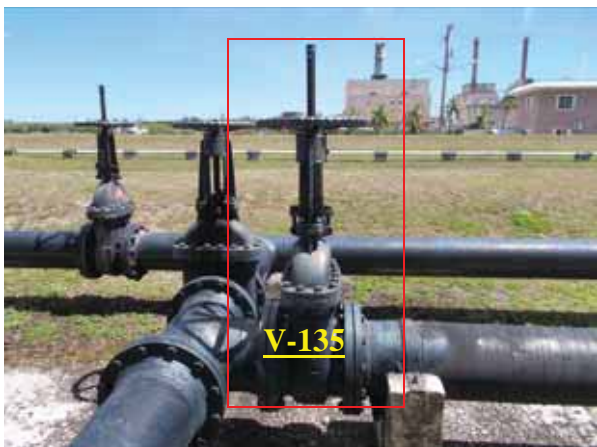
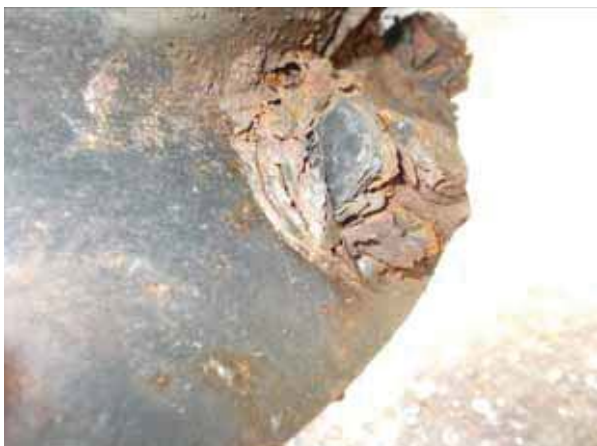
LINE SERVICE	DRAWING REFERENCE
12" (B) Residual Fuel Oil No. 6	ISO drawing no. 16
DESCRIPTION	LOCATION
Circuit 3 - Fuel supply line	Inside Terminal – Tank 1935 Farm Area <i>*Please refer Appendix 3 for detail location</i>
FINDING	RECOMMENDATIONS
<ol style="list-style-type: none"> <li>1. Stud bolts of valve was noted corroded.</li> <li>2. Paint failure with surface rust was noted at some section of the valve.</li> </ol>	<ol style="list-style-type: none"> <li>1. To replace the corroded stud bolts with the same material and specification.</li> <li>2. To perform surface preparation and follows by maintenance painting as per client's specification.</li> </ol>

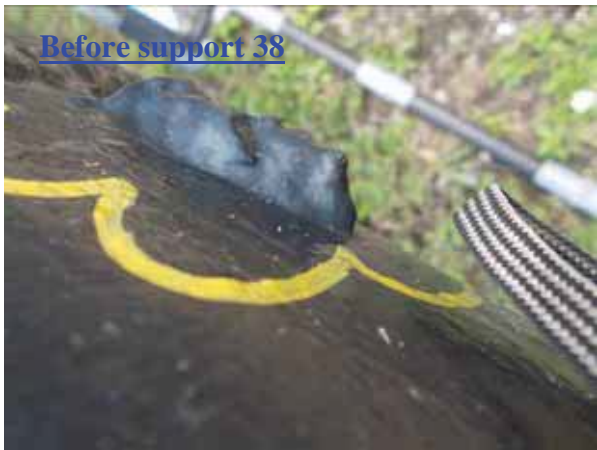
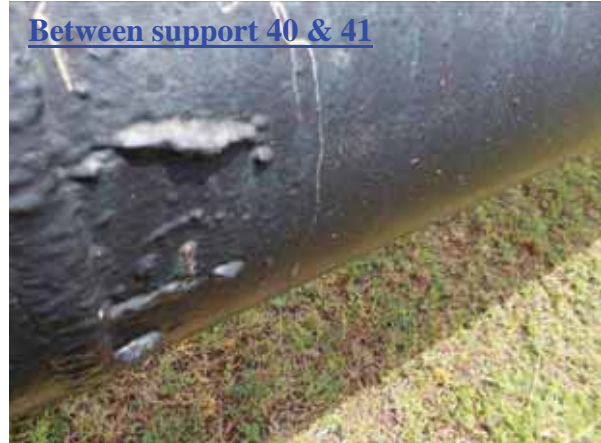
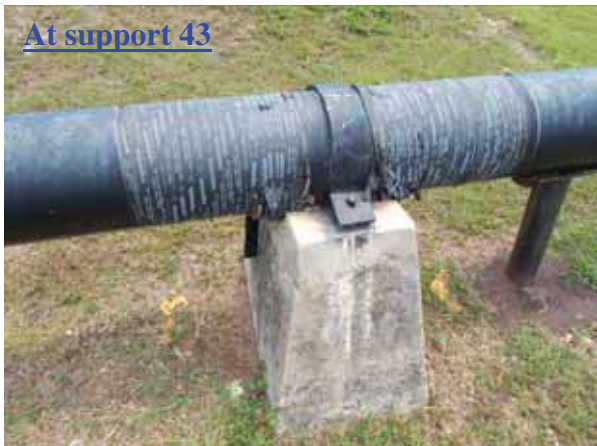
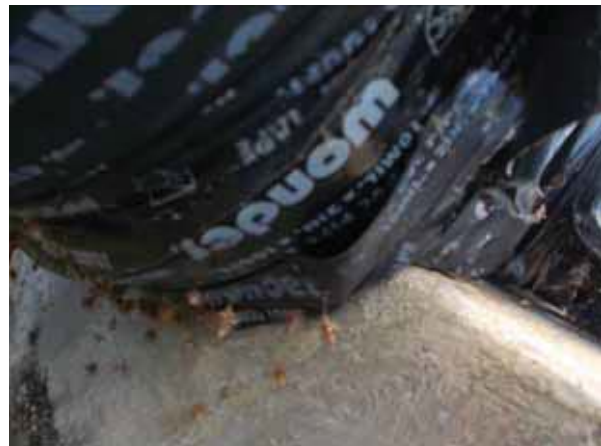
LINE SERVICE	DRAWING REFERENCE
12" (A) Residual Fuel Oil No. 6	ISO drawing no. 16
DESCRIPTION	LOCATION
Circuit 3 - Fuel supply line	Inside Terminal – Tank 1935 Farm Area <i>*Please refer Appendix 3 for detail location</i>
FINDING	RECOMMENDATIONS
<p>1. Remnant tack weld was noted at side section of piping.</p> <p>2. Temporary repair was noted at bottom section of piping.</p> <p>According to API 570 paragraph 8.1.4.1, <i>the design of temporary enclosures and repair shall be approved by piping engineer and temporary repairs should be removed and replaced with a suitable permanent repair at the next available maintenance opportunity.</i></p>	<p>1. To grind flush and follows by maintenance painting as per client's specification.</p> <p>2. Consideration to perform permanent repair in accordance to API 570, restore with weld metal deposited/insert weld patch follows by NDE and painting as per client's specification.</p>

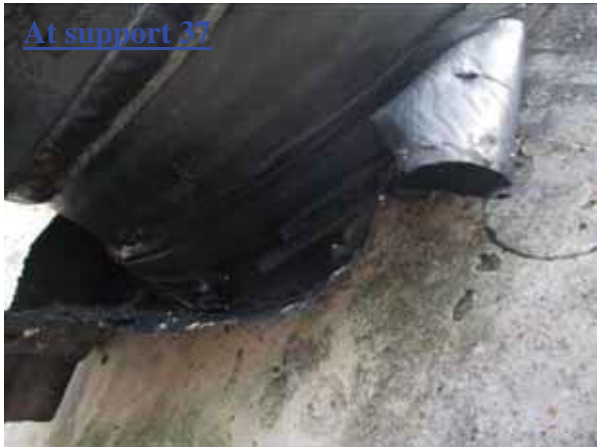
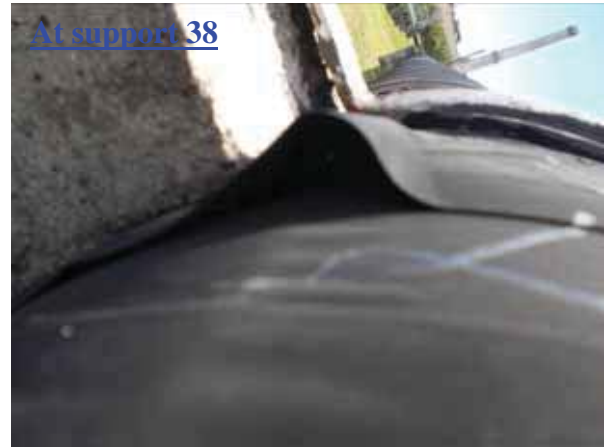
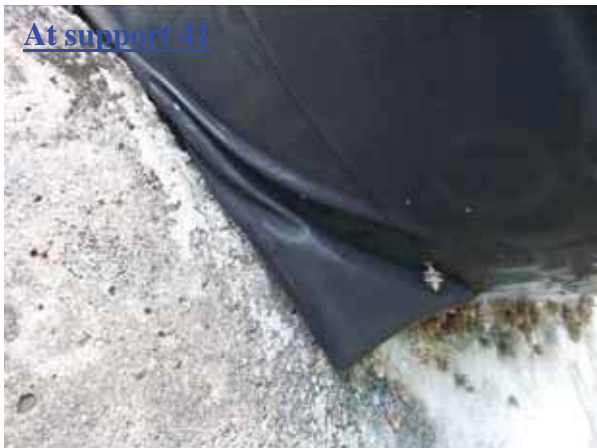
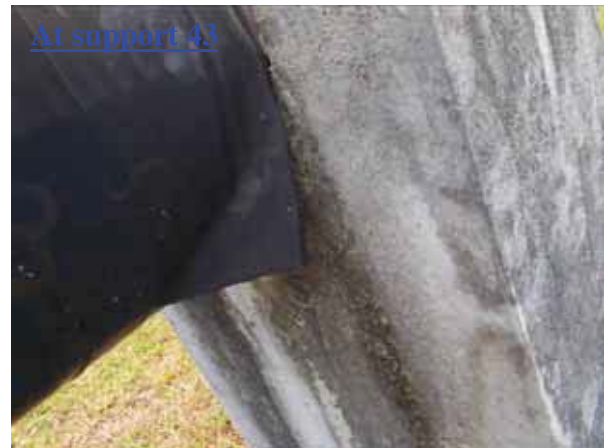
LINE SERVICE	DRAWING REFERENCE
12" (B) Residual Fuel Oil No. 6	ISO drawing no. 16
DESCRIPTION	LOCATION
Circuit 3 - Fuel supply line	Inside Terminal – Tank 1935 Farm Area <i>*Please refer Appendix 3 for detail location</i>
FINDING	RECOMMENDATIONS
Wrapping tape was observed not intact, however no sign of corrosion was noted at the area.	To tidy up the wrapping and ensure without gap to avoid water ingress inside and promote to corrosion.

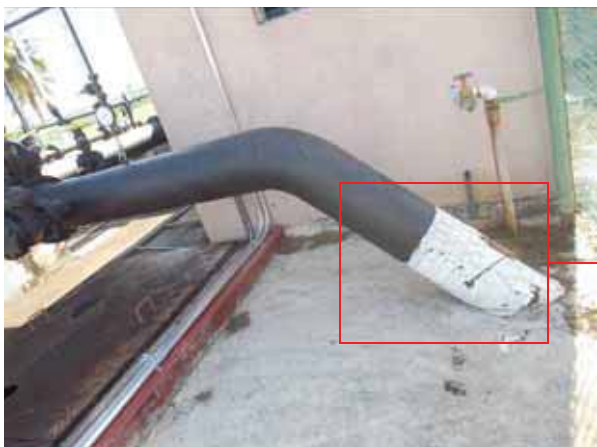
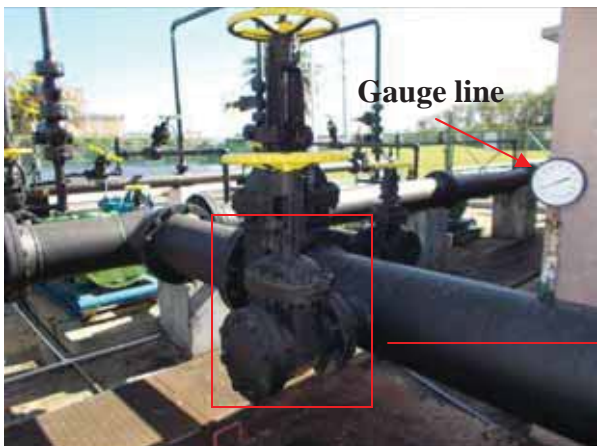
LINE SERVICE	DRAWING REFERENCE
12" (B) Residual Fuel Oil No. 6	ISO drawing no. 17
DESCRIPTION	LOCATION
Circuit 3 - Fuel supply line	Inside Terminal – Pump Area <i>*Please refer Appendix 3 for detail location</i>
FINDING	RECOMMENDATIONS
<ol style="list-style-type: none"> <li>1. Wrapping tape at concrete to air interface was observed deteriorated and minor corrosion under wrapping was noted at the area.</li> <li>2. Paint failure with surface rust was noted at some section of 6" valve.</li> <li>3. Small bore piping (gauge line) was noted without gusset plates.</li> </ol>	<ol style="list-style-type: none"> <li>1. To un-install the wrapping, perform surface preparation, painting as per client's specification and re-wrap at concrete to air interface area (6" above from ground level) with proper procedure.</li> <li>2. To perform surface preparation and follows by maintenance painting as per client's specification.</li> <li>3. To install 2 gusset plates on the piping to strengthen the pressure line.</li> </ol> <p><i>Please refer ISO Drawing for detail location base on reference support/area as stated above.</i></p>

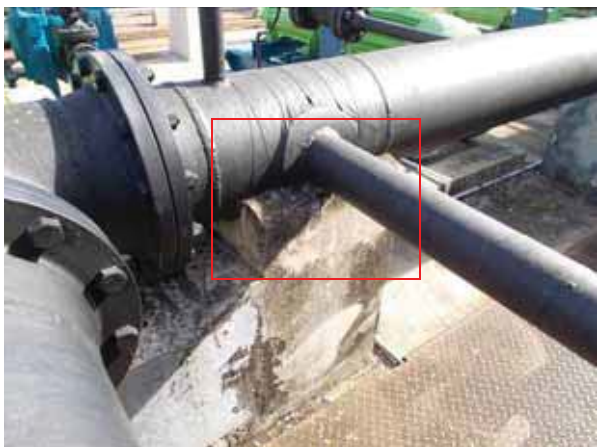
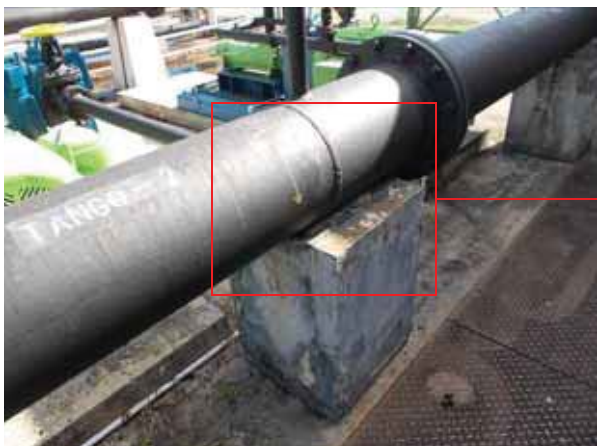
LINE SERVICE	DRAWING REFERENCE
12" Residual Fuel Oil No. 6	ISO drawing no. 17
DESCRIPTION	LOCATION
Circuit 3 - Fuel supply line	Inside Terminal – Pump Area <i>*Please refer Appendix 3 for detail location</i>
FINDING	RECOMMENDATIONS
Excessive in contact between piping and support. Crevice corrosion was noted at support 2.	To lift the piping, perform surface preparation and follows by maintenance painting as per client's specification. Consideration to modify existing support and to install rounded/angle bar or other materials to give single contact point between piping and support. Single contact point is to prevent moisture or water sitting against the piping surface and promote to corrosion.

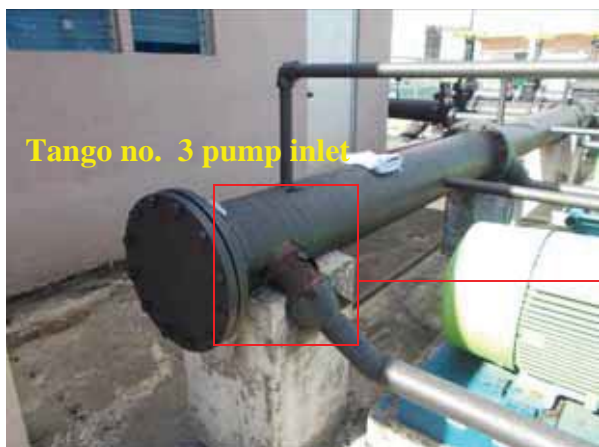
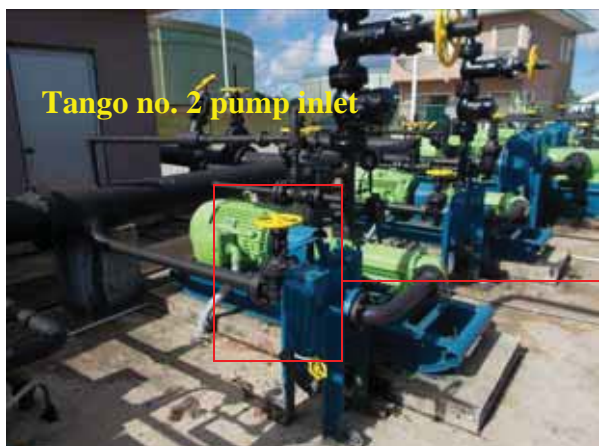
LINE SERVICE	DRAWING REFERENCE
3" Residual Fuel Oil No. 6	ISO drawing no. 17
DESCRIPTION	LOCATION
Circuit 3 - Fuel supply line	Inside Terminal – Pump Area <i>*Please refer Appendix 3 for detail location</i>
FINDING	RECOMMENDATIONS
<ol style="list-style-type: none"> <li>1. Wrapping tape at 5"x3" was observed deteriorated and minor corrosion under wrapping was noted at the area.</li> <li>2. Stud bolts and nuts at 3" valve inlet to Tango 2 pump was noted corroded.</li> </ol>	<ol style="list-style-type: none"> <li>1. To un-install the wrapping, perform surface preparation, painting as per client's specification.</li> <li>2. To replace the corroded stud bolts and nuts with the same material and specification.</li> </ol>

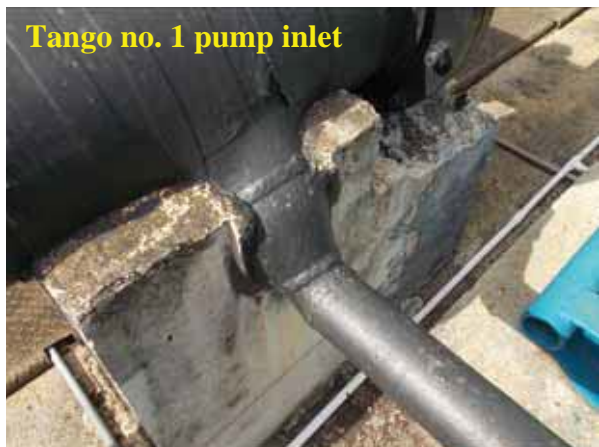
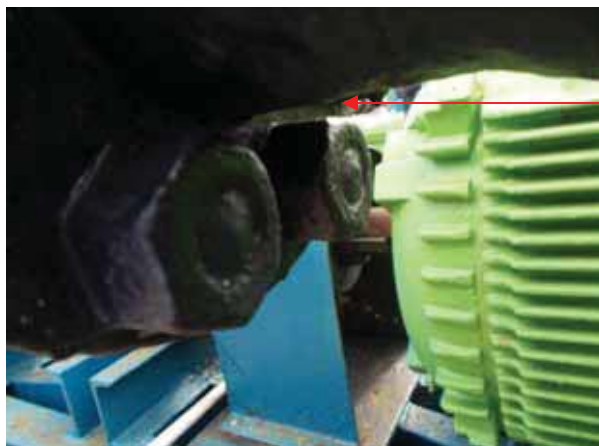
LINE SERVICE	DRAWING REFERENCE
3" Residual Fuel Oil No. 6	ISO drawing no. 17
DESCRIPTION	LOCATION
Circuit 3 - Fuel supply line	Inside Terminal – Pump Area <i>*Please refer Appendix 3 for detail location</i>
FINDING	RECOMMENDATIONS
Stud bolts of 3" valve was noted not extend out from their nuts and corroded.	To replace the stud bolts and nuts with the same material and specification.

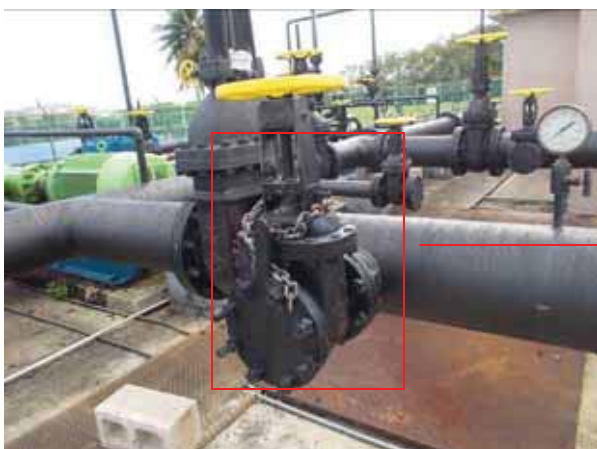
LINE SERVICE	DRAWING REFERENCE
12" (A) Residual Fuel Oil No. 6	ISO drawing no. 18
DESCRIPTION	LOCATION
Circuit 3 - Fuel supply line	Inside Terminal – Pump Area <i>*Please refer Appendix 3 for detail location</i>
FINDING	RECOMMENDATIONS
1. Product stain sign of leak was noted at flanges joint to 12" valve. 2. Stud bolts of 6" valve was noted not extend out from their nuts and corroded at 12" valve.	1. Consideration to dismantle the valve to check for corrosion at raise face and to replace with new gasket. 2. To replace with longer stud bolt for 6" valve and to replace corroded nuts at 12" valve. <i>Please refer ISO Drawing for detail location base on reference support/area as stated above.</i>

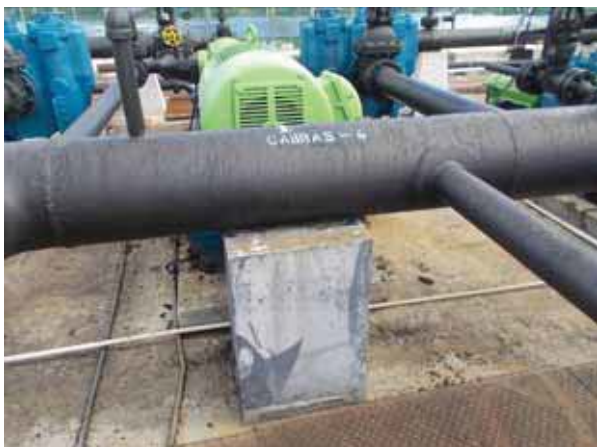
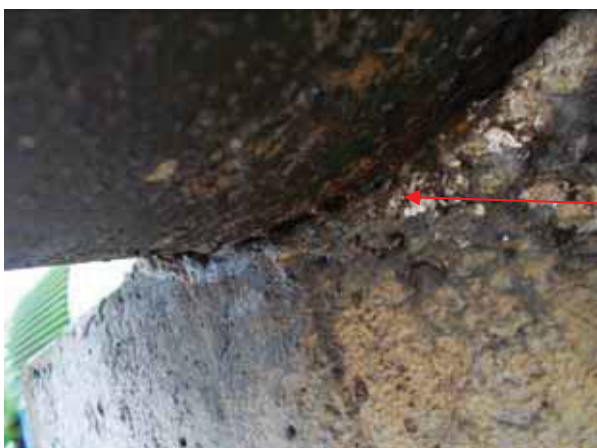
LINE SERVICE	DRAWING REFERENCE
12" Residual Fuel Oil No. 6	ISO drawing no. 18
DESCRIPTION	LOCATION
Circuit 3 - Fuel supply line	Inside Terminal – Pump Area <i>*Please refer Appendix 3 for detail location</i>
FINDING	RECOMMENDATIONS
Excessive in contact between piping and support. Crevice corrosion was noted at support 5.	To lift the piping, perform surface preparation and follows by maintenance painting as per client's specification. Consideration to modify existing support and to install rounded/angle bar or other materials to give single contact point between piping and support. Single contact point is to prevent moisture or water sitting against the piping surface and promote to corrosion. <i>Please refer ISO Drawing for detail location base on reference support/area as stated above.</i>

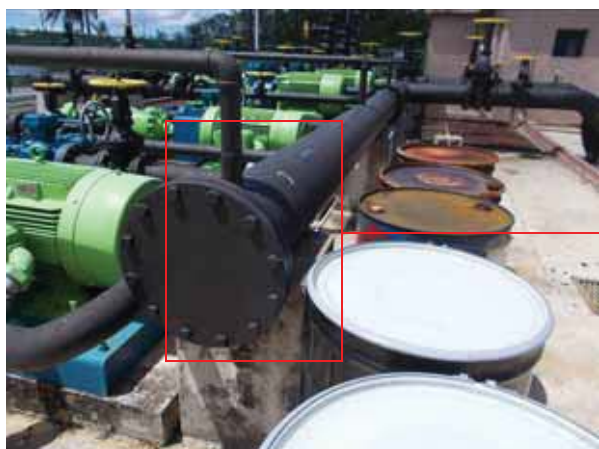
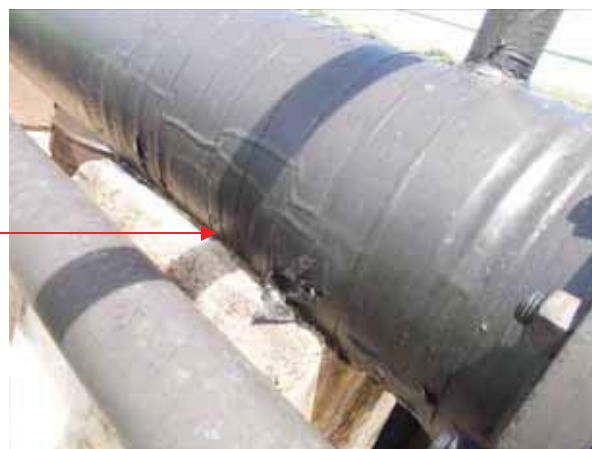
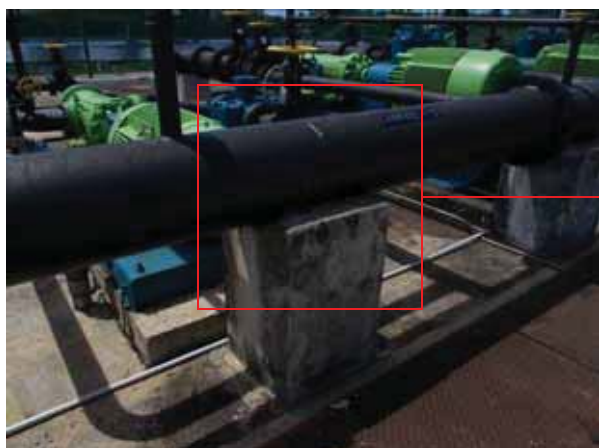
LINE SERVICE	DRAWING REFERENCE
12" Residual Fuel Oil No. 6	ISO drawing no. 18
DESCRIPTION	LOCATION
Circuit 3 - Fuel supply line	Inside Terminal – Pump Area <i>*Please refer Appendix 3 for detail location</i>
FINDING	RECOMMENDATIONS
<ol style="list-style-type: none"> <li>1. Wrapping tape at support was noted deteriorated.</li> <li>2. Excessive in contact between piping and support.</li> </ol>	<ol style="list-style-type: none"> <li>1. To uninstall the wrap for preventing water ingress inside and promote to corrosion.</li> <li>2. Consideration to modify existing support and to install rounded/angle bar or other materials to give single contact point between piping and support. Single contact point is to prevent moisture or water sitting against the piping surface and promote to corrosion.</li> </ol>

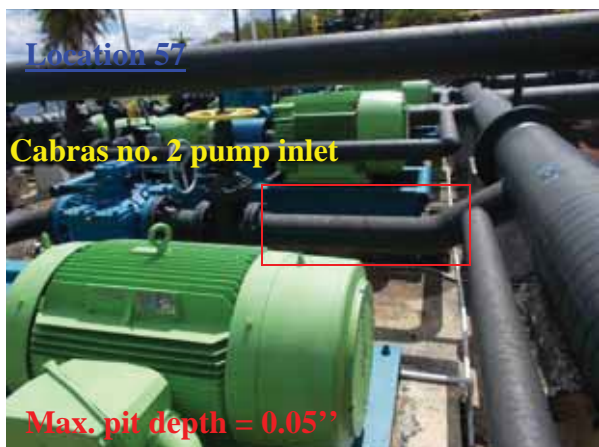
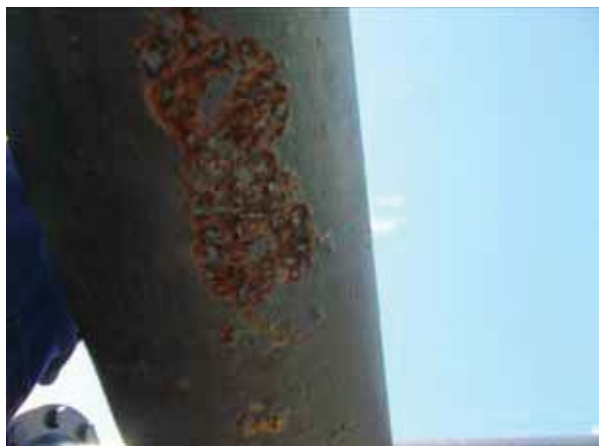
LINE SERVICE	DRAWING REFERENCE
6" Residual Fuel Oil No. 6	ISO drawing no. 18
DESCRIPTION	LOCATION
Circuit 3 - Fuel supply line	Inside Terminal – Pump Area <i>*Please refer Appendix 3 for detail location</i>
FINDING	RECOMMENDATIONS
Localized corrosion/pits was noted at bottom section of piping, marked as location 57 in ISO drawing. <i>*Please refer Appendix 2 for ½ remaining life calculation at pits area.</i>	To perform surface preparation and follows by maintenance painting as per client's specification.
