**INSIDE TERMINAL**  
**Circuit 3**  
**- Transfer line -**

**INSIDE TERMINAL**  
**Circuit 3**  
**- Fuel supply line -**

INSIDE TERMINAL  
Circuit 4  
- Tango line -

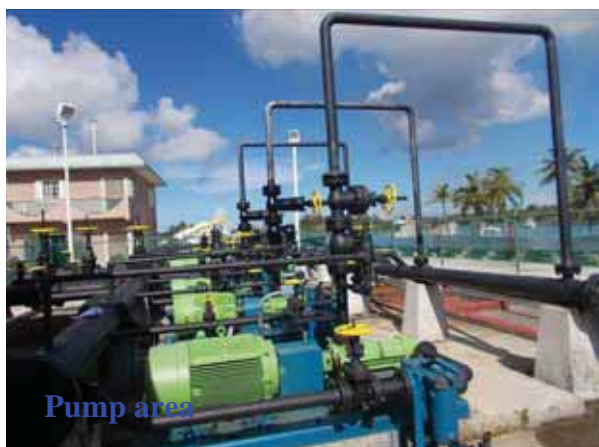
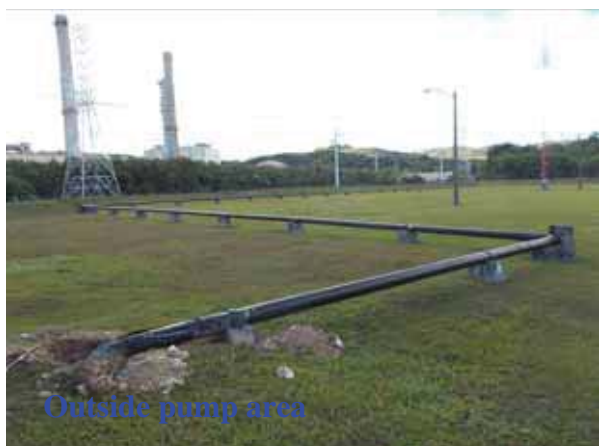
LINE SERVICE	DRAWING REFERENCE
14" Residual Fuel Oil No. 6	ISO drawing no. 19 to 23
DESCRIPTION	LOCATION
Circuit 4 - Tango Line	Inside Terminal – Pump and outside pump area <i>*Please refer Appendix 3 for detail location</i>
FINDING	RECOMMENDATIONS
1. General view of 8" Tango line outlet from T -1, T - 2 and T 3 pump. 2. Excessive in contact between piping and all pedestals support.	1. Nil. 2. Consideration to modify existing support and to install rounded/angle bar or others material to give single contact point between piping and support. Single contact point is to prevent moisture or water sitting against the piping surface and promote to corrosion.

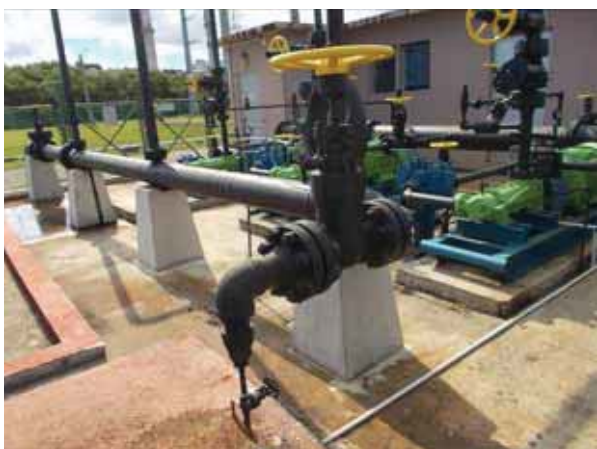
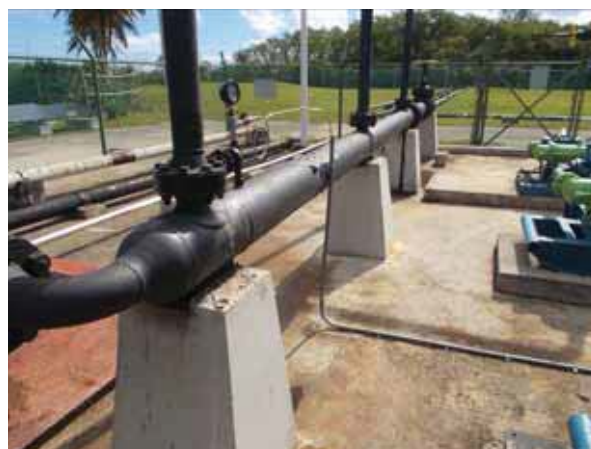
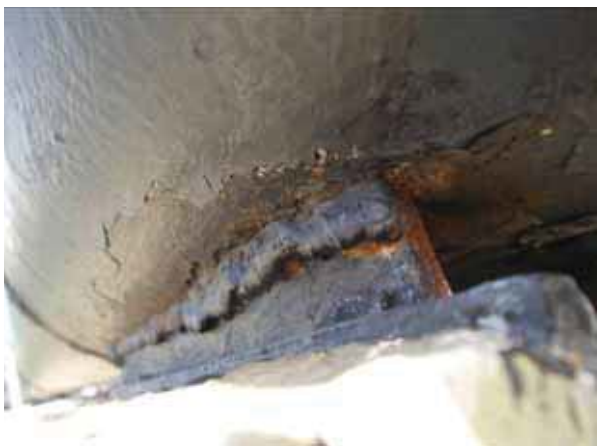
LINE SERVICE	DRAWING REFERENCE
4", 8" Residual Fuel Oil No. 6	ISO drawing no. 19
DESCRIPTION	LOCATION
Circuit 4 - Tango line	Inside Terminal – Pump Area <i>*Please refer Appendix 3 for detail location</i>
FINDING	RECOMMENDATIONS
<ol style="list-style-type: none"> <li>1. Pipe support modification was noted from support 4 to 7 and surface rust was noted at the area.</li> <li>2. Wrapping tape at underground piping was observed intact, no sign of corrosion was noted at the wrapping area.</li> </ol>	<ol style="list-style-type: none"> <li>1. To perform surface preparation and follows by maintenance painting as per client's specification.</li> <li>2. Nil.</li> </ol>
