LINE SERVICE	DRAWING REFERENCE
14" Residual Fuel Oil No. 6	ISO drawing no. 20
DESCRIPTION	LOCATION
Circuit 4 - Tango line	Inside Terminal – Outside pump area <i>*Please refer Appendix 3 for detail location</i>
FINDING	RECOMMENDATIONS
Corrosion under wrapping was noted at soil to air interface area due to wrap failure and gives a path to water ingress inside, marked as location 1 in ISO drawing. No sign of corrosion propagate deeper after the wrapping end. <i>*Please refer Appendix 2 for ½ remaining life calculation at pits area.</i>	Consideration to perform permanent repair at this area with remove the corrosion, restore with weld metal deposited/insert weld patch, apply coal tar enamel and re-wrap with proper procedure and suitable wrapping for buried piping up to 6" from soil to air interface.

INSIDE TERMINAL
Circuit 5
- Cabras line -

APPENDIX 3
- PIPELINE ISOMETRIC DRAWING -
(Support numbering for visual report reference location & corrosion location)

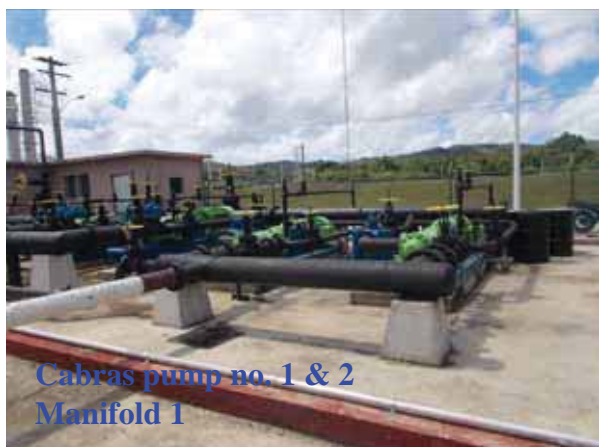
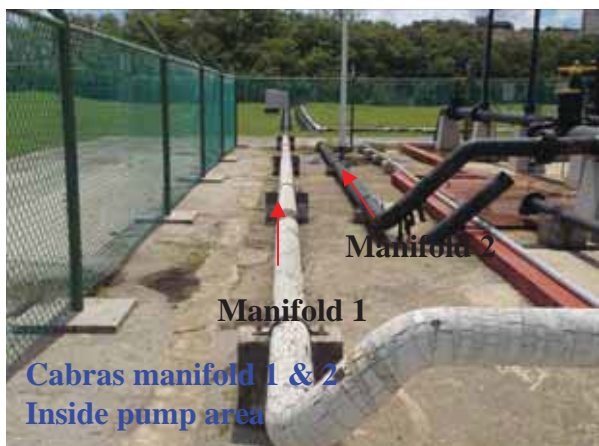
LINE SERVICE	DRAWING REFERENCE
Residual Fuel Oil No. 6	ISO drawing no. 24 to 26
DESCRIPTION	LOCATION
Circuit 5 – Cabras pump no. 1,2,3 & 4 discharge	Inside Terminal – Pump & outside pump area <i>*Please refer Appendix 3 for detail location</i>
FINDING	RECOMMENDATIONS
1. General view of 6" Cabras line outlet from C -1, C - 2 and C- 3 and C – 4 pumps. 2. Excessive in contact between piping and pedestal support at outside pump area.	1. Nil. 2. Consideration to modify existing support and to install rounded/angle bar or others material to give single contact point between piping and support. Single contact point is to prevent moisture or water sitting against the piping surface and promote to corrosion.

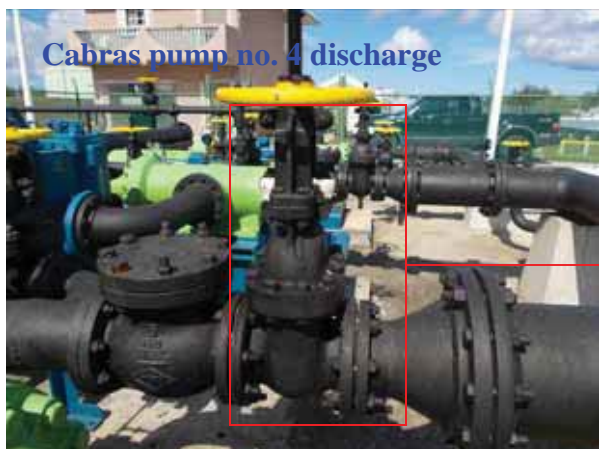
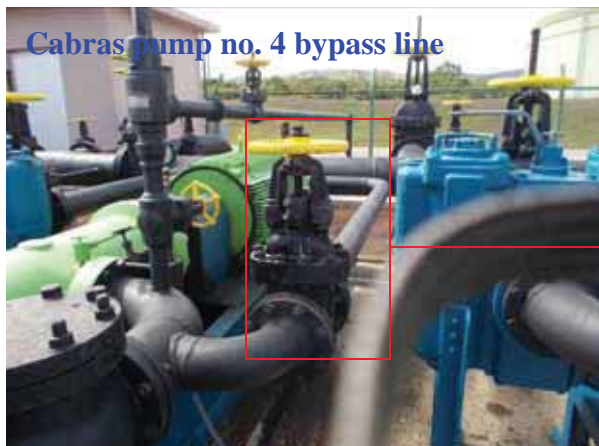
LINE SERVICE	DRAWING REFERENCE
4', 5" Residual Fuel Oil No. 6	ISO drawing no. 24
DESCRIPTION	LOCATION
Circuit 5 – Cabras Manifold 2	Inside Terminal – Pump area <i>*Please refer Appendix 3 for detail location</i>
FINDING	RECOMMENDATIONS
<ol style="list-style-type: none"> 1. Product stain sign of leak was noted on 4" and 5" valve (by pass line). 2. Stud bolts and nuts of the 5" valve was noted corroded. 	<ol style="list-style-type: none"> 1. Consideration to dismantle the valves to check for corrosion at raise face and replace with new gasket. 2. To replace the corroded stud bolts and nuts at the same material and specification.

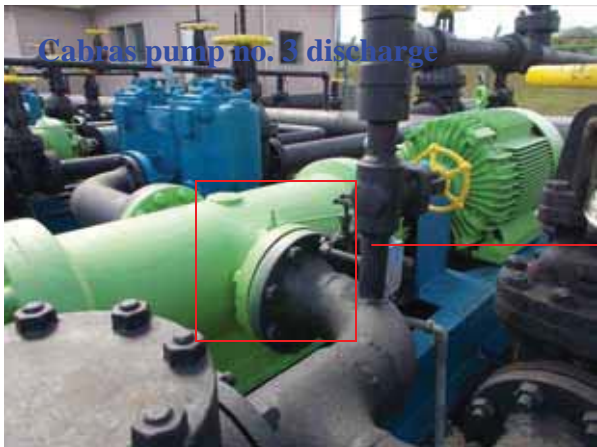
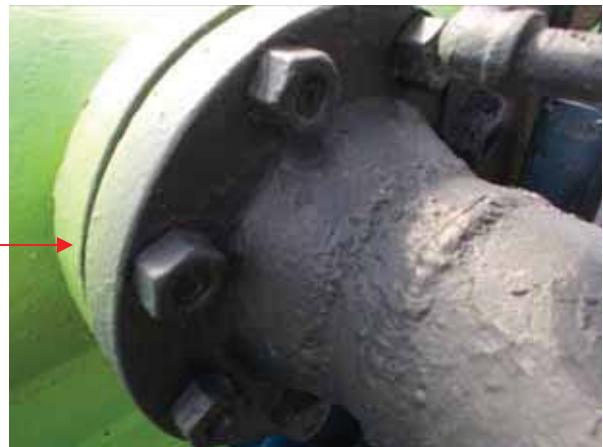
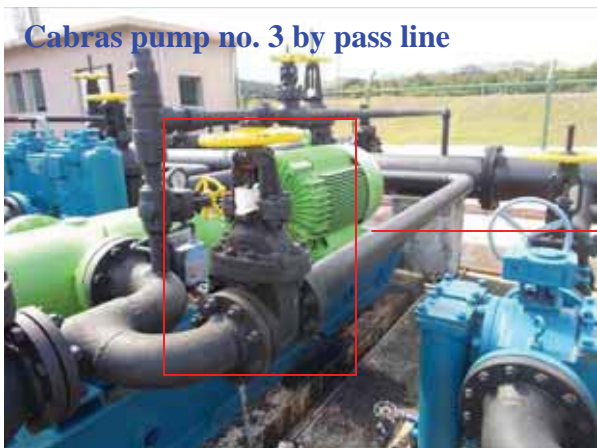
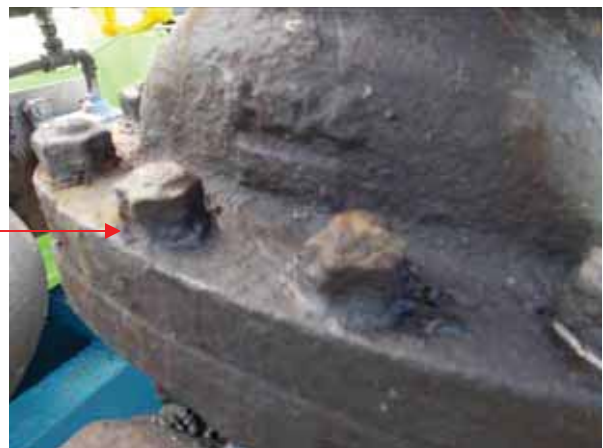
LINE SERVICE	DRAWING REFERENCE
4' & 5" Residual Fuel Oil No. 6	ISO drawing no. 24
DESCRIPTION	LOCATION
Circuit 5 – Cabras Manifold 2	Inside Terminal – Pump area <i>*Please refer Appendix 3 for detail location</i>
FINDING	RECOMMENDATIONS
<ol style="list-style-type: none"> 1. Stud bolts of flanges joint to Pump Cabras 3 was noted not extend out from their nuts. 2. Product stain sign of leak was noted at 4" valve by pass line. Corroded was noted at stud bolts of the valve. 	<ol style="list-style-type: none"> 1. To replace with longer stud bolts with the same material specification. 2. Consideration to dismantle the valves to check for corrosion at raise face and replace with new gasket and to replace the corroded stud bolts.

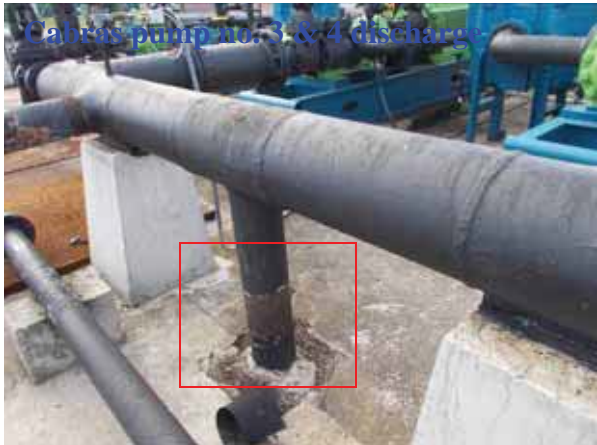
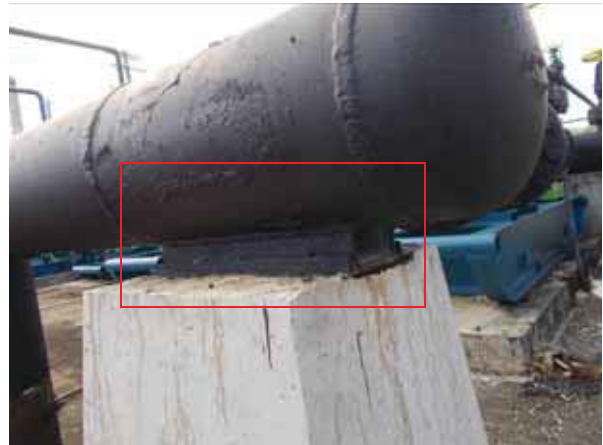
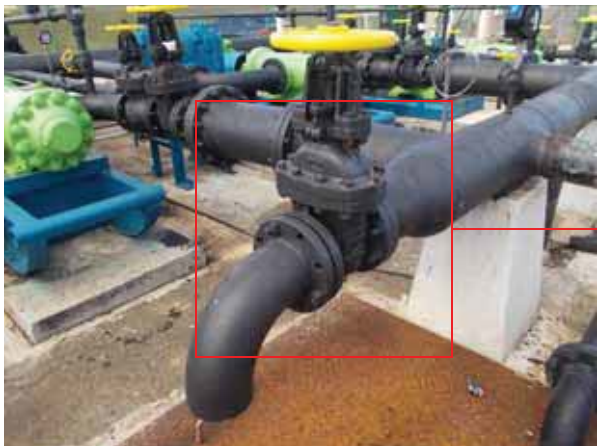
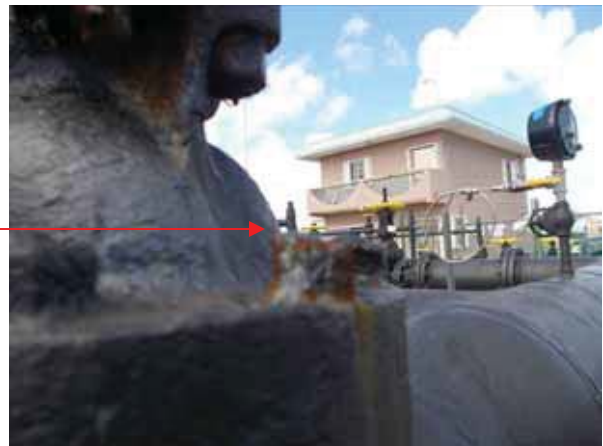
LINE SERVICE	DRAWING REFERENCE
4", 6", 10" Residual Fuel Oil No. 6	ISO drawing no. 24
DESCRIPTION	LOCATION
Circuit 5 – Cabras Manifold 2	Inside Terminal – Pump area <i>*Please refer Appendix 3 for detail location</i>
FINDING	RECOMMENDATIONS
<ol style="list-style-type: none"> 1. Wrapping tape at 6" piping was observed deteriorated and minor corrosion under wrapping was noted at the area. 2. Pipe support modification was noted at support 3, 5 and surface rust was noted at the area. 3. Stud bolts of flange was noted to be missing at 4" valve. 4. Stud bolts at upper housing of 4" valve was noted corroded. 	<ol style="list-style-type: none"> 1. To perform surface preparation and follows by maintenance painting as per client's specification. 2. To perform surface preparation and follows by maintenance painting as per client's specification and to monitor periodically. 3. To replace the missing/corroded stud bolts.

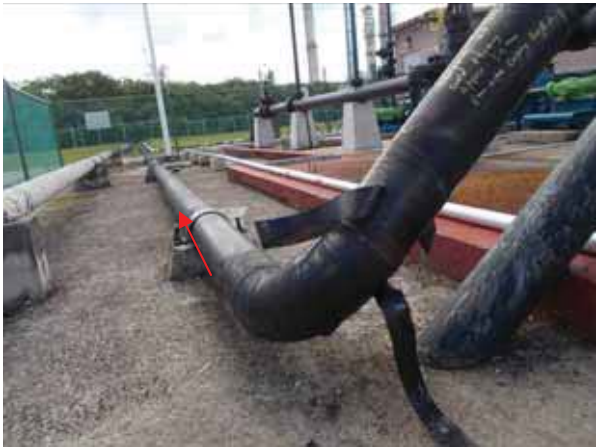
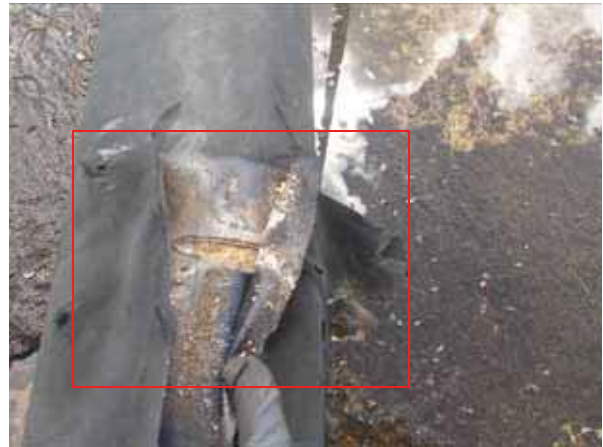
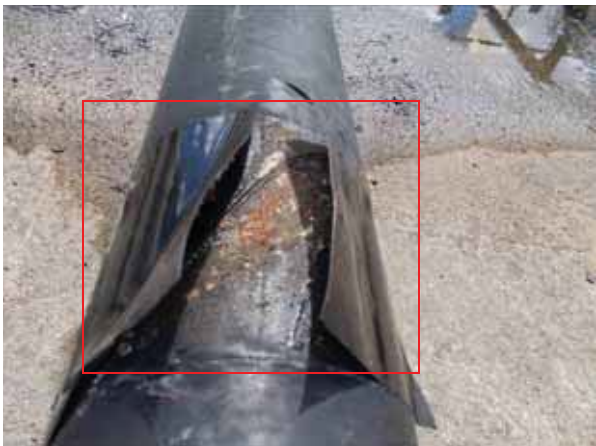
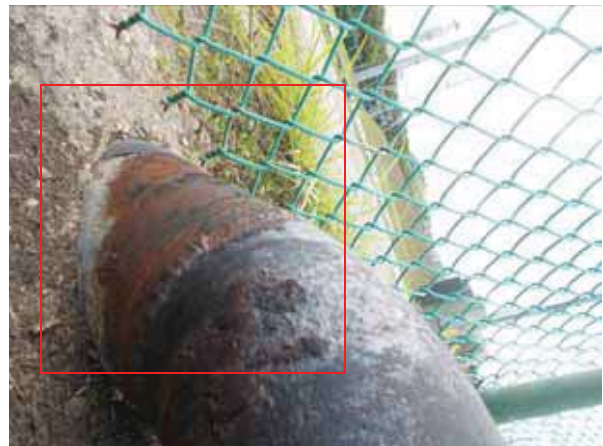
LINE SERVICE	DRAWING REFERENCE
6" Residual Fuel Oil No. 6	ISO drawing no. 25
DESCRIPTION	LOCATION
Circuit 5 – Cabras Manifold 2	Inside Terminal – Pump area <i>*Please refer Appendix 3 for detail location</i>
FINDING	RECOMMENDATIONS
Wrapping tape was observed deteriorated at some location and surface rust was noted at the area.	To un-install the wrapping, perform surface preparation, painting as per client's specification, to monitor periodically especially at bottom section since the piping layout close to ground level.

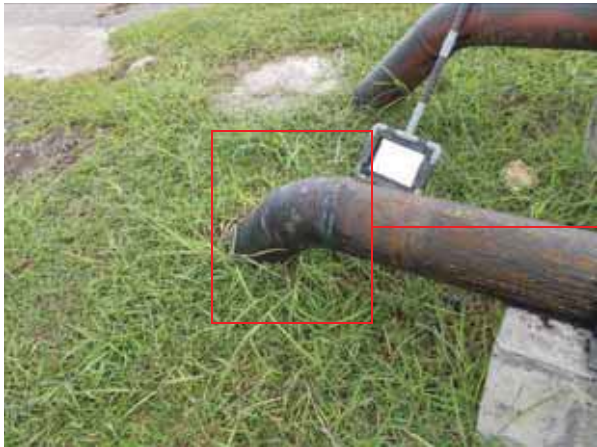
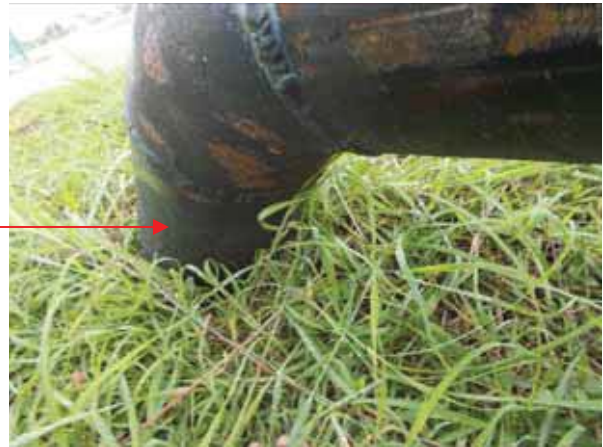
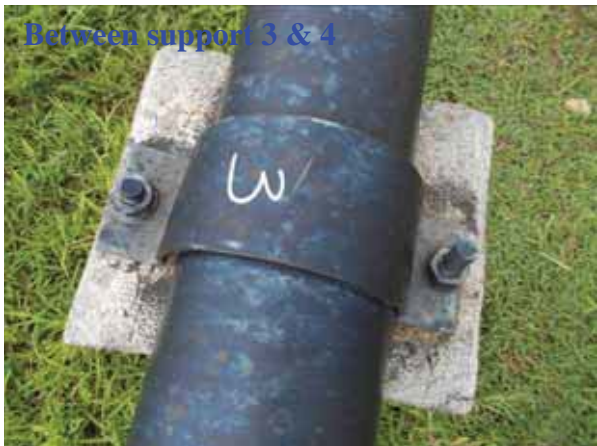
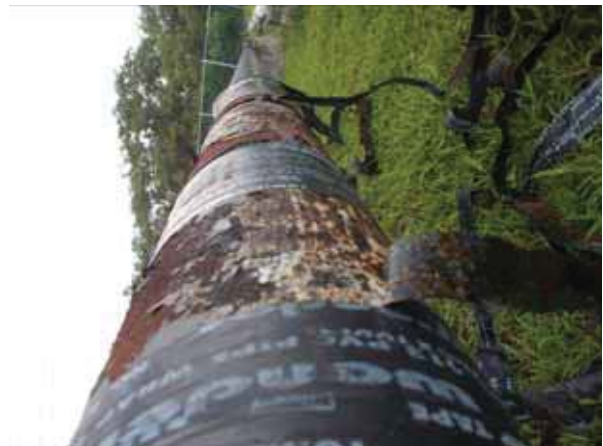
LINE SERVICE	DRAWING REFERENCE
6" Residual Fuel Oil No. 6	ISO drawing no. 26
DESCRIPTION	LOCATION
Circuit 5 – Cabras Manifold 2	Inside Terminal – Outside pump area <i>*Please refer Appendix 3 for detail location</i>
FINDING	RECOMMENDATIONS
<ol style="list-style-type: none"> 1. No sign of corrosion at soil to air interface area. 2. Corrosion under wrapping with maximum pit depth below than 1mm was noted due to wrap failure and gives a path to water ingress inside. 	<ol style="list-style-type: none"> 1. Nil. 2. To perform surface preparation and follow by maintenance painting as per client's specification.

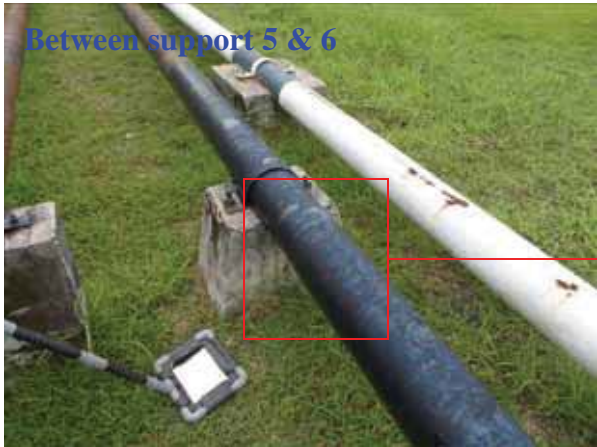
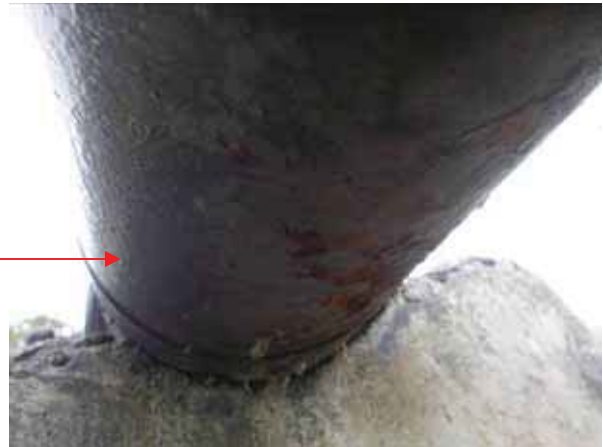
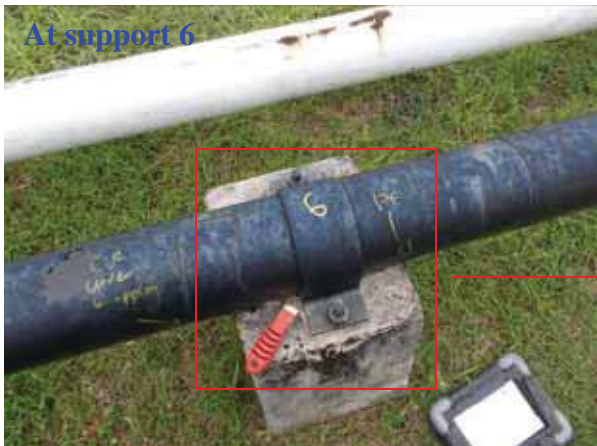
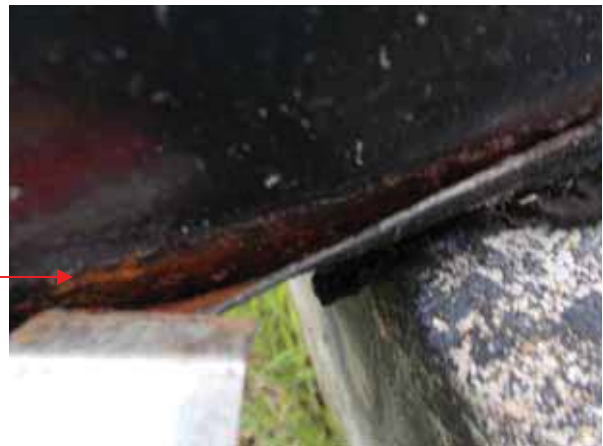
LINE SERVICE	DRAWING REFERENCE
6" Residual Fuel Oil No. 6	ISO drawing no. 26
DESCRIPTION	LOCATION
Circuit 5 – Cabras Manifold 2	Inside Terminal – Outside pump area <i>*Please refer Appendix 3 for detail location</i>
FINDING	RECOMMENDATIONS
<ol style="list-style-type: none"> 1. Localized corrosion/pits with maximum pit depth below than 1mm was noted at bottom section of piping. 2. Corrosion under wrapping with maximum pit depth below than 1mm was noted due to wrap failure and gives a path to water ingress inside. 	To perform surface preparation and follow by maintenance painting as per client's specification.

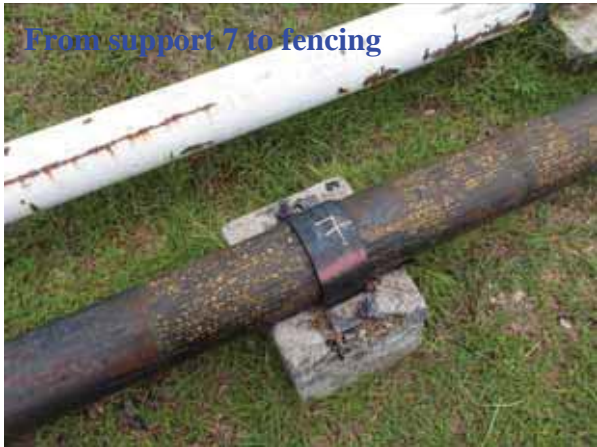
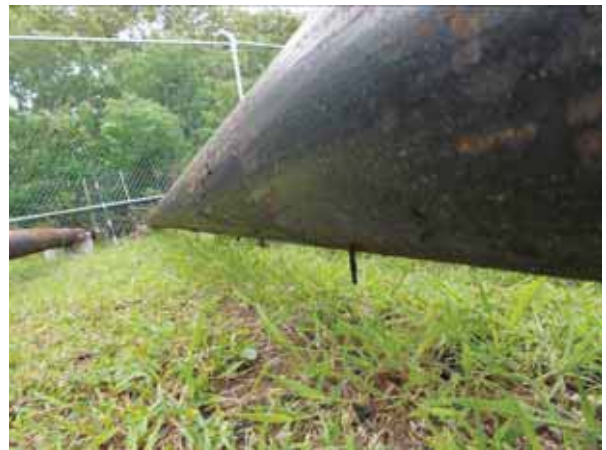
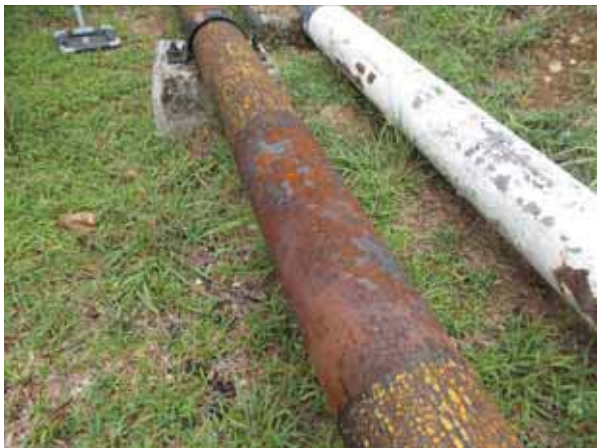
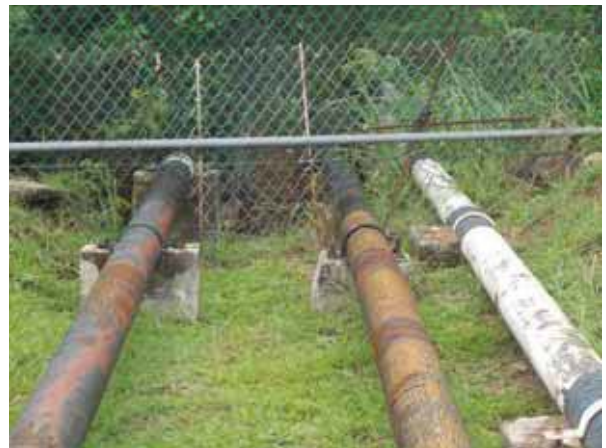
LINE SERVICE	DRAWING REFERENCE
6" Residual Fuel Oil No. 6	ISO drawing no. 26
DESCRIPTION	LOCATION
Circuit 5 – Cabras Manifold 2	Inside Terminal – Outside pump area <i>*Please refer Appendix 3 for detail location</i>
FINDING	RECOMMENDATIONS
Paint failure with surface rust was noted all along of piping.	To perform surface preparation and follow by maintenance painting as per client's specification.

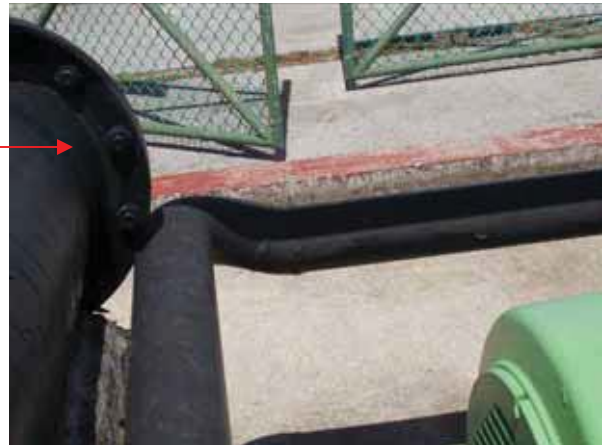
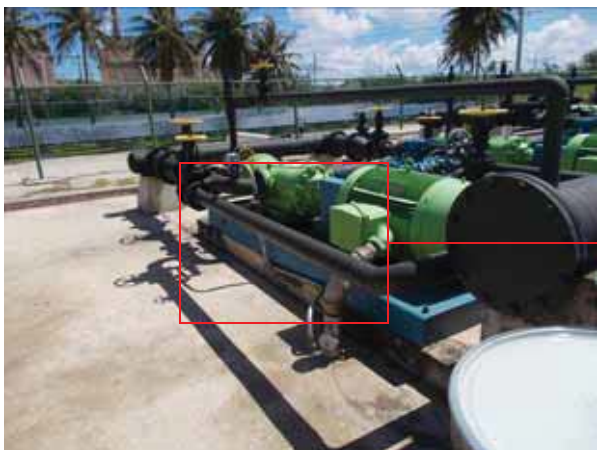
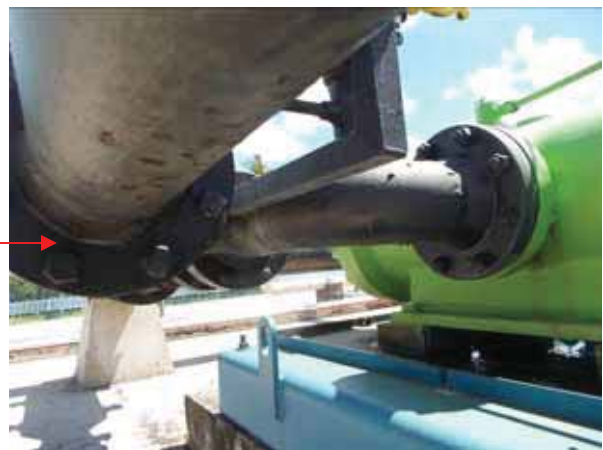
LINE SERVICE	DRAWING REFERENCE
4" Residual Fuel Oil No. 6	ISO drawing no. 24
DESCRIPTION	LOCATION
Circuit 5 – Cabras Manifold 1	Inside Terminal – Pump area <i>*Please refer Appendix 3 for detail location</i>
FINDING	RECOMMENDATIONS
<ol style="list-style-type: none"> 1. Piping was noted in contact with flange. 2. Paint failure with surface rust was noted at bottom section of piping. 	<ol style="list-style-type: none"> 1. To use protective material to prevent abrasion at the contacting area or to re-align the pipeline. 2. To perform surface preparation and follows by maintenance painting as per client's specification.

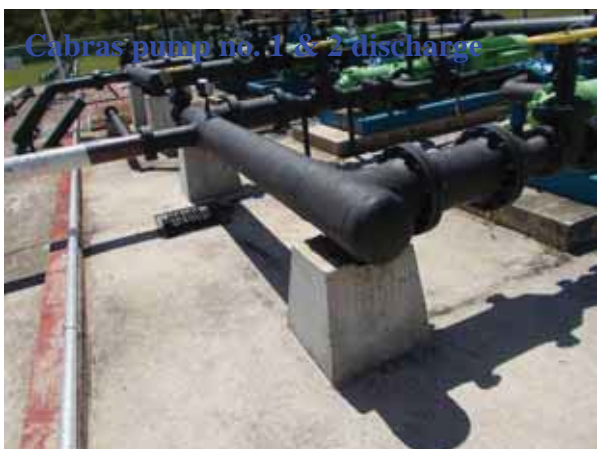
LINE SERVICE	DRAWING REFERENCE
10" Residual Fuel Oil No. 6	ISO drawing no. 24
DESCRIPTION	LOCATION
Circuit 5 – Cabras Manifold 1	Inside Terminal – Pump area <i>*Please refer Appendix 3 for detail location</i>
FINDING	RECOMMENDATIONS
<ol style="list-style-type: none"> 1. Small bore piping (gauge line) was noted without gusset plates. 2. Pipe support modification was noted at support 5 and 6 and surface rust was noted at the area. 	<ol style="list-style-type: none"> 1. To replace with longer stud bolts with the same material specification. 2. To install 2 gusset plates on the piping to strengthen the pressure line.

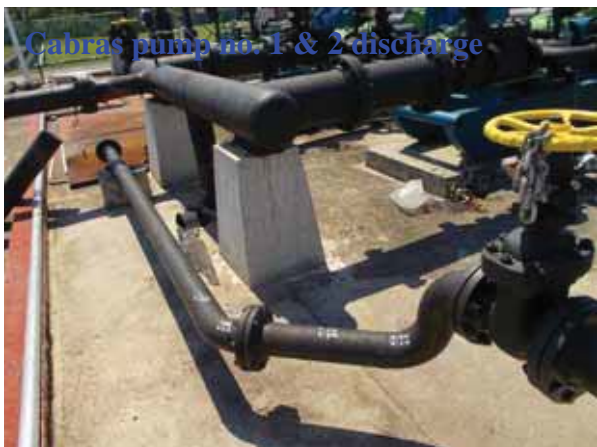
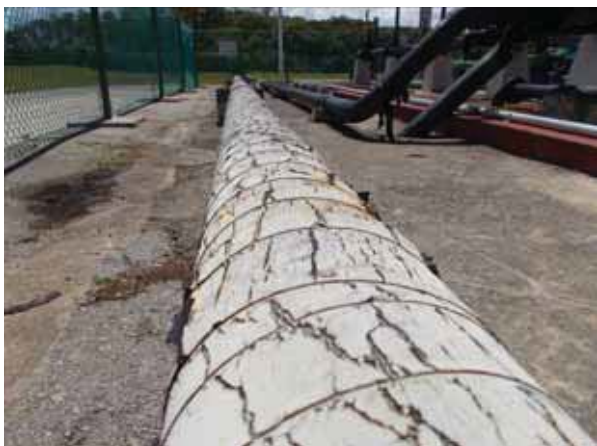
LINE SERVICE	DRAWING REFERENCE
4" & 6" Residual Fuel Oil No. 6	ISO drawing no. 25
DESCRIPTION	LOCATION
Circuit 5 – Cabras Manifold 1	Inside Terminal – Pump area <i>*Please refer Appendix 3 for detail location</i>
FINDING	RECOMMENDATIONS
<ol style="list-style-type: none"> 1. Wrapping tape was noted deteriorated at some locations and paint failure with surface rust was noted at the area. 2. Paint failure with surface was noted at soil to air interface Area. 	<ol style="list-style-type: none"> 1. To un-install the wrapping tape and perform surface preparation follows by maintenance painting as per client's specification. 2. To perform surface preparation and follows by maintenance painting as per client's specification.

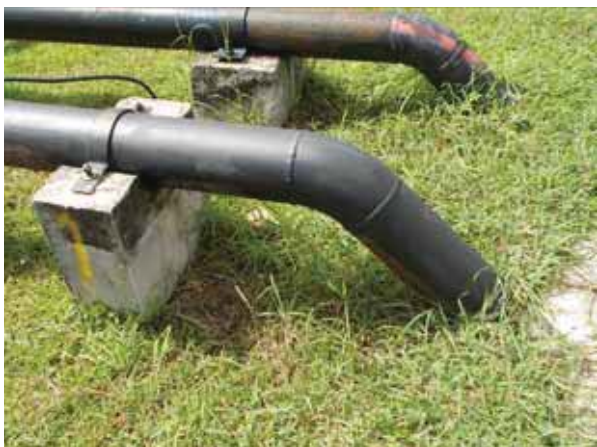
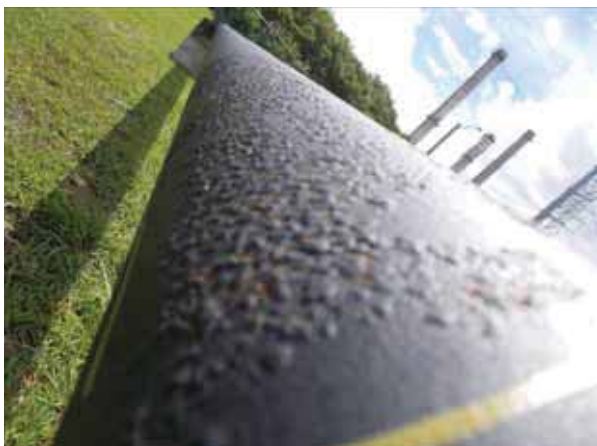
LINE SERVICE	DRAWING REFERENCE
6" Residual Fuel Oil No. 6	ISO drawing no. 26
DESCRIPTION	LOCATION
Circuit 5 – Cabras Manifold 1	Inside Terminal – Outside pump area <i>*Please refer Appendix 3 for detail location</i>
FINDING	RECOMMENDATIONS
<ol style="list-style-type: none"> 1. No sign of corrosion at soil to air interface area. 2. General corrosion with maximum pit depth below than 1mm was noted all along of piping. 	<ol style="list-style-type: none"> 1. Nil. 2. To perform surface preparation and follows by maintenance painting as per client's specification.

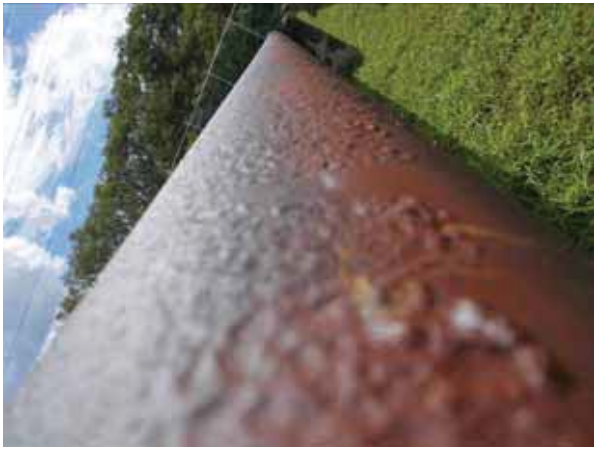
LINE SERVICE	DRAWING REFERENCE
6" Residual Fuel Oil No. 6	ISO drawing no. 26
DESCRIPTION	LOCATION
Circuit 5 – Cabras Manifold 1	Inside Terminal – Outside pump area <i>*Please refer Appendix 3 for detail location</i>
FINDING	RECOMMENDATIONS
General corrosion with maximum pit depth below than 1mm was noted all along of piping.	To perform surface preparation and follows by maintenance painting as per client's specification.

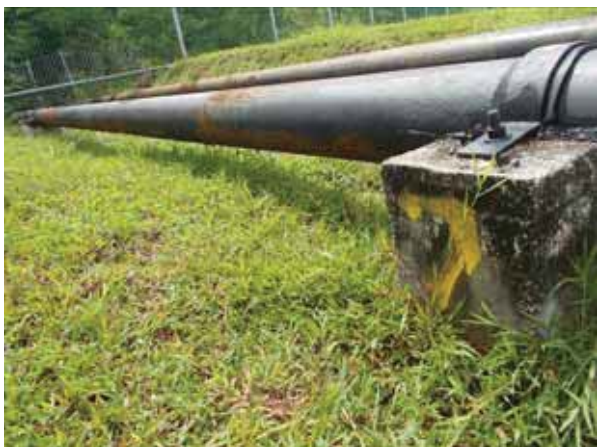
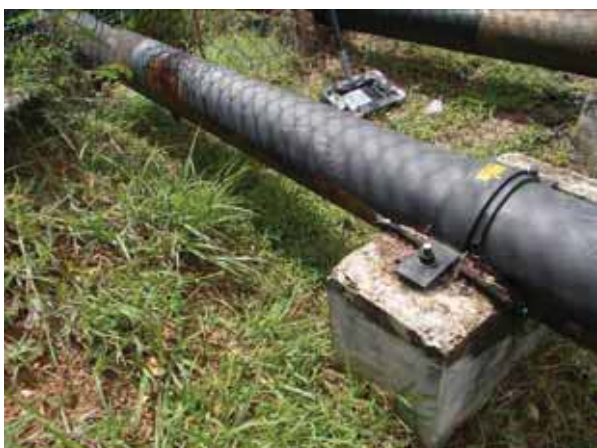
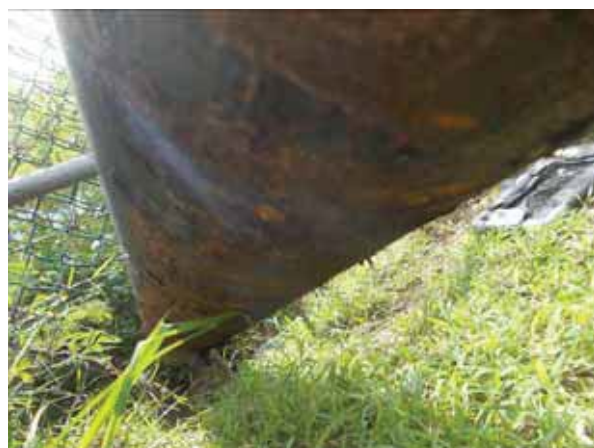
LINE SERVICE	DRAWING REFERENCE
6" Residual Fuel Oil No. 6	ISO drawing no. 26
DESCRIPTION	LOCATION
Circuit 5 – Cabras Manifold 1	Inside Terminal – Outside pump area <i>*Please refer Appendix 3 for detail location</i>
FINDING	RECOMMENDATIONS
General corrosion with maximum pit depth below than 1mm was noted all along of piping.	To perform surface preparation and follows by maintenance painting as per client's specification.
