3.0 GUIDED WAVE REPORT

3.1 24"RESIDUAL FUEL OIL (RFO)

Test ID: G4-214#2203	Result: Minor Concern
Pipe: 14" RFO (S0)	Ring: R2B14(1525)
Site: Outside Terminal	Config: 8.2FR, T(0,1)
Location: Weld bend -0.23m	Calibration: Automatic (2935.84 mV)
Size: 14 inch (6.35mm)	Version: 3.103, Wavemaker G4-214
	GPS: 13°27.4223'N, 144°40.9832'E
Tested: 12 Jun 2014 12:45	Client: Vital Energy
Tested by: Khairul Anuar Husain [SGS]	Procedure: WI-TM-065/Ver.00/27.04.2011
	DACs: Call=6%, Weld=23%

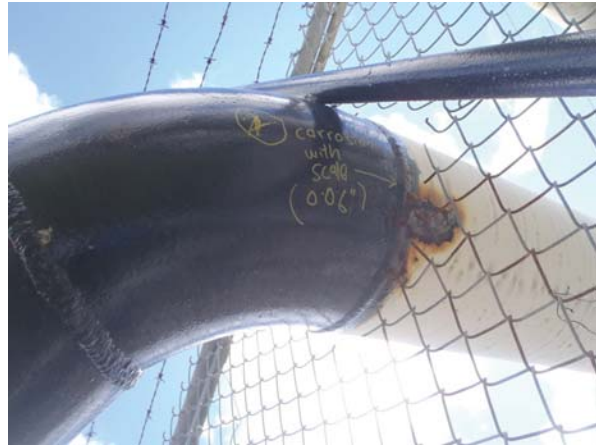
Feature	Location	ECL	Length	Extent	Class	Notes
A1	-4.96	60	0.1	70	Minor	Visually confirm external corrosion closed to weld bend at 6H00 with max. pit depth is 0.06"@ 1.5 mm. UT reading adjacent to pit is 6.52 mm. Remaining wall thickness is 5.02 mm (23.0% wall loss)
R1	-0.96	-	0	60	Trailing Echoes	False echo
B1	-4.41	-	0	50	45 deg Bend	
B2	0.14	-	0	60	1D Bend	Datum of screening
F1	1.21	-	0	25	Flange	
U1	-5.6	-	~		End

External corrosion at 6 o'clock

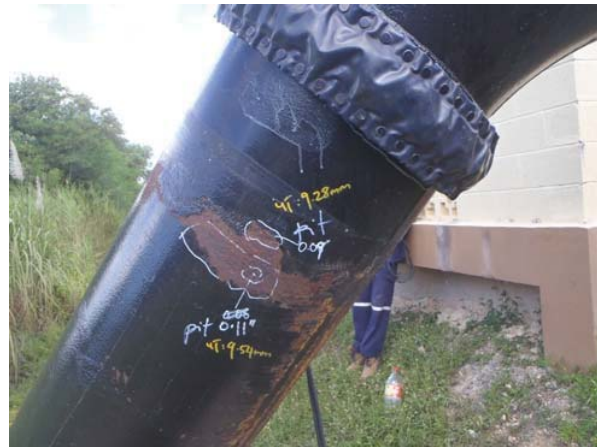
External corrosion with max. pitting is 0.11" @ 2.8 mm

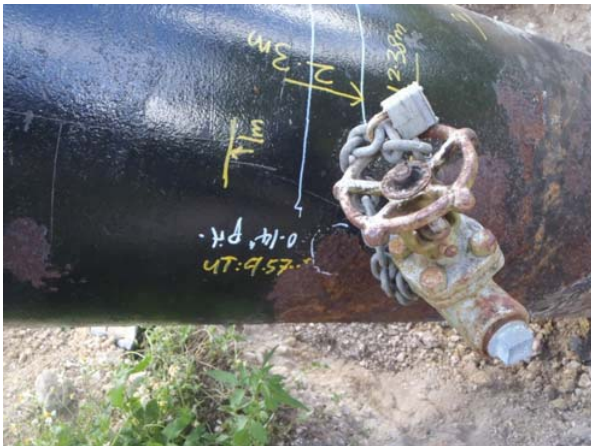
External corrosion with max. pitting is 0.14" @ 3.5 mm

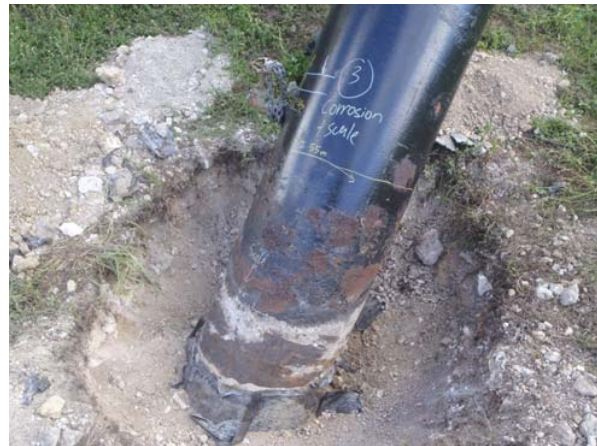
General view of external corrosion at soil to air interface

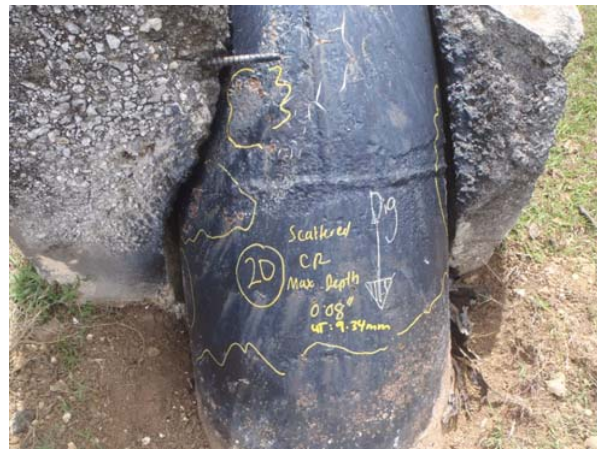
Feature	Location	ECL	Length	Extent	Class	Notes
E1	-5.57	-	~	18	Earth	Underground
U1	-5.06	-	~		End	
A1	-4.82	30	0.7	40	Minor	Visually confirm scattered corrosion with maximum pit depth is 0.08" (2.0 mm) - UT adjacent to corrosion 9.34 mm. Remaining wall thickness is 7.34mm. (21.4% wall loss)
B1	-4.37	-	0.69	45	45 deg Bend	
S1	-3.37	-	1.5	20	Support	
B2	-3.41	-	0	20	45 deg Bend	
F1	0.25	-	0	70	Flange	Datum of screening

Scattered corrosion with maximum pit depth is 0.08" @ 2.0 mm

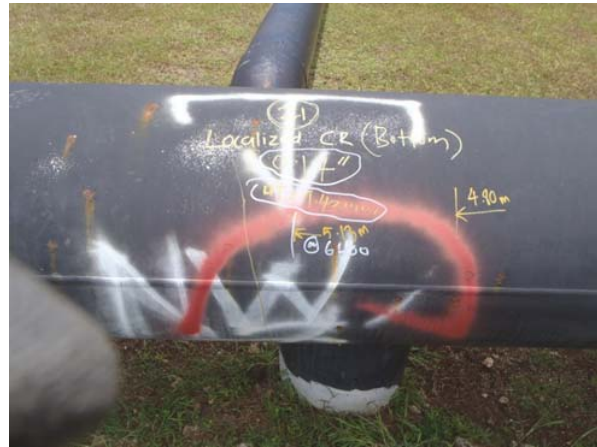
Feature	Location	ECL	Length	Extent	Class	Notes
F1	-9.75	-	0	60	Flange	
R1	-7.54	-	0	0	Mirror	False echo
R2	-5.71	-	0	19	Mirror	False echo
A1	-5.13	1	0	14	Medium	Visually confirm localized external corrosion at 6H00 with max. depth is 0.17" @ 4.3 mm. UT reading adjacent to pit is 9.42 mm. Remaining wall thickness is 5.12 mm (45.6% wall loss)
F2	-4.8	-	0	0	Branch	branch 14" to 24"
A2	-4.2	0	0	40	Minor	Visually confirm localized external corrosion at 6H00 with max. depth is 0.05" @ 1.27 mm. UT reading adjacent to pit is 9.59 mm. Remaining wall thickness is 8.32 mm (13.2% wall loss)
A3	-3.85	1	0	0	Minor	Visually confirm localized external corrosion at 6H00 with max. depth is 0.07" @ 1.8 mm. UT reading adjacent to pit is 9.59 mm. Remaining wall thickness is 7.79 mm (18.8% wall loss)
S1	-3.56	-	0.15	0	Clamp	
S2	-3.46	-	0.3	0	Support	
W1	-1.82	20	0	60	Weld	
A4	1.57	0	0	30	Minor	
R3	1.81	-	0	30	Mirror	
U2	4.4	-	0	0	User1	insert patch plate (0.12x0.12 m)

Localized external corrosion at 6H00. Max. pit depth: 0.17" @ 4.3 mm

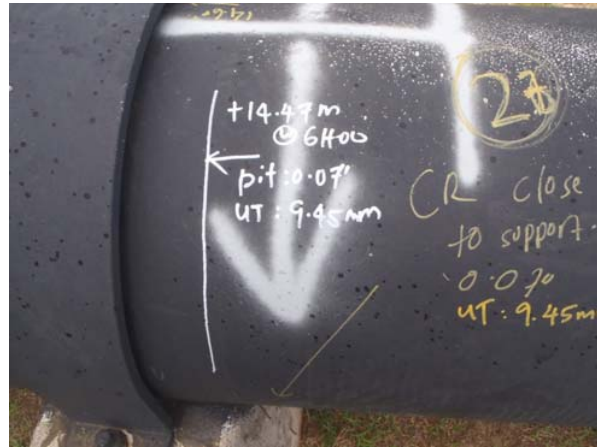
External corrosion near to pipe support

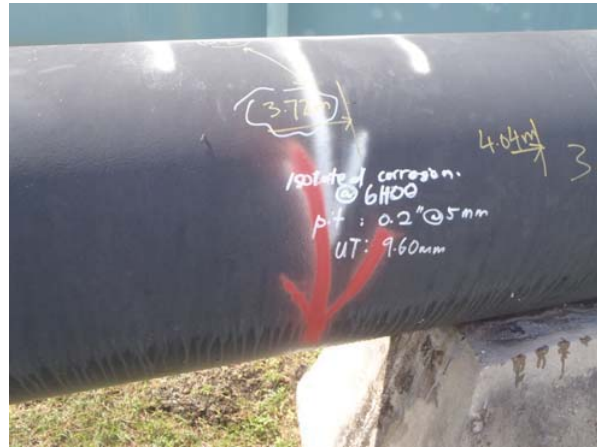
Isolated external corrosion at 6H00 near the pipe support

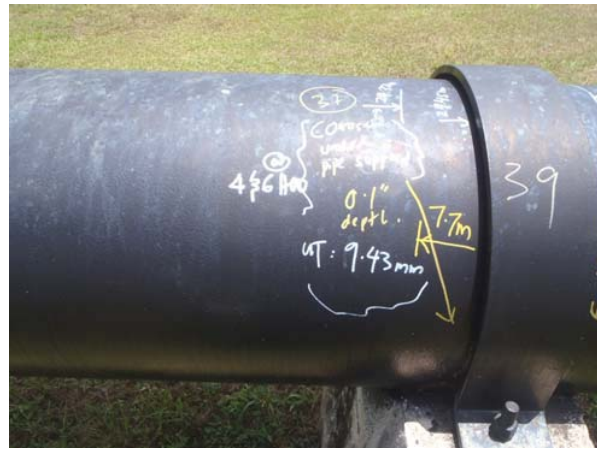
Corrosion closed to the pipe support

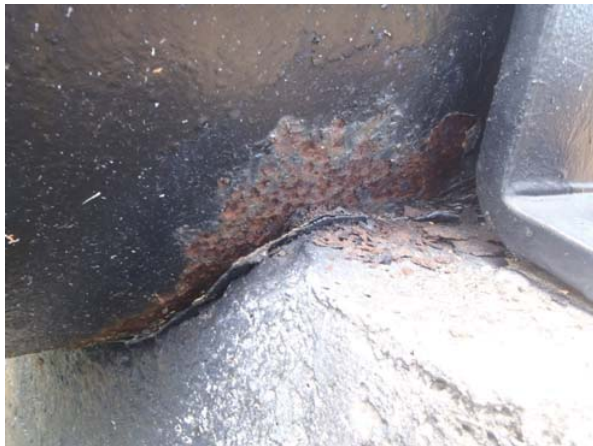
closed view of the corrosion

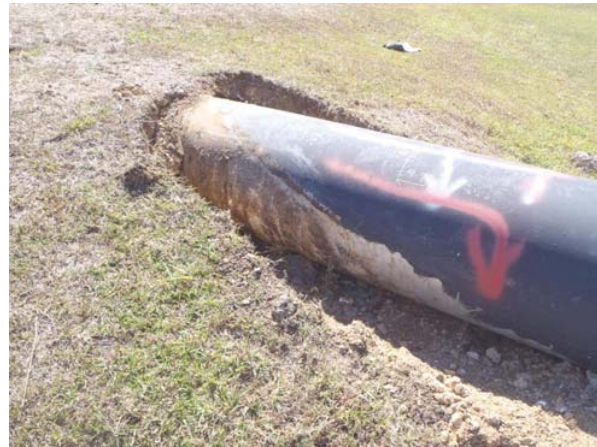
Corrosion at soil to air interface on wrapping section

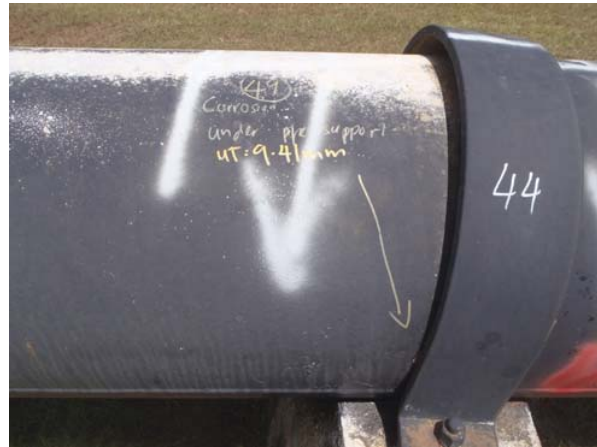
Corrosion under pipe support

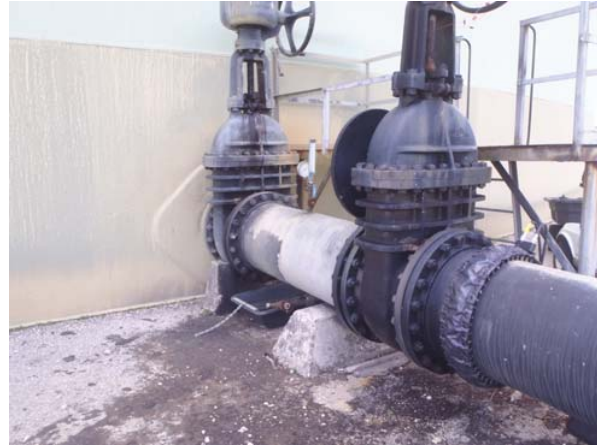
General view of external corrosion

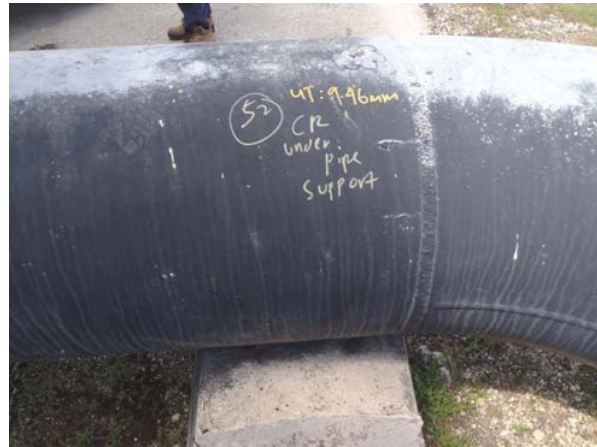
corrosion under pipe support

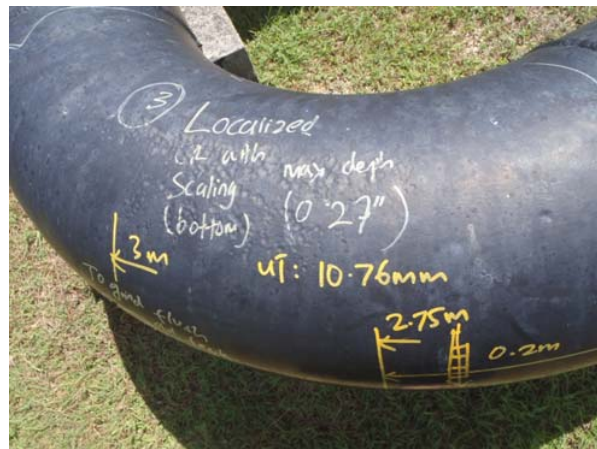
Feature	Location	ECL	Length	Extent	Class	Notes
F1	-5.23	-	0	4	Flange	
F2	-4.24	-	0	50	Y	
A1	-3.91	7	0.1	6	Medium	Visually confirm external corrosion at 6H00 with max. pit depth is 0.13"@ 3.3 mm. UT reading adjacent to pit is 11.58 mm. Remaining wall thickness is 8.28 mm (28.5% wall loss)
S1	-3.65	-	0.3	19	Support	
A2	-2.47	60	1	90	Severe	Visually confirm external corrosion at the bend (6H00 position) with max. pit depth is 0.27"@ 6.8 mm. UT reading adjacent to pit is 10.76 mm. Remaining wall thickness is 3.84 mm (63.2% wall loss)
B1	-2.43	-	0	90	1D Bend	
A3	-1.54	1	0.2	5	Medium	Visually confirm external corrosion at 6H00 with max. pit depth is 0.13"@ 3.3 mm. UT reading adjacent to pit is 11.58 mm. Remaining wall thickness is 8.28 mm (28.5% wall loss)
S2	-0.4	-	0.3	70	Support	
F3	0.23	-	0	80	Flange	Datum of screening

Severe level corrosion at 6H00

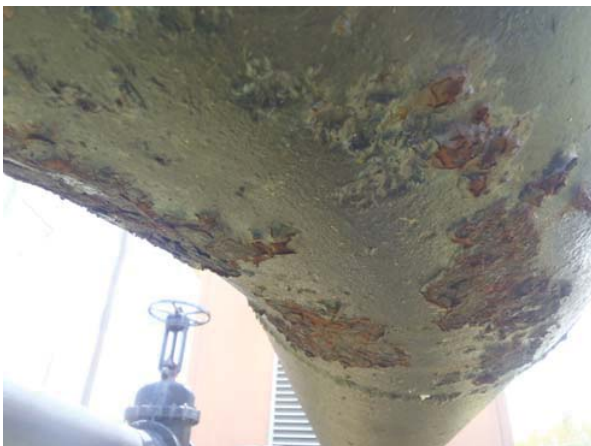
View of external corrosion with max. depth is 0.27" @ 6.8 mm

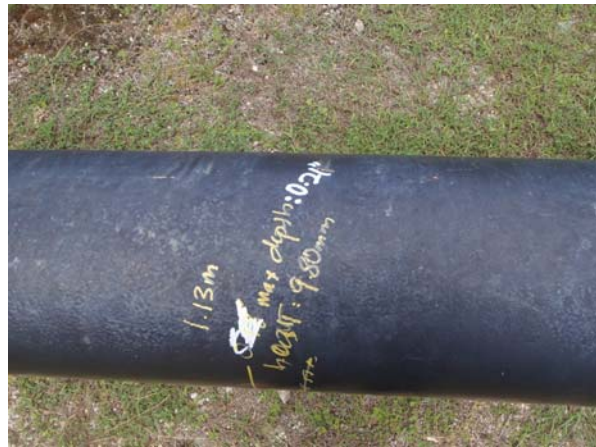
Feature	Location	ECL	Length	Extent	Class	Notes
F1	-0.28	-	0	60	T	Datum of screening
A1	0	0	1.13	35	Severe	Visually confirm external corrosion at 6H00 with max. pit depth is 0.21"@ 5.3 mm. UT reading adjacent to pit is 9.80 mm. Remaining wall thickness is 4.50 mm (54.1% wall loss)
W1	2.65	-	0	80	Weld	
F2	2.85	-	0	90	Flange

External corrosion at 6H00 with max. pit depth is 0.21" @ 5.3 mm.

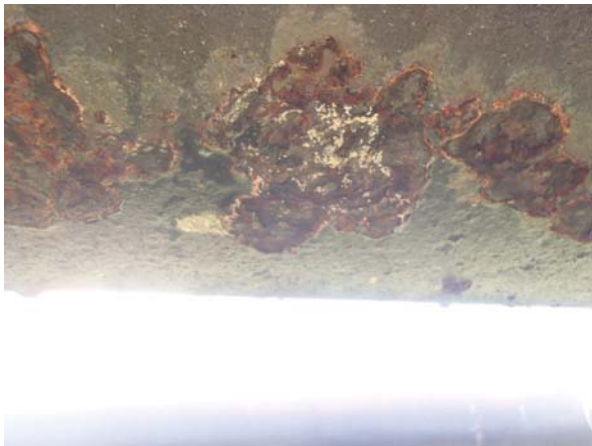
Closed view of corrosion

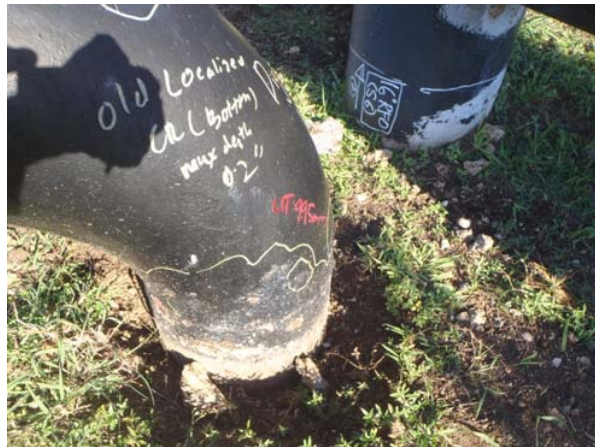
Corrosion at soil to air interface

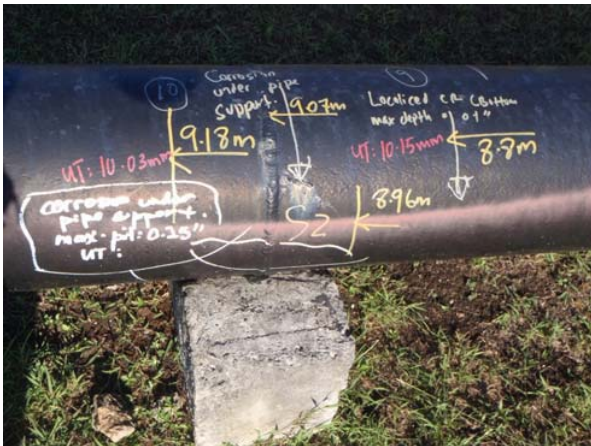
Corrosion under pipe support

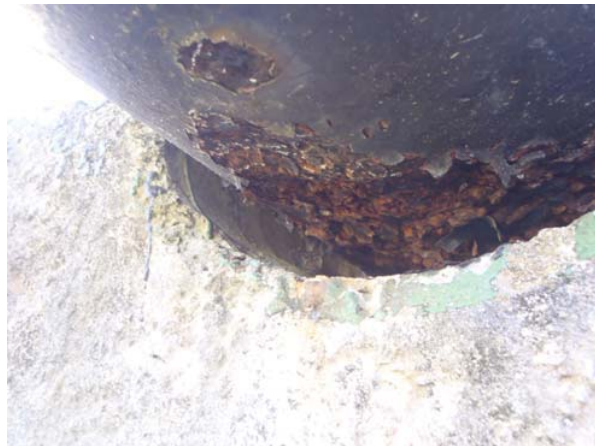
Closed view corrosion under pipe support

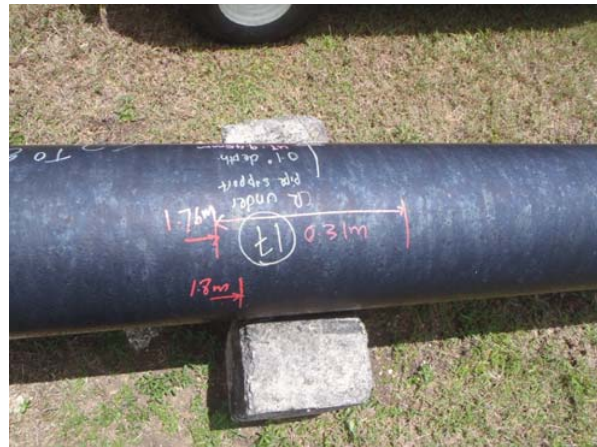
W2	-4.19	20	0	80	Weld	Datum of screening
S3	-4.05	-	0.2	90	Support	
A8	-3.9	3	0.66	40	Severe	Visually confirm external corrosion under pipe support (6H00) with max. pit depth is 0.22"@ 5.5 mm. UT reading adjacent to pit is 9.82 mm. Remaining wall thickness is 4.32 mm (56.0% wall loss)

Corrosion under pipe support
