Test ID: G4-214#2209	Result: Medium Concern
Pipe: 12" RFO (S4)	Ring: R2B12(1507)
Site: Inside Terminal	Config: 4.6FR, T(0,1)
Location: Weld bend -0.11m	Calibration: Automatic (1271.25 mV)
Size: 12 inch (10.3mm)	Version: 3.103, Wavemaker G4-214
	GPS: 13°27.6425'N, 144°41.1241'E
Tested: 16 Jun 2014 12:00	Client: Vital Energy
Tested by: Khairul Anuar Husain [SGS]	Procedure: WI-TM-065/Ver.00/27.04.2011
	DACs: Call=6%, Weld=23%

General Notes: 14" RFO-No.6 - Test Point No.: S5
Positive direction with product flow.
Found external corrosion concentrate at bottom side (refer class, note and location as table below).
Location of signals measuring from center of ring.
Thickness at ring position are (12 o'clock:10.26 mm), (3 o'clock:10.31 mm), (6 o'clock:10.40 mm), (9 o'clock:10.41 mm)

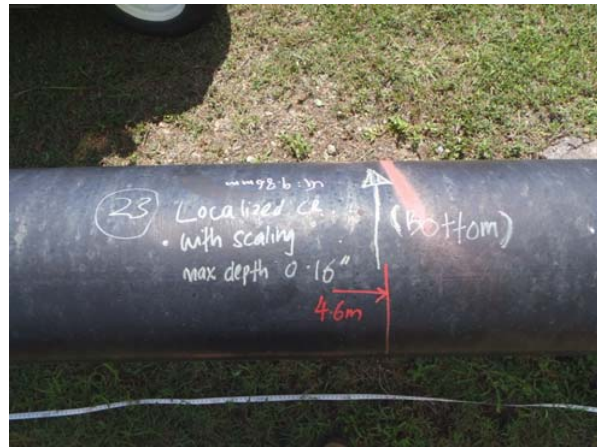
Localized corrosion at 6H00

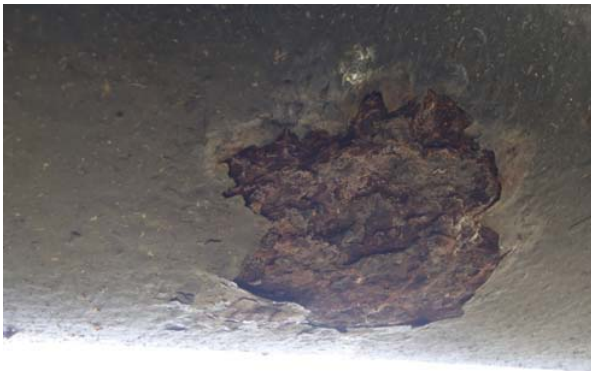
Closed view of corrosion

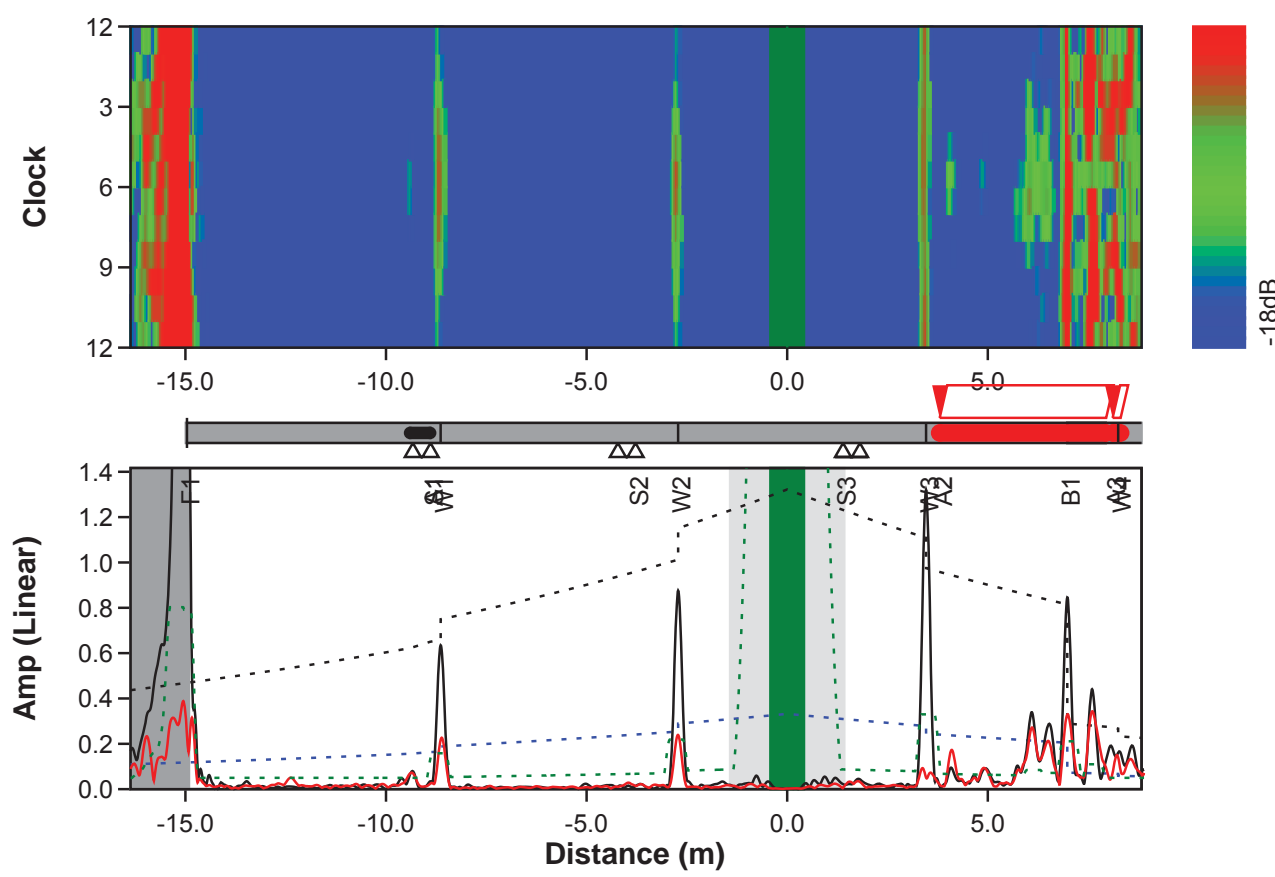
Feature	Location	ECL	Length	Extent	Class	Notes
F1	-14.96	-	0	90	Flange	
A1	-8.9	1	0.5	20	Minor	Visually confirm external corrosion under pipe support. No access to confirm corrosion depth.
S1	-8.89	-	0.44	20	Support	
W1	-8.63	19	0	60	Weld	
S2	-3.78	-	0.44	0	Support	
W2	-2.71	17	0	70	Weld	Datum of screening
S3	1.39	-	0.42	35	Support	
W3	3.46	25	0	90	Weld	
A2	3.8	1	4.15	25	Severe	Visually confirm external corrosion at 6H00 with max. pit depth is 0.32"@ 8.1 mm. UT reading adjacent to pit is 9.47 mm. Remaining wall thickness is 1.37 mm (85.5% wall loss)
B1	6.98	-	0	60	1D Bend	
A3	8.11	16	0.2	35	Severe	Visually confirm external corrosion at 6H00 with max. pit depth is 0.23"@ 5.8 mm. UT reading adjacent to pit is 9.42 mm. Remaining wall thickness is 3.62 mm (61.5% wall loss)
W4	8.25	-	0	10	Weld

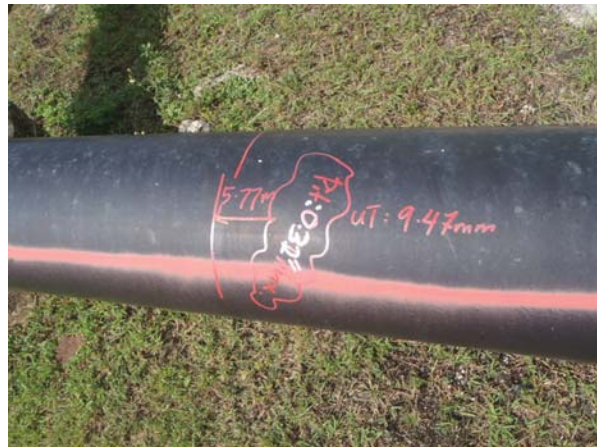
Severe corrosion localized at 6H00

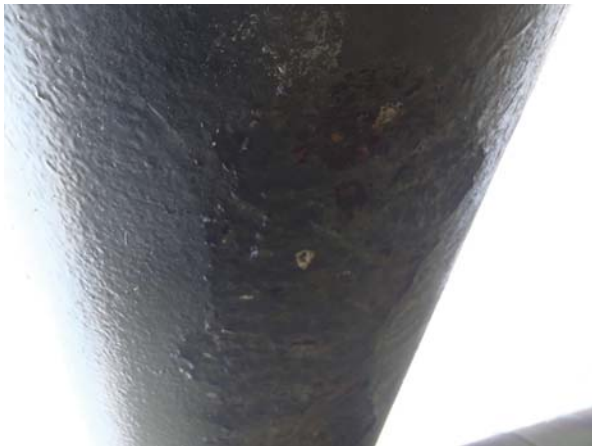
Closed view of corrosion

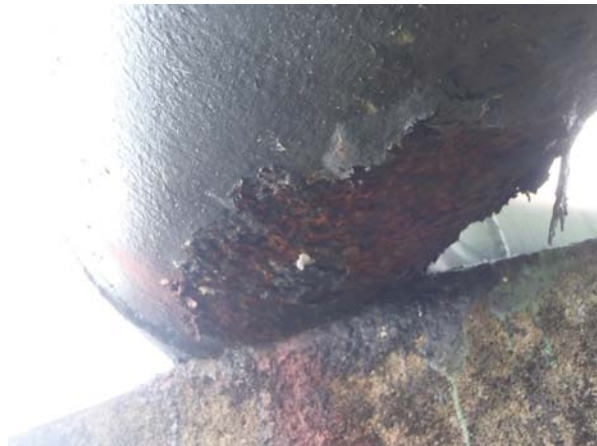
Closed view of corrosion

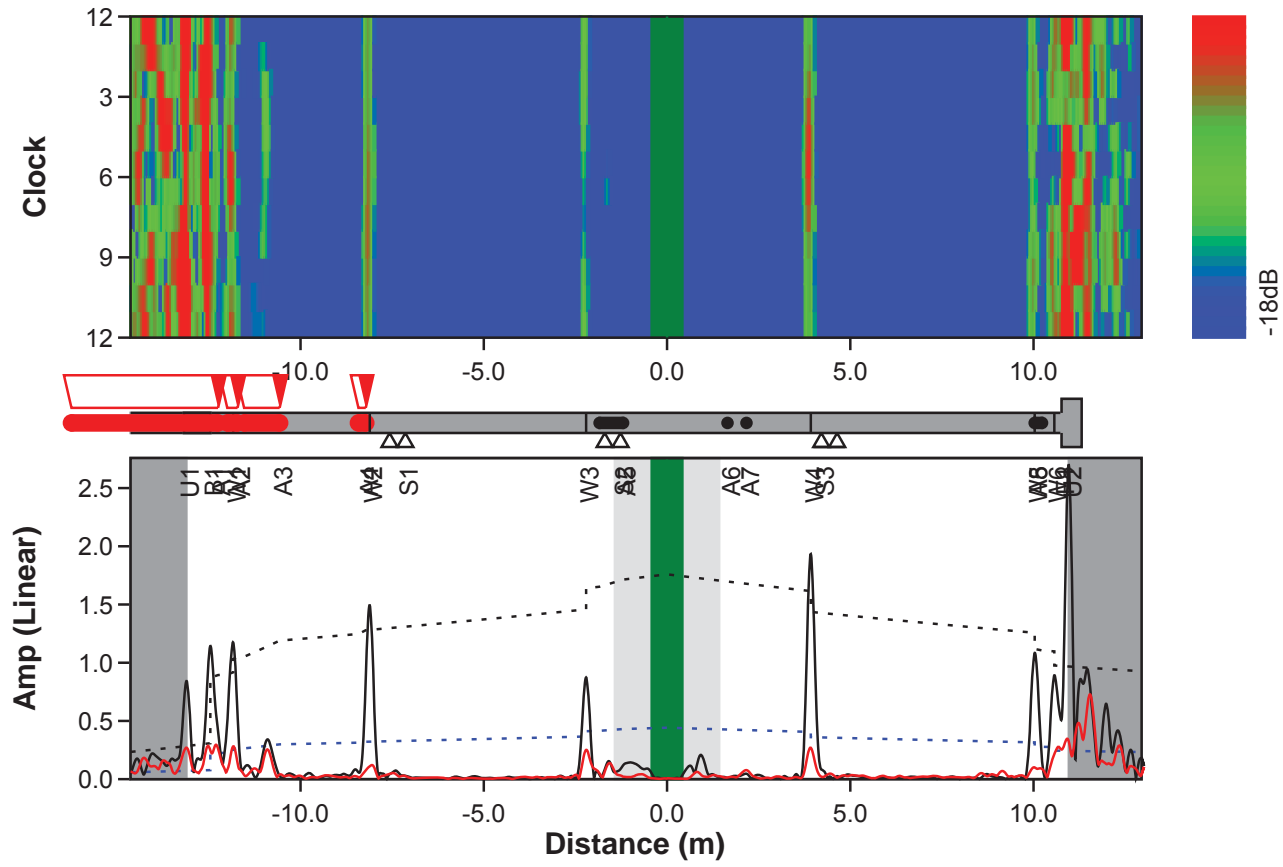
General Notes: 14" RFO-No.6 - Test Point No.: S6
 Positive direction with product flow.
 Found external corrosion concentrate at bottom side (refer class, note and location as table below).
 Location of signals measuring from center of ring.
 Thickness at ring position are (12 o'clock:10.26 mm), (3 o'clock:10.31 mm), (6 o'clock:10.40 mm), (9 o'clock:10.41 mm)

Feature	Location	ECL	Length	Extent	Class	Notes
U1	-13.11	-	~		End	
B1	-12.46	-	0	70	1D Bend	
A1	-12.25	15	4	50	Severe	Visually confirm external corrosion at 6H00 with max. pit depth is 0.32"@ 8.1 mm. UT reading adjacent to pit is 9.47 mm. Remaining wall thickness is 1.37 mm (85.5% wall loss)
W1	-11.83	25	0	80	Weld	
A2	-11.71	20	0.28	80	Severe	Visually confirm external corrosion at 6H00 with max. pit depth is 0.23"@ 5.8 mm. UT reading adjacent to pit is 9.42 mm. Remaining wall thickness is 3.62 mm (61.5% wall loss)
A3	-10.57	1	0.97	35	Severe	Visually confirm localized corrosion at 6H00 with max. pit depth is 0.21"@ 5.3 mm. UT reading adjacent to pit is 9.41 mm. Remaining wall thickness is 4.11 mm (56.3% wall loss)
A4	-8.22	25	0.2	90	Severe	Visually confirm localized corrosion at 6H00 with max. pit depth is 0.20"@ 5.0 mm. UT reading adjacent to pit is 9.78 mm. Remaining wall thickness is 4.78 mm (51.1% wall loss)

W2	-8.11	25	0	90	Weld	
S1	-7.14	-	0.43	6	Support	
W3	-2.2	12	0	70	Weld	Datum of screening
S2	-1.27	-	0.43	70	Support	
A5	-1.2	2	0.64	17	Minor	Visually confirm corrosion under pipe support (6H00) with max. pit depth is 0.07"@ 1.8 mm. UT reading adjacent to pit is 9.67 mm. Remaining wall thickness is 7.87 mm (18.6% wall loss)

Feature	Location	ECL	Length	Extent	Class	Notes
A6	1.65	0	0	0	Minor	Visually confirm external corrosion at 12H00 with max. pit depth is 0.06"@ 1.5 mm. UT reading adjacent to pit is 9.40 mm. Remaining wall thickness is 7.90 mm (15.9% wall loss)
A7	2.16	1	0	0	Minor	Visually confirm external corrosion at 6H00 with max. pit depth is 0.08"@ 2.0 mm. UT reading adjacent to pit is 9.40 mm. Remaining wall thickness is 7.40 mm (21.3% wall loss)
W4	3.92	25	0	90	Weld	
S3	4.21	-	0.43	80	Support	
A8	10.03	20	0.2	90	Minor	Visually confirm external corrosion at 6H00 with max. pit depth is 0.05"@ 1.30 mm. UT reading adjacent to pit is 9.54 mm. Remaining wall thickness is 8.24 mm (13.6% wall loss)
W5	10.03	20	0	90	Weld	
W6	10.56	-	0	70	Weld	
F1	10.76	-	0	70	T	
U2	10.96	-	~		End

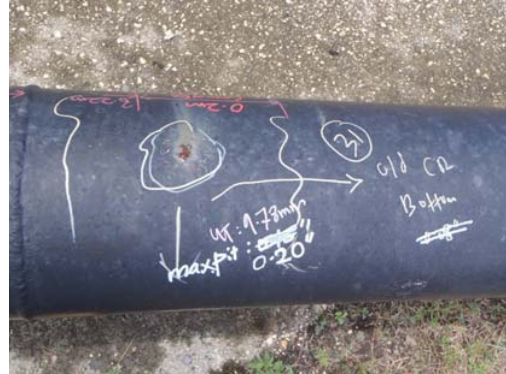
Localize corrosion at 6H00

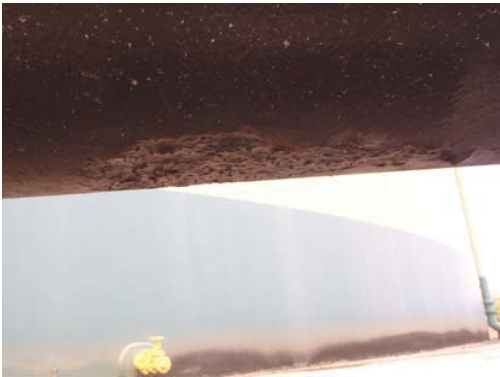
Closed view of corrosion

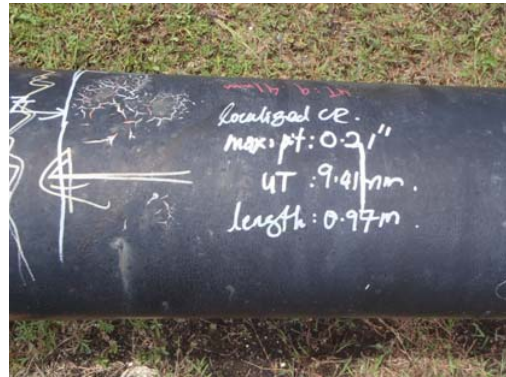
Localized corrosion at 6H00

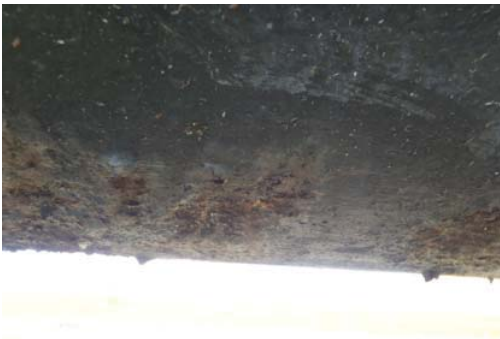
closed view of corrosion

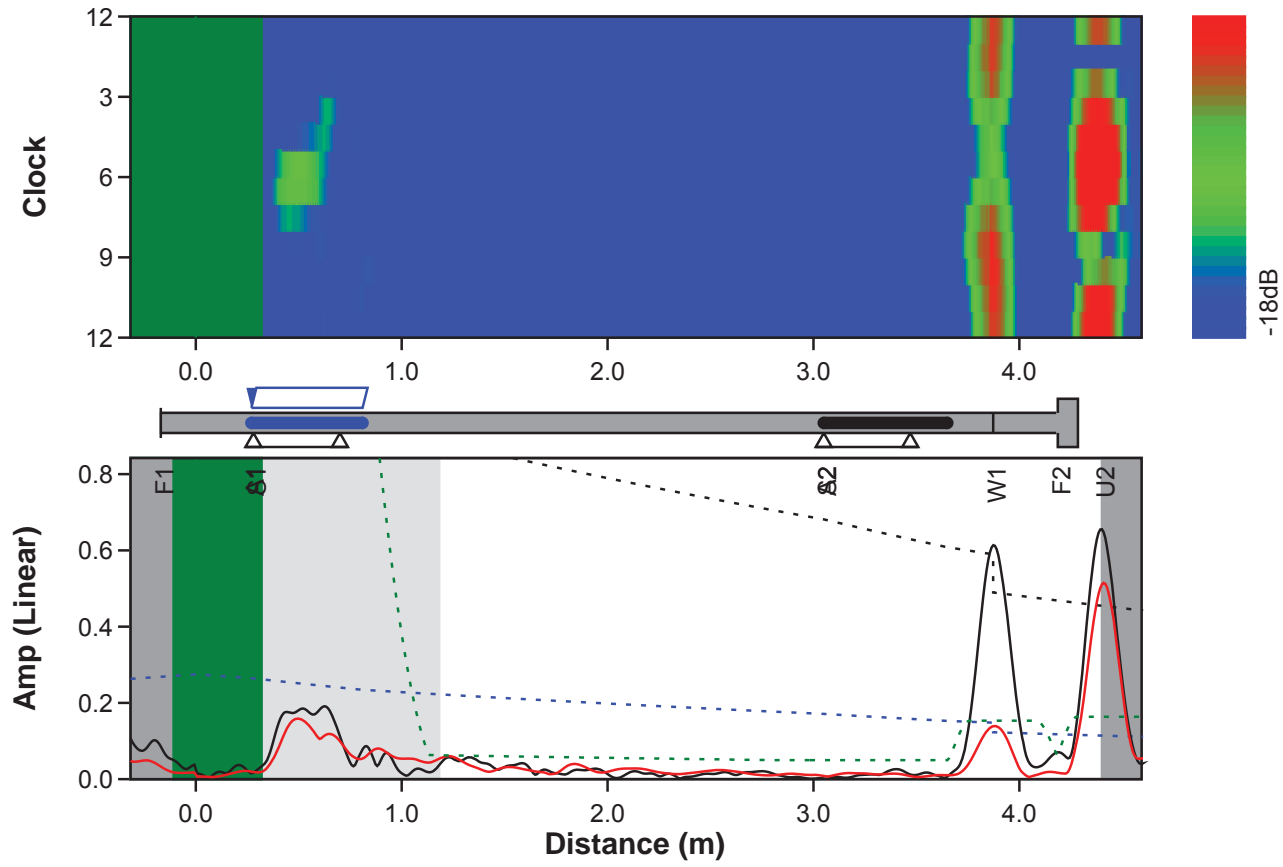
General Notes: 14" RFO-No.6 - Test Point No.: S7
 Positive direction with product flow.
 Found external corrosion under pipe support at bottom side (refer class, note and location as table below).
 Location of signals measuring from center of ring.
 Thickness at ring position are (12 o'clock:5.70 mm), (3 o'clock:6.46 mm), (6 o'clock:6.21 mm), (9 o'clock:5.75 mm)

Feature	Location	ECL	Length	Extent	Class	Notes
F1	-0.17	-	0	50	Flange	Datum of screening
A1	0.27	1	0.54	40	Medium	Visually confirm external corrosion under pipe support (6H00) with max. pit depth is 0.1" @ 2.5 mm. UT reading adjacent to pit is 6.35 mm. Remaining wall thickness is 3.85 mm (39.4 % wall loss)
S1	0.28	-	0.42	40	Support	
S2	3.05	-	0.42	0	Support	
A2	3.05	0	0.6	0	Minor	Visually confirm external corrosion under pipe support. No access to confirm corrosion depth.
W1	3.87	-	0	80	Weld	
F2	4.18	-	0	60	T	
U2	4.4	-	~		End

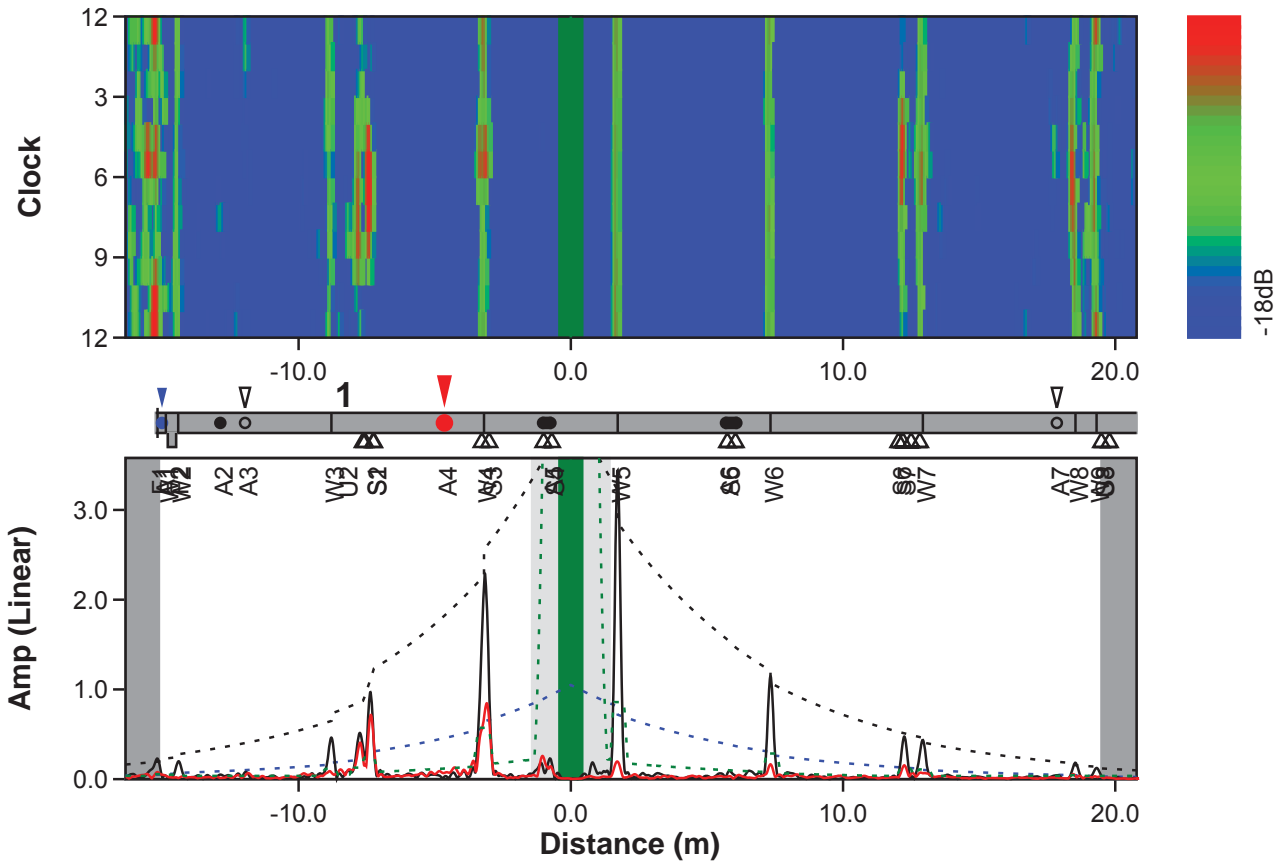
General Notes: 14" RFO-No.6 - Test Point No.: S8
 Positive direction with product flow.
 Found external corrosion at several location (refer class, note and location as table below).
 Location of signals measuring from center of ring.
 Thickness at ring position are (12 o'clock:6.32 mm), (3 o'clock:6.44 mm), (6 o'clock:6.30 mm), (9 o'clock:6.29 mm)

Feature	Location	ECL	Length	Extent	Class	Notes
F1	-15.18	-	0	70	End	
A1	-15.01	13	0	50	Medium	Visually confirm external corrosion at 5H00 with max. pit depth is 0.18"@ 4.5 mm. UT reading adjacent to pit is 12.73 mm. Remaining wall thickness is 8.23 mm (35.3% wall loss)
W1	-14.87	-	0	0	Weld	
F2	-14.5	-	0	80	Y	
W2	-14.42	-	0	90	Weld	
A2	-12.87	3	0	60	Minor	UT confirm internal corrosion with maximum wall thickness is 5.36 mm (15.6% wall loss)
A3	-11.96	5	0	25	Anomaly	UT confirm no significant finding. Minimum thickness reading is 5.72 mm.
W3	-8.79	15	0	80	Weld	
U2	-8.3	-	0	5	User1	Insert weld patch (0.08 x 0.08m) - see attached picture
S1	-7.26	-	0.3	20	Support	
S2	-7.23	-	0.4	16	Saddle	Patch plate at 3 to 10H00
A4	-4.64	0	0	0	Severe	Visually confirm external corrosion at 6H00 with max. pit depth is 0.14"@ 3.5 mm. UT reading adjacent to pit is 6.36 mm. Remaining wall thickness is 2.86 mm (55.0% wall loss)

W4	-3.18	20	0	60	Weld	
S3	-3	-	0.27	50	Saddle	Patch plate at 6H00
A5	-0.75	1	0.27	40	Minor	Visually confirm external corrosion under pipe support. No access to confirm corrosion depth.
S4	-0.7	-	0.3	40	Support

Feature	Location	ECL	Length	Extent	Class	Notes
W5	1.72	25	0	90	Weld	Datum of screening
A6	5.7	1	0.38	60	Minor	Visually confirm external corrosion under pipe support. No access to confirm corrosion depth.
S5	5.75	-	0.3	70	Support	
W6	7.33	20	0	90	Weld	
S6	12.04	-	0.78	70	Saddle	Patch plate
S7	12.2	-	0.3	70	Support	
W7	12.93	-	0	80	Weld	
A7	17.85	5	0	60	Anomaly	UT confirm no significant finding. Minimum thickness reading is 5.97 mm.
W8	18.53	-	0	70	Weld	
W9	19.31	-	0	70	Weld	
S8	19.48	-	0.3	60	Support	
U3	19.49	-	~		End	
W10	24.92	-	0	80	Weld

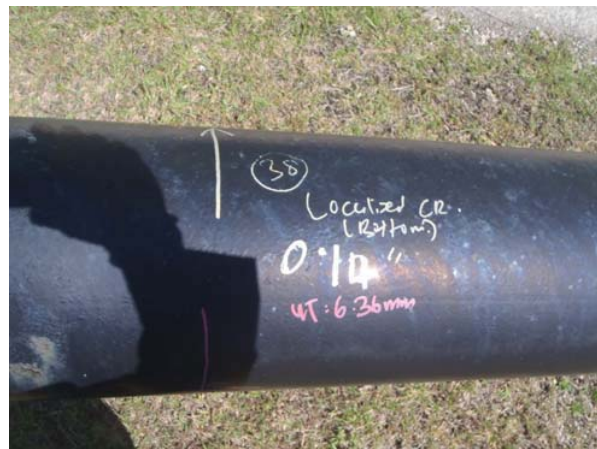
Localized corrosion at 6H00

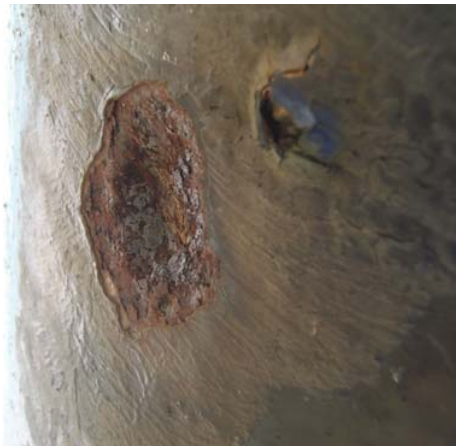
Closed view of corrosion

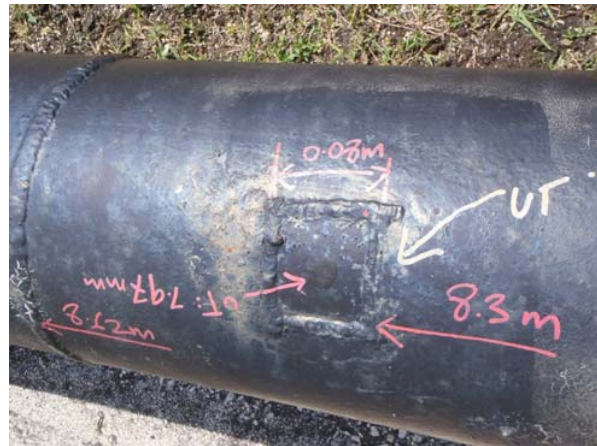
Insert weld patch

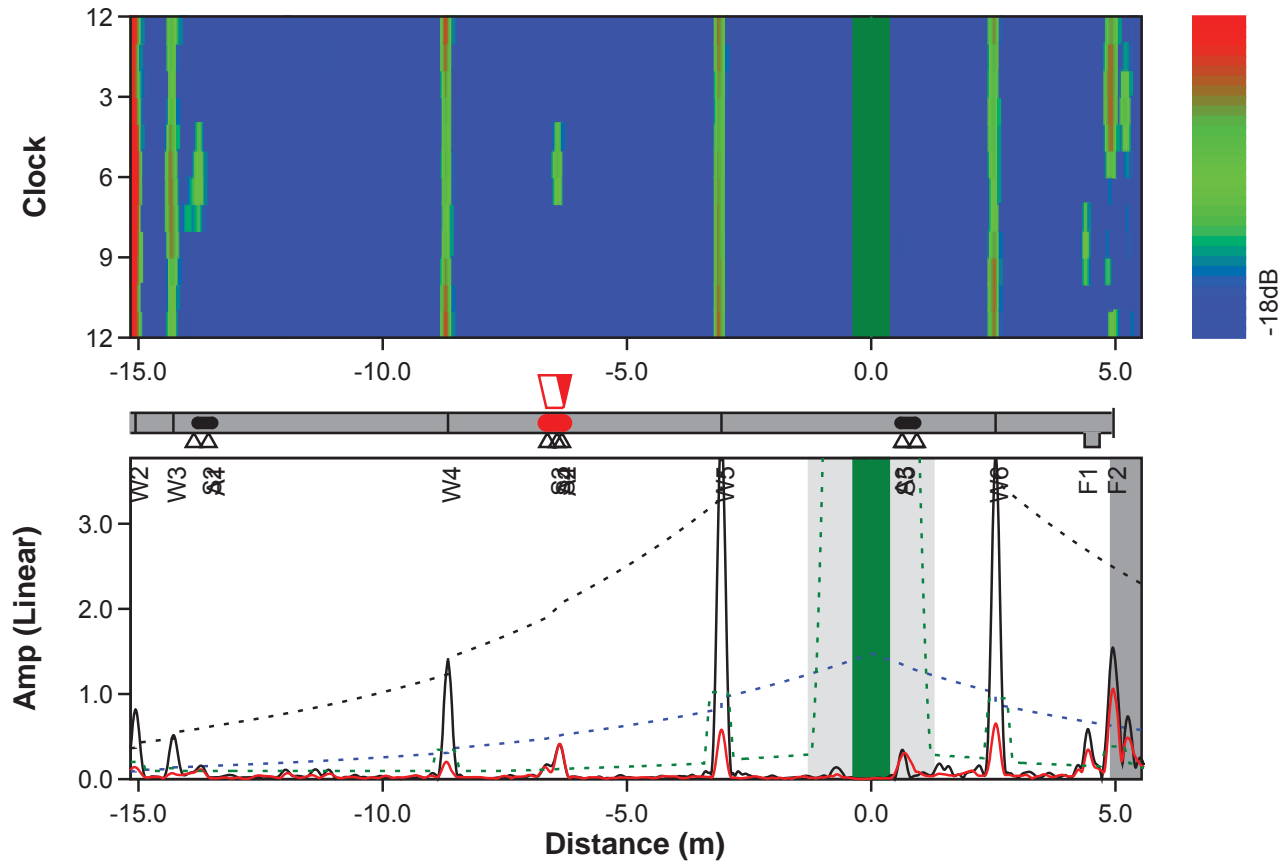
General Notes: 14" RFO-No.6 - Test Point No.: S9
 Positive direction with product flow.
 Found external corrosion under pipe support (refer class, note and location as table below).
 Location of signals measuring from center of ring.
 Thickness at ring position are (12 o'clock:6.30 mm), (3 o'clock:6.42 mm), (6 o'clock:6.07 mm), (9 o'clock:6.41 mm)

Feature	Location	ECL	Length	Extent	Class	Notes
U1	-15.36	-	~		End	
W2	-15.05	40	0	80	Weld	
W3	-14.28	20	0	90	Weld	
S2	-13.56	-	0.3	25	Support	
A1	-13.49	1	0.3	30	Minor	Visually confirm external corrosion under pipe support. No access to confirm corrosion depth.
W4	-8.66	20	0	90	Weld	
S3	-6.43	-	0	0	Clamp	
S4	-6.33	-	0.3	0	Support	
A2	-6.3	4	0.35	0	Severe	Visually confirm external corrosion at 6H00 under pipe support with max. pit depth is 0.16" @ 3.8 mm. UT reading adjacent to pit is 6.16 mm. Remaining wall thickness is 2.36 mm (61.7% wall loss)
W5	-3.06	25	0	90	Weld	
A3	0.6	2	0.3	13	Minor	Visually confirm external corrosion under pipe support. No access to confirm corrosion depth.
S5	0.63	-	0.3	11	Support	
W6	2.54	20	0	80	Weld	Datum of screening
F1	4.37	-	0	40	Y	
F2	4.96	-	0	30	Flange

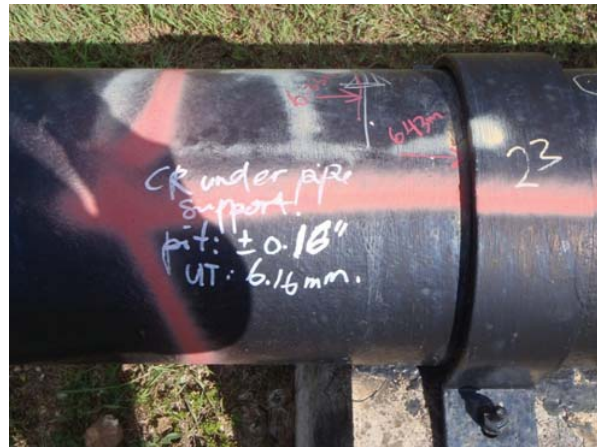
Corrosion on pipe support

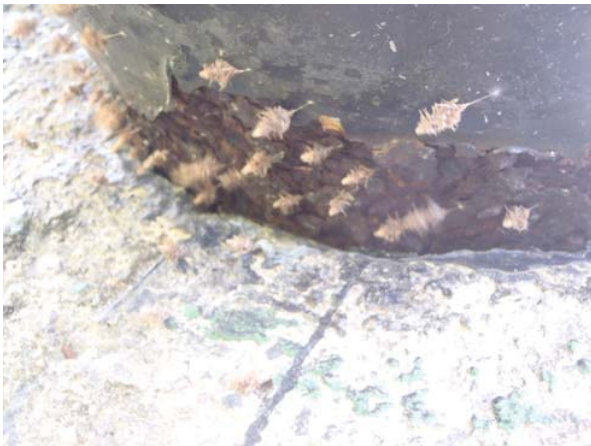
Closed view of corrosion

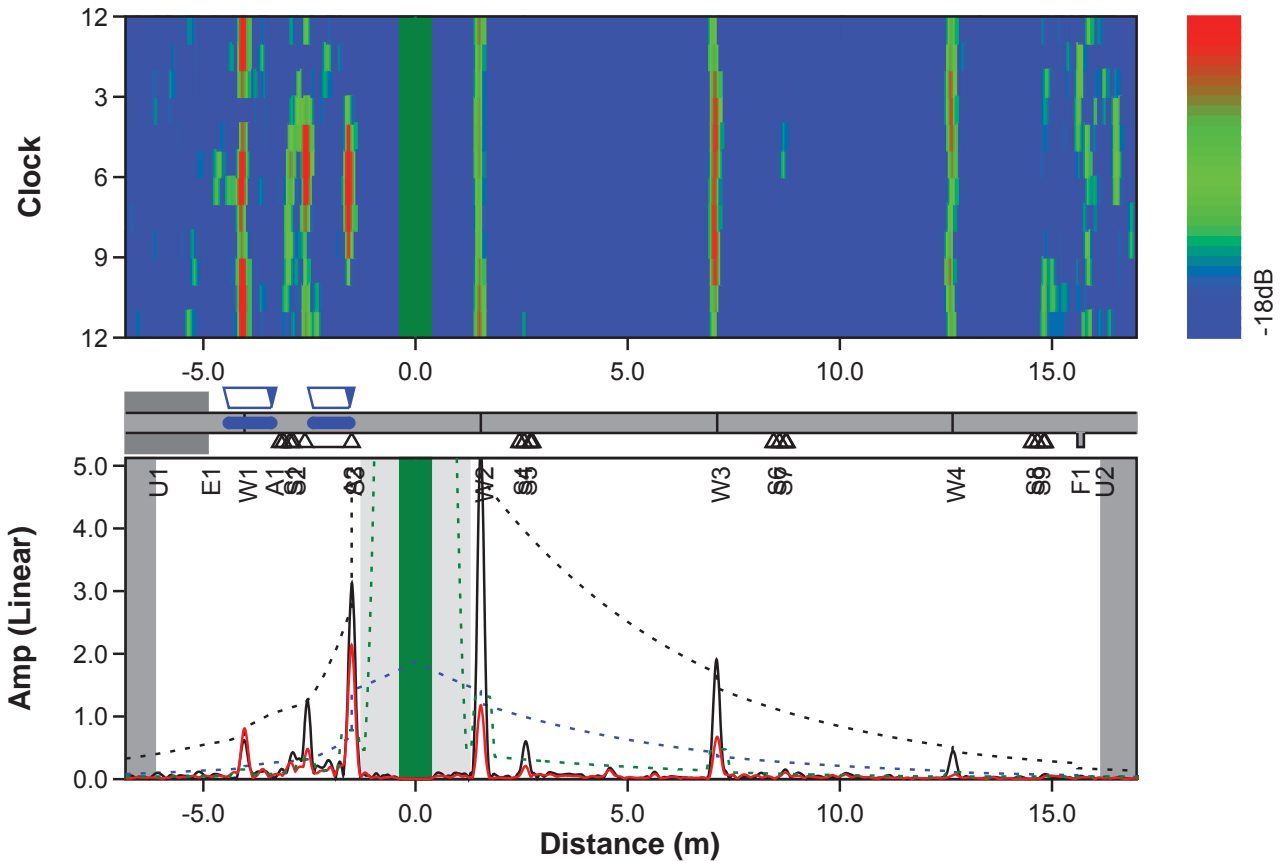
General Notes: 12" RFO-No.6 - Test Point No.: S11
Positive direction with product flow.
Found external corrosion at several corrosion (refer class, note and location as table below).
Location of signals measuring from center of ring.
Thickness at ring position are (12 o'clock:6.33 mm), (3 o'clock:6.35 mm), (6 o'clock:6.33 mm), (9 o'clock:6.33 mm)

Feature	Location	ECL	Length	Extent	Class	Notes
U1	-6.14	-	~		End	
E1	-4.9	-	~	0	Earth	underground
W1	-4.02	-	0	0	Weld	
A1	-3.4	2	1	15	Medium	Visually confirm external corrosion at 6H00 with max. pit depth is 0.12"@ 3.0 mm. UT reading adjacent to pit is 6.35 mm. Remaining wall thickness is 3.35 mm (47.2% wall loss)
S1	-2.96	-	0.15	40	Clamp	
S2	-2.89	-	0.3	40	Support	
A2	-1.56	25	0.85	30	Medium	Visually confirm external corrosion at 1 - 3H00 with max. pit depth is 0.12"@ 3.0 mm. UT reading adjacent to pit is 6.20 mm. Remaining wall thickness is 3.20 mm. (48.4% wall loss)
S3	-1.5	-	1.1	30	Saddle	Patch plate
W2	1.53	-	0	80	Weld	Datum of screening
S4	2.45	-	0.3	60	Support	
S5	2.56	-	0.15	70	Clamp	
W3	7.11	-	0	60	Weld	
S6	8.44	-	0.3	0	Support	
S7	8.58	-	0.15	30	Clamp	
W4	12.65	-	0	80	Weld	
S8	14.53	-	0.3	30	Support	
S9	14.66	-	0.15	60	Clamp	
F1	15.59	-	0	45	Branch	
U2	16.16	-	~		End

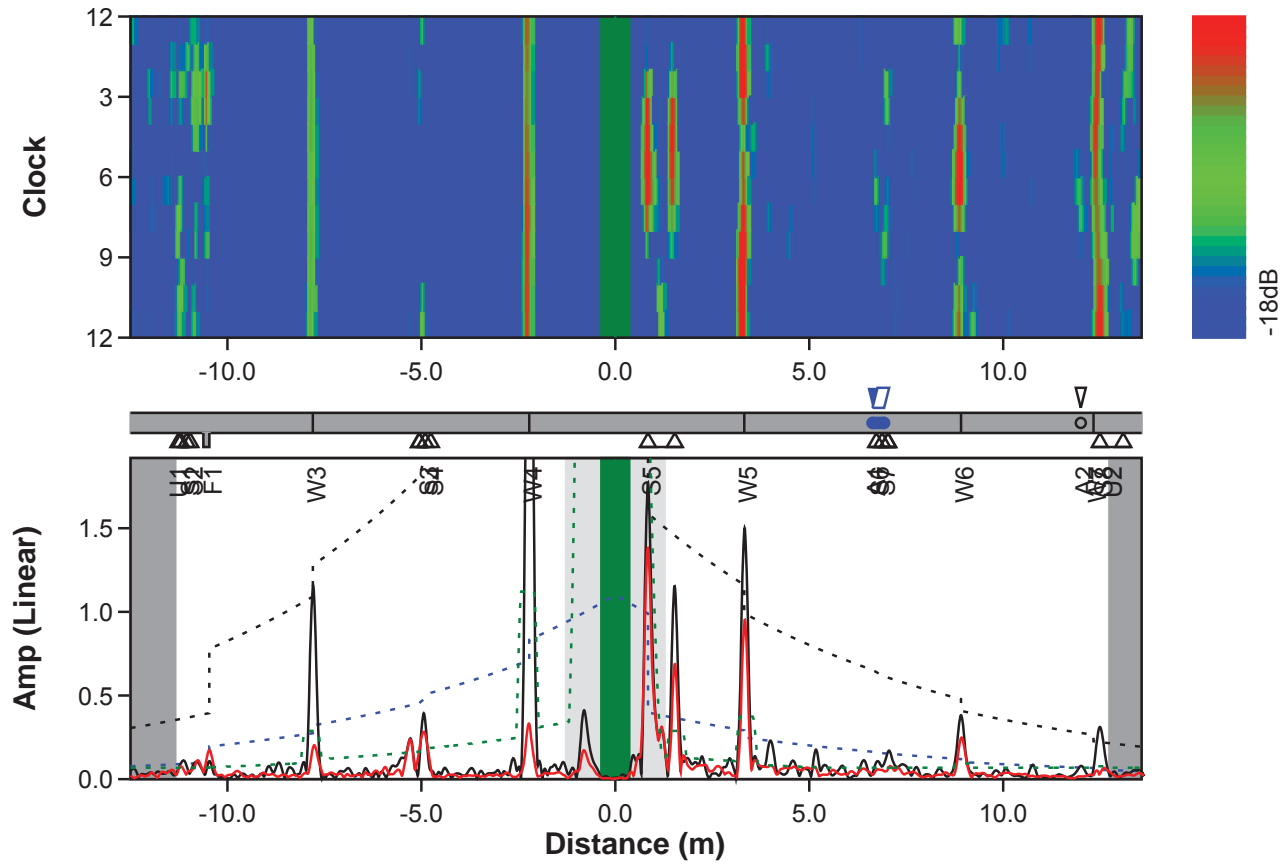
General Notes: 14" RFO-No.6 - Test Point No.: S12
Positive direction with product flow.
Found external corrosion at pipe support (refer class, note and location as table below).
Location of signals measuring from center of ring.
Thickness at ring position are (12 o'clock:6.17 mm), (3 o'clock:6.13 mm), (6 o'clock:6.27 mm), (9 o'clock:6.71 mm)

Feature	Location	ECL	Length	Extent	Class	Notes
U1	-11.34	-	~		End	
S1	-11.05	-	0.15	50	Clamp	
S2	-10.96	-	0.3	25	Support	
F1	-10.46	-	0	0	Branch	
W3	-7.79	-	0	80	Weld	
S3	-4.9	-	0.15	30	Clamp	
S4	-4.75	-	0.3	0	Support	
W4	-2.21	-	0	90	Weld	Datum of screening
S5	0.84	-	0.69	20	Saddle	Patch plate at bottom side
W5	3.32	-	0	35	Weld	
A1	6.63	3	0.3	45	Medium	Visually confirm external corrosion under pipe support (6H00) with max. pit depth is 0.10"@ 2.5 mm. UT reading adjacent to pit is 6.25 mm. Remaining wall thickness is 3.75 mm (40.0% wall loss)
S6	6.73	-	0.3	45	Support	
S7	6.88	-	0.15	45	Clamp	
W6	8.91	-	0	35	Weld	
A2	12	7	0	80	Anomaly	UT confirm no significant finding. Minimum UTreading is 5.70 mm.
W7	12.32	-	0	70	Weld	
S8	12.49	-	0.6	80	Saddle	
U2	12.73	-	~		End

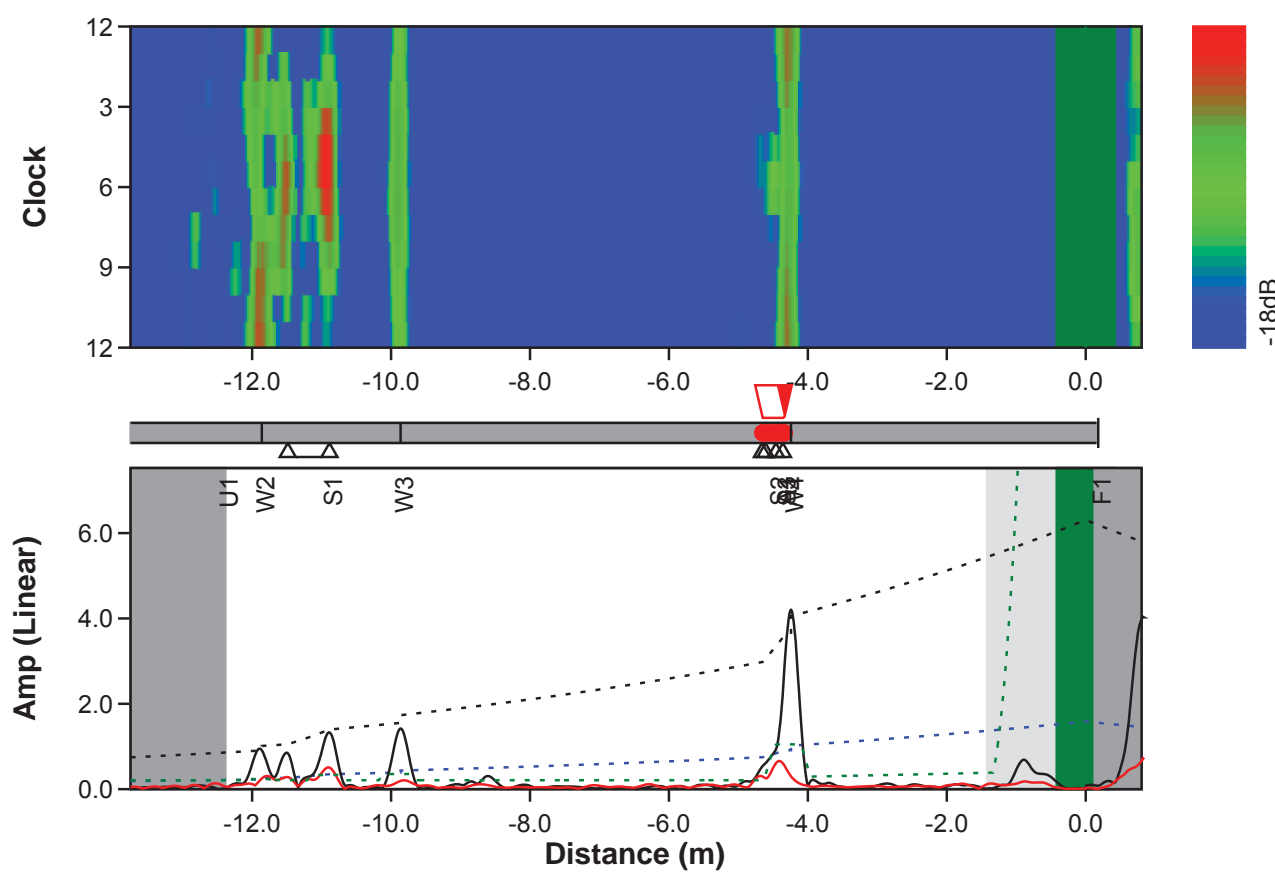
General Notes: 14" RFO-No.6 - Test Point No.: S13
 Positive direction with product flow.
 Found external corrosion at pipe support (refer class, note and location as table below).
 Location of signals measuring from center of ring.
 Thickness at ring position are (12 o'clock:6.20 mm), (3 o'clock:6.07 mm),
 (6 o'clock:6.13 mm), (9 o'clock:6.27 mm)

Feature	Location	ECL	Length	Extent	Class	Notes
U1	-12.38	-	~		End	
W2	-11.86	-	0	70	Weld	
S1	-10.88	-	0.6	60	Saddle	
W3	-9.86	-	0	90	Weld	
S2	-4.46	-	0.15	50	Clamp	
S3	-4.36	-	0.3	80	Support	
A1	-4.34	25	0.31	80	Severe	Visually confirm external corrosion under pipe support (6H00) with max. pit depth is 0.15"@ 3.8 mm. UT reading adjacent to pit is 6.27 mm. Remaining wall thickness is 2.47 mm (60.6% wall loss)
W4	-4.24	-	0	90	Weld	
F1	0.18	-	0	80	Flange	Datum of screening

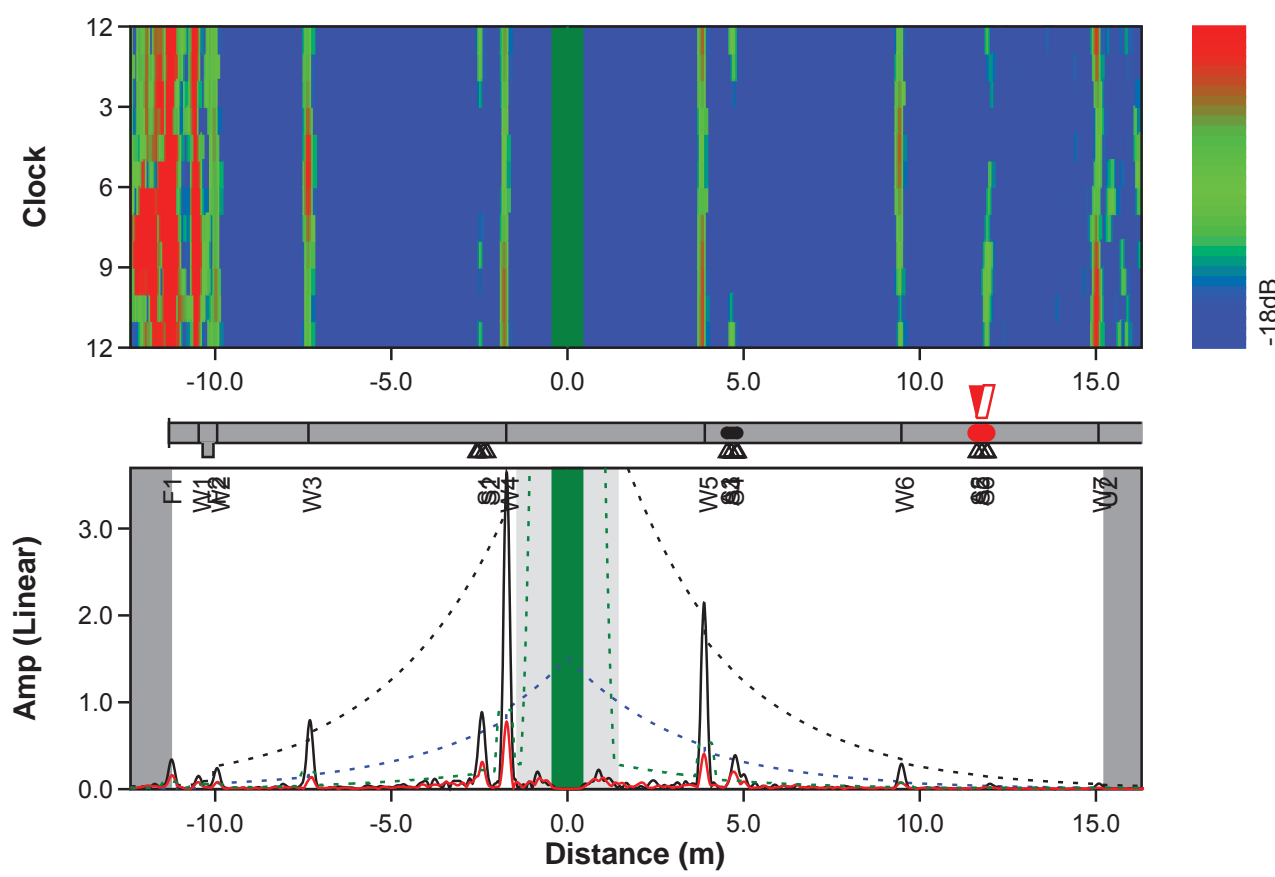
General Notes: 14" RFO-No.6 - Test Point No.: S15
Positive direction with product flow.
Found external corrosion at pipe support (refer class, note and location as table below).
Location of signals measuring from center of ring.
Thickness at ring position are (12 o'clock:6.24 mm), (3 o'clock:6.21 mm), (6 o'clock:6.54 mm), (9 o'clock:6.34 mm)

Feature	Location	ECL	Length	Extent	Class	Notes
F1	-11.3	-	0	50	Flange	
W1	-10.46	-	0	45	Weld	
F2	-10.05	-	0	70	Y	Branch
W2	-9.94	-	0	70	Weld	
W3	-7.35	25	0	80	Weld	
S1	-2.38	-	0.15	60	Clamp	
S2	-2.28	-	0.3	70	Support	
W4	-1.73	20	0	80	Weld	Datum of screening
W5	3.89	25	0	80	Weld	
A1	4.51	2	0.3	0	Minor	Visually confirm external corrosion under pipe support (6H00) with max. pit depth approximately 0.07" @ 1.3 mm. UT reading adjacent to pit is 6.29 mm. Remaining wall thickness approximately 4.99 mm (20.7% wall loss)
S3	4.53	-	0.3	0	Support	
S4	4.65	-	0.15	40	Clamp	
W6	9.47	-	0	70	Weld	
A2	11.6	2	0.3	1	Severe	Visually confirm external corrosion under pipe support (6H00) with max. pit depth approximately 0.17" @ 3.8 mm. UT reading adjacent to pit is 6.35 mm. Remaining wall thickness approximately 2.55 mm (59.8% wall loss)
S5	11.62	-	0.3	0	Support	
S6	11.76	-	0.15	0	Saddle	
W7	15.07	-	0	70	Weld	
U2	15.24	-	~		End

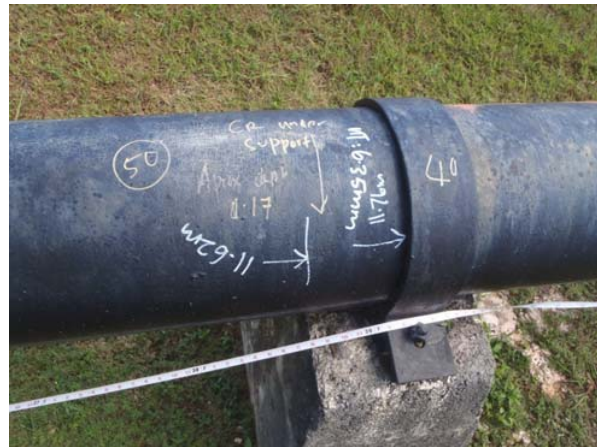
Corrosion under pipe support

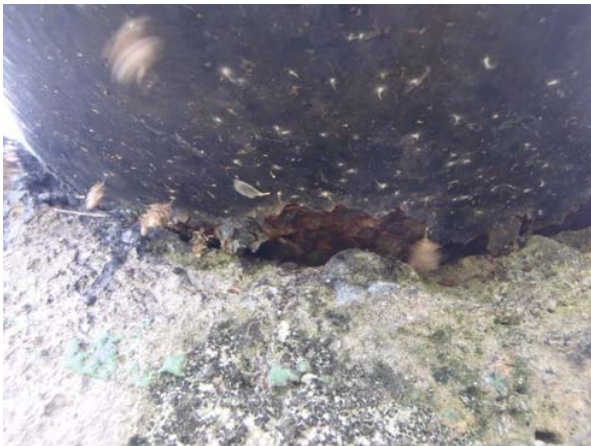
Closed view of corrosion

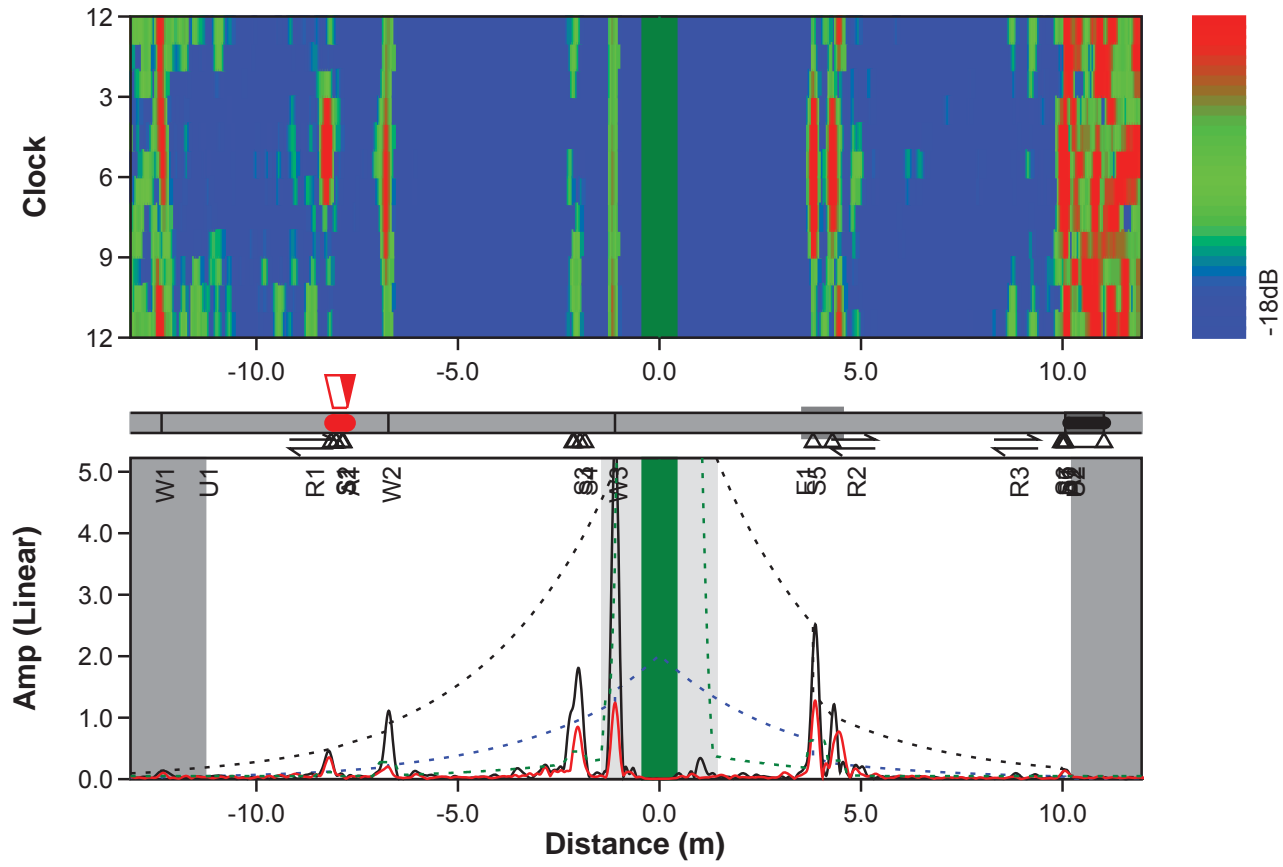
General Notes: 14" RFO-No.6 - Test Point No.: S17
 Positive direction with product flow.
 Found external corrosion at pipe support (refer class, note and location as table below).
 Location of signals measuring from center of ring.
 Thickness at ring position are (12 o'clock:6.42 mm), (3 o'clock:6.09 mm), (6 o'clock:6.05 mm), (9 o'clock:6.31 mm)

Feature	Location	ECL	Length	Extent	Class	Notes
W1	-12.35	-	0	25	Weld	
U1	-11.27	-	~		End	
R1	-8.63	-	0	35	Reverb.	False echo
S1	-7.87	-	0.15	30	Clamp	
S2	-7.84	-	0.3	35	Support	
A1	-7.75	3	0.35	40	Severe	Visually confirm external corrosion under pipe support (6H00) with max. pit depth approximately 0.20" @ 5.0 mm. UT reading adjacent to pit is 6.18 mm. Remaining wall thickness approximately 1.18 mm(80.9%wall loss)
W2	-6.72	-	0	80	Weld	
S3	-1.97	-	0.15	50	Clamp	
S4	-1.85	-	0.3	60	Support	
W3	-1.1	20	0	80	Weld	Datum of screening
E1	3.54	-	1	50	Wrapping	
S5	3.81	-	0.48	50	Saddle	
R2	4.8	-	0	25	Trailing Echoes	False echo
R3	8.84	-	0	60	Reverb.	False echo
S6	9.96	-	0.1	1	Saddle	
S7	10.02	-	1	12	Support	
B1	10.06	-	0	12	1D Bend	
A2	10.15	60	0.9	16	Minor	Visually confirm general corrosion under pipe support.
U2	10.23	-	~		End

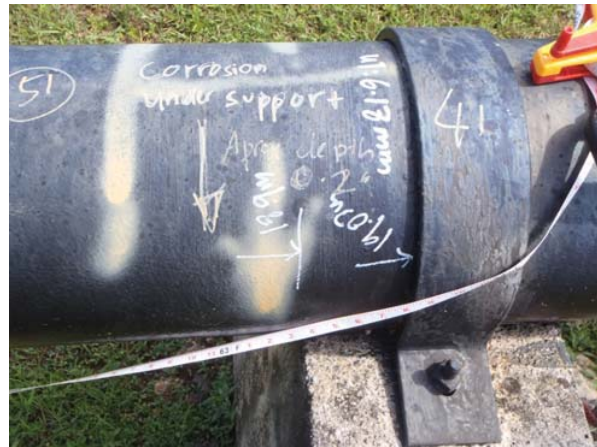
Corrosion under pipe support

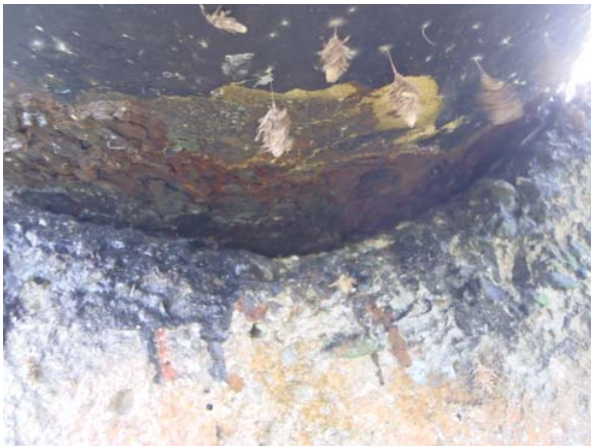
Closed view of corrosion under pipe support

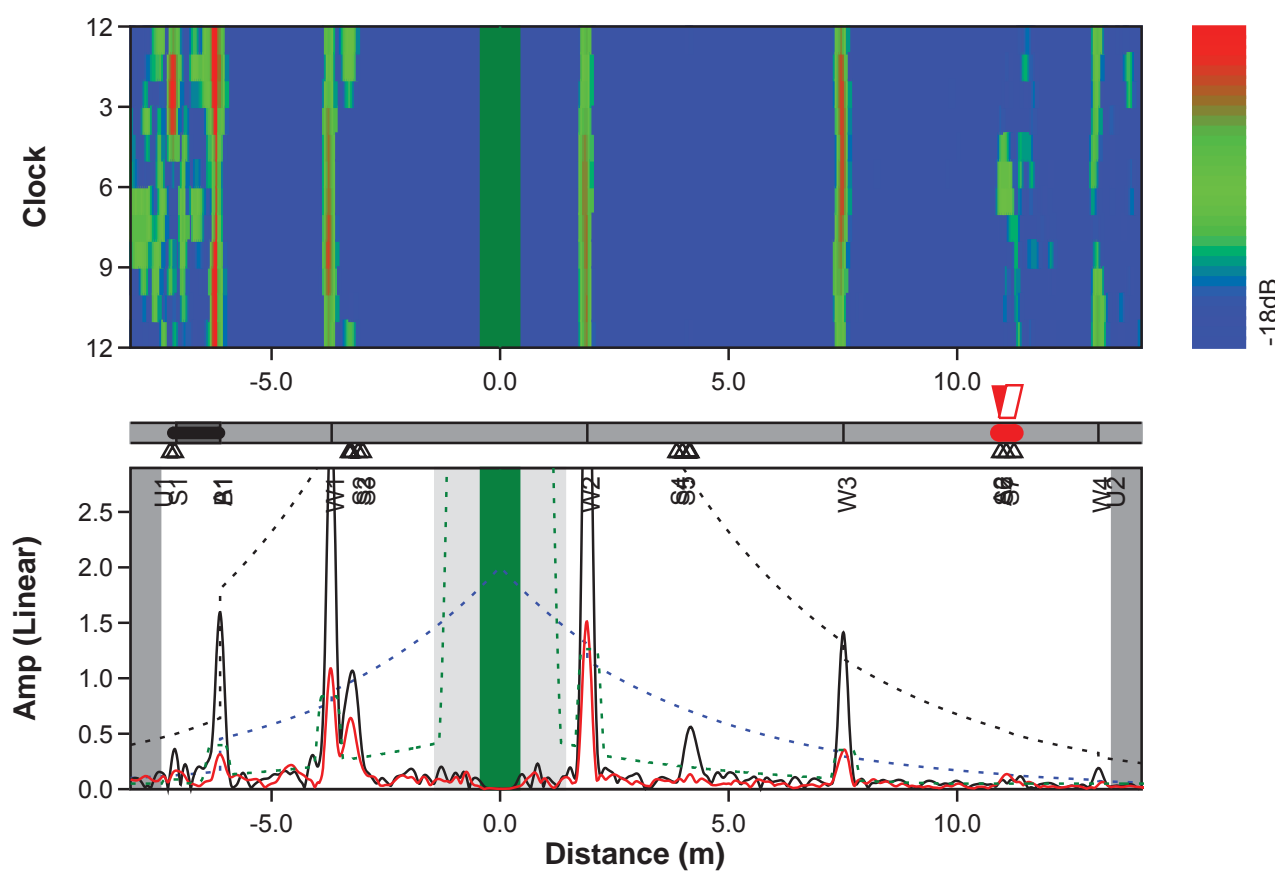
General Notes: 14" RFO-No.6 - Test Point No.: S18
Positive direction with product flow.
Found external corrosion at pipe support (refer class, note and location as table below).
Location of signals measuring from center of ring.
Thickness at ring position are (12 o'clock:6.50 mm), (3 o'clock:6.03 mm), (6 o'clock:6.77 mm), (9 o'clock:5.93 mm)

Feature	Location	ECL	Length	Extent	Class	Notes
U1	-7.43	-	~		End	
S1	-7.11	-	0.1	50	Saddle	Patch plate (0.1x0.1)m at bottom side
A1	-6.15	50	1	80	Minor	General corrosion under pipe support
B1	-6.12	-	0	80	1D Bend	
W1	-3.68	-	0	70	Weld	
S2	-3.1	-	0.15	50	Clamp	
S3	-3	-	0.3	50	Support	
W2	1.9	-	0	70	Weld	Datum of screening
S4	3.86	-	0.3	14	Support	
S5	3.98	-	0.15	80	Clamp	
W3	7.51	-	0	70	Weld	
A2	10.91	3	0.35	0	Severe	Visually confirm external corrosion under pipe support (6 - 9H00) with max. pit depth approximately 0.20"@ 5.0 mm. UT reading adjacent to pit is 6.15 mm. Remaining wall thickness approximately 1.15 mm (81.3%wall loss)
S6	10.94	-	0.3	0	Saddle	
S7	11.07	-	0	0	Clamp	
W4	13.09	-	0	70	Weld	
U2	13.39	-	~		End

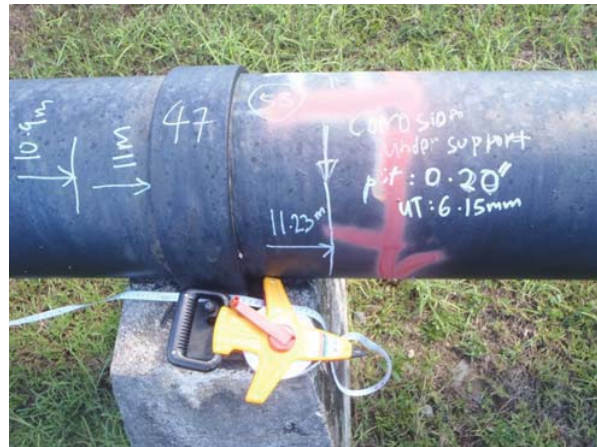
Corrosion under pipe support

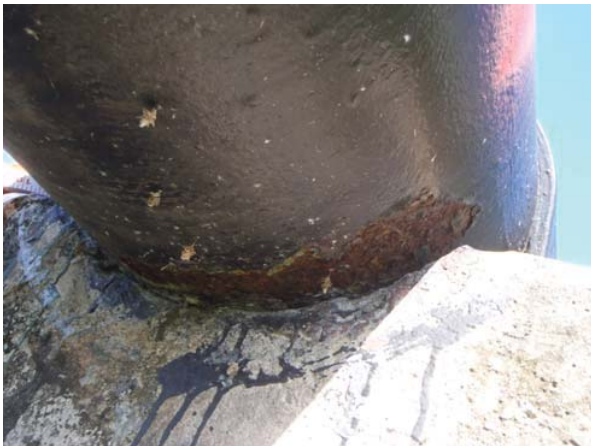
Closed view of corrosion

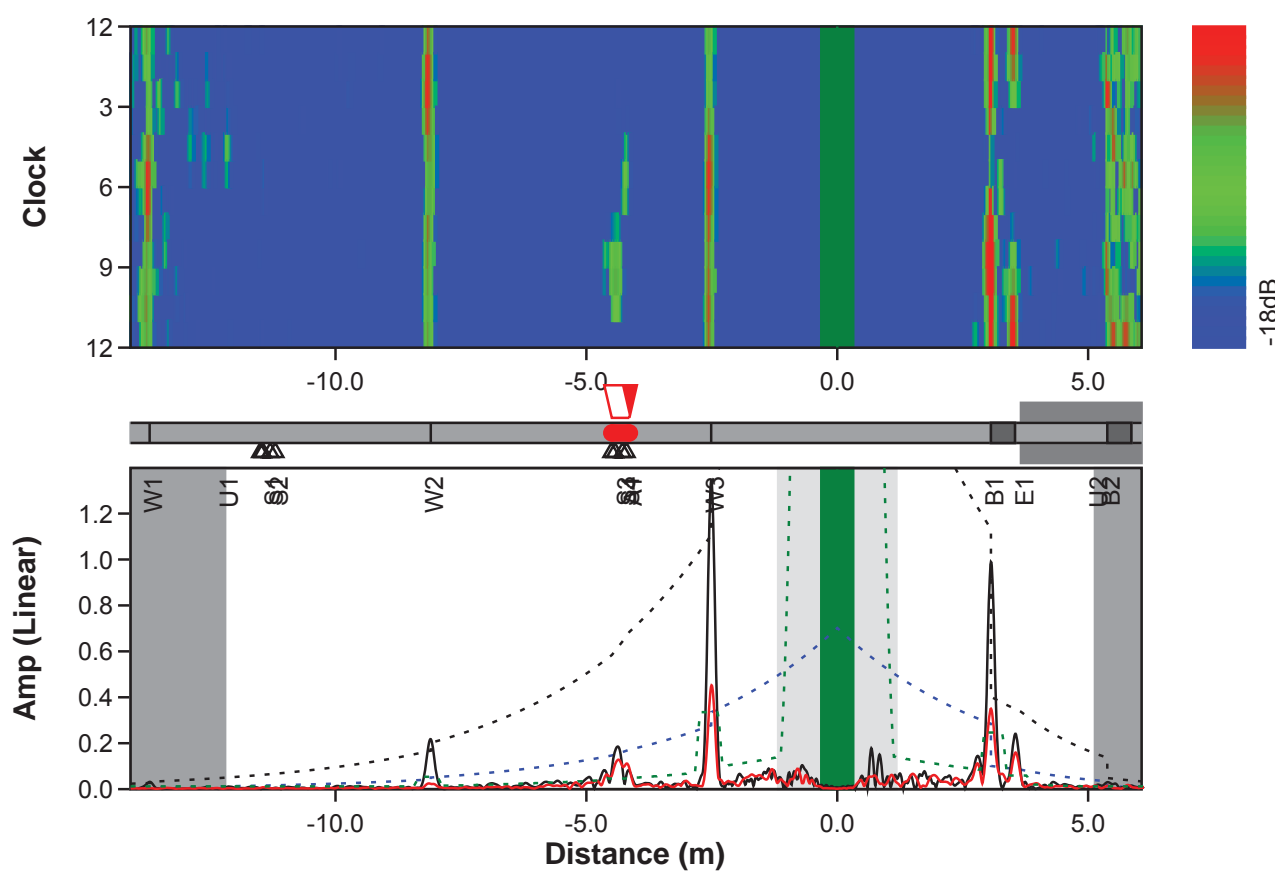
General Notes: 14" RFO-No.6 - Test Point No.: S19
Positive direction with product flow.
Found external corrosion at pipe support (refer class, note and location as table below).
Location of signals measuring from center of ring.
Thickness at ring position are (12 o'clock:5.87 mm), (3 o'clock:5.79 mm), (6 o'clock:6.27 mm), (9 o'clock:5.95 mm)

Feature	Location	ECL	Length	Extent	Class	Notes
W1	-13.7	-	0	90	Weld	
U1	-12.19	-	~		End	
S1	-11.3	-	0.15	0	Clamp	
S2	-11.2	-	0.3	35	Support	
W2	-8.1	-	0	90	Weld	
S3	-4.28	-	0.15	30	Clamp	
S4	-4.2	-	0.3	0	Support	
A1	-4.14	3	0.35	0	Severe	Visually confirm external corrosion under pipe support (6 - 9H00) with max. pit depth approximately 0.20" @ 5.0 mm. UT reading adjacent to pit is 6.15 mm. Remaining wall thickness approximately 1.15 mm. (81.3% wall loss)
W3	-2.51	-	0	70	Weld	Datum of screening
B1	3.06	-	0	60	45 deg Bend	
E1	3.66	-	~	30	Earth	
U2	5.13	-	~		End	
B2	5.38	-	0	50	45 deg Bend
