Test ID: G4-214#2209	Result: Medium Concern
Pipe: 12" RFO (S4)	Ring: R2B12(1507)
Site: Inside Terminal	Config: 4.6FR, T(0,1)
Location: Weld bend -0.11m	Calibration: Automatic (1271.25 mV)
Size: 12 inch (10.3mm)	Version: 3.103, Wavemaker G4-214
	GPS: 13°27.6425'N, 144°41.1241'E
Tested: 16 Jun 2014 12:00	Client: Vital Energy
Tested by: Khairul Anuar Husain [SGS]	Procedure: WI-TM-065/Ver.00/27.04.2011
	DACs: Call=6%, Weld=23%

General Notes: 14" RFO-No.6 - Test Point No.: S5
Positive direction with product flow.
Found external corrosion concentrate at bottom side (refer class, note and location as table below).
Location of signals measuring from center of ring.
Thickness at ring position are (12 o'clock:10.26 mm), (3 o'clock:10.31 mm), (6 o'clock:10.40 mm), (9 o'clock:10.41 mm)

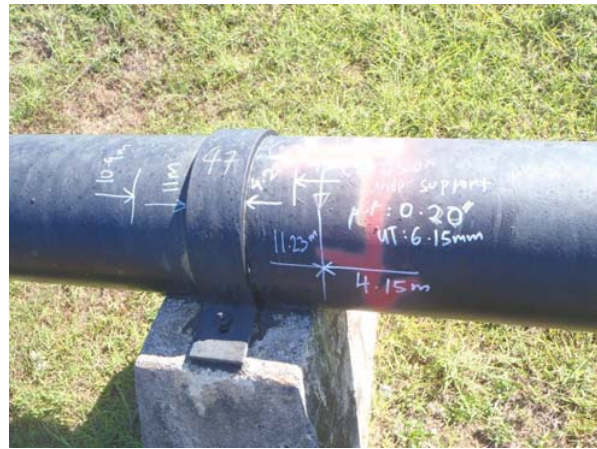
Corrosion under pipe support

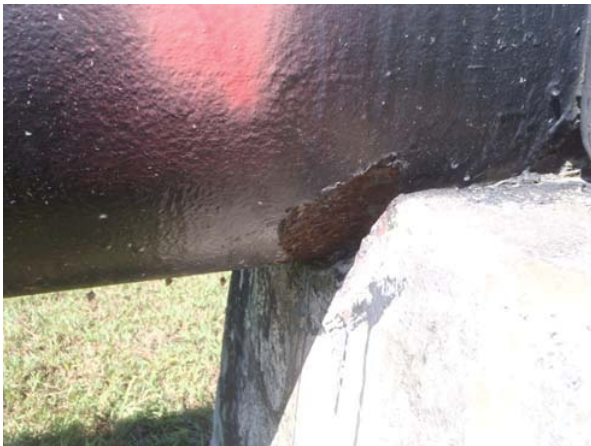
Closed view of corrosion

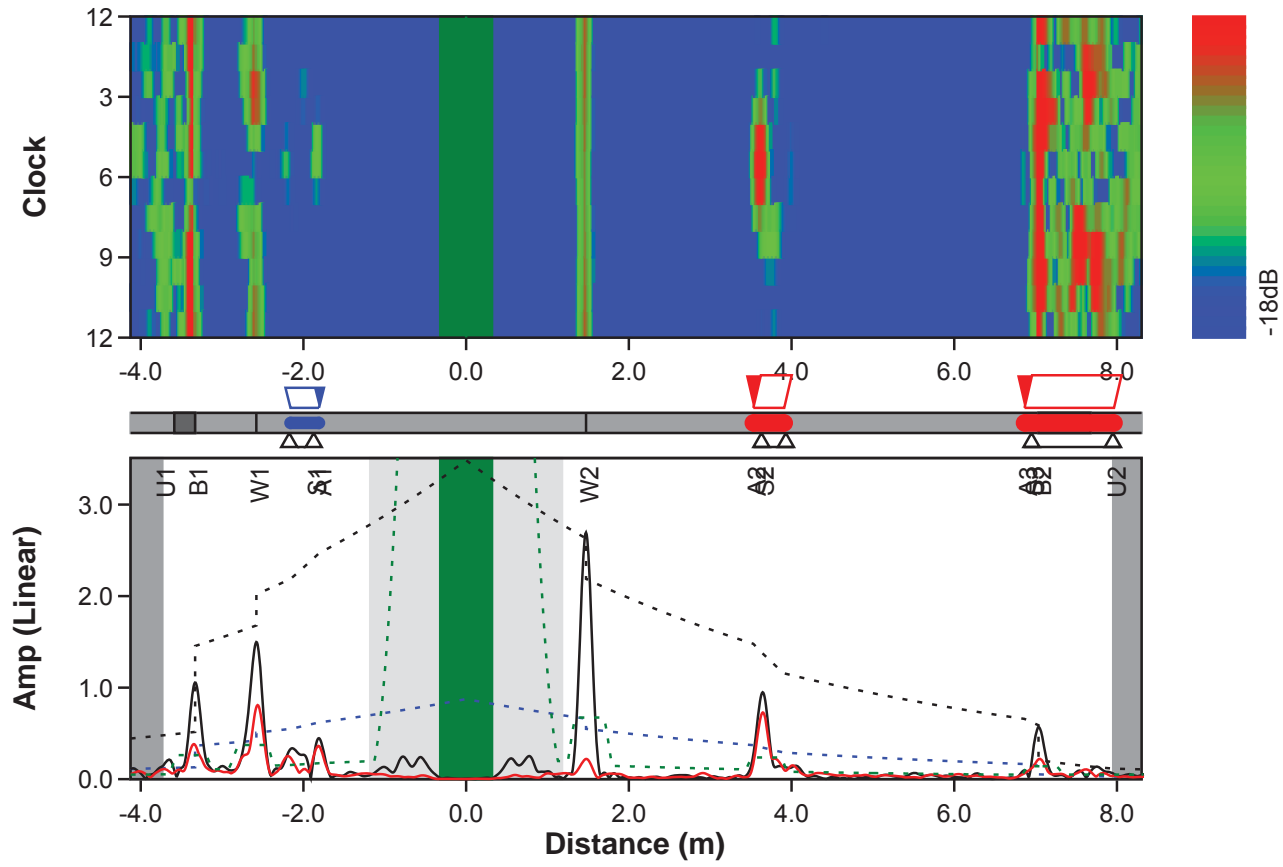
General Notes: 8" RFO-No.6 - Test Point No.: S1
 Positive direction with product flow.
 Found external corrosion at pipe support (refer class, note and location as table below).
 Location of signals measuring from center of ring.
 Thickness at ring position are (12 o'clock:7.29 mm), (3 o'clock:7.06 mm),
 (6 o'clock:7.07 mm), (9 o'clock:7.01 mm)

Feature	Location	ECL	Length	Extent	Class	Notes
U1	-3.73	-	~		End	
B1	-3.33	-	0	60	45 deg Bend	
W1	-2.57	-	0	45	Weld	
S1	-1.87	-	0.3	19	Support	
A1	-1.8	4	0.35	19	Medium	Visually confirm external corrosion under pipe support (6H00) with max. pit depth approximately 0.13"@ 3.3 mm. UT reading adjacent to pit is 7.25 mm. Remaining wall thickness approximately 3.95 mm (45.5% wall loss)
W2	1.47	-	0	90	Weld	Datum of screening
A2	3.53	11	0.38	25	Severe	Visually confirm external corrosion under pipe support (6H00) with max. pit depth approximately 0.20"@ 5.0 mm. UT reading adjacent to pit is 7.09 mm. Remaining wall thickness approximately 2.09 mm (70.5% wall loss)
S2	3.63	-	0.3	25	Support	
A3	6.86	3	1.1	0	Severe	Visually confirm external corrosion under pipe support (3-6H00) with max. pit depth approximately 0.22" @ 5.5 mm. UT reading adjacent to pit is 6.96 mm. Remaining wall thickness approximately 1.46 mm (79.0% wall loss)

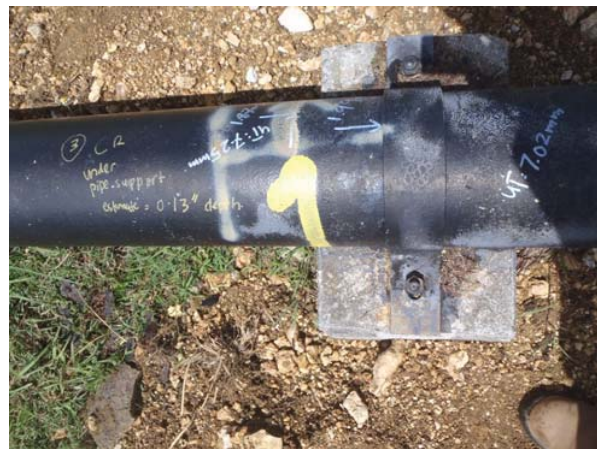
Corrosion under pipe support

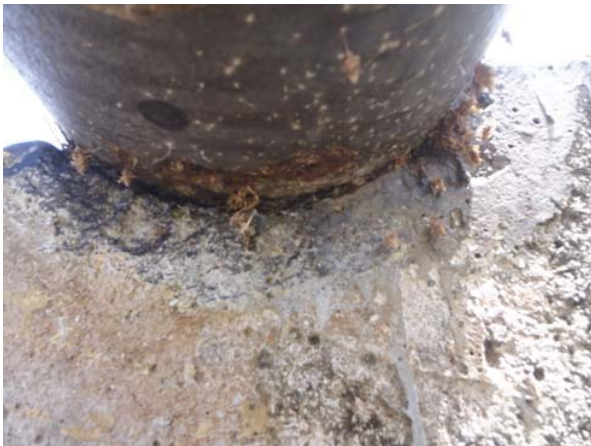
Close view of corrosion

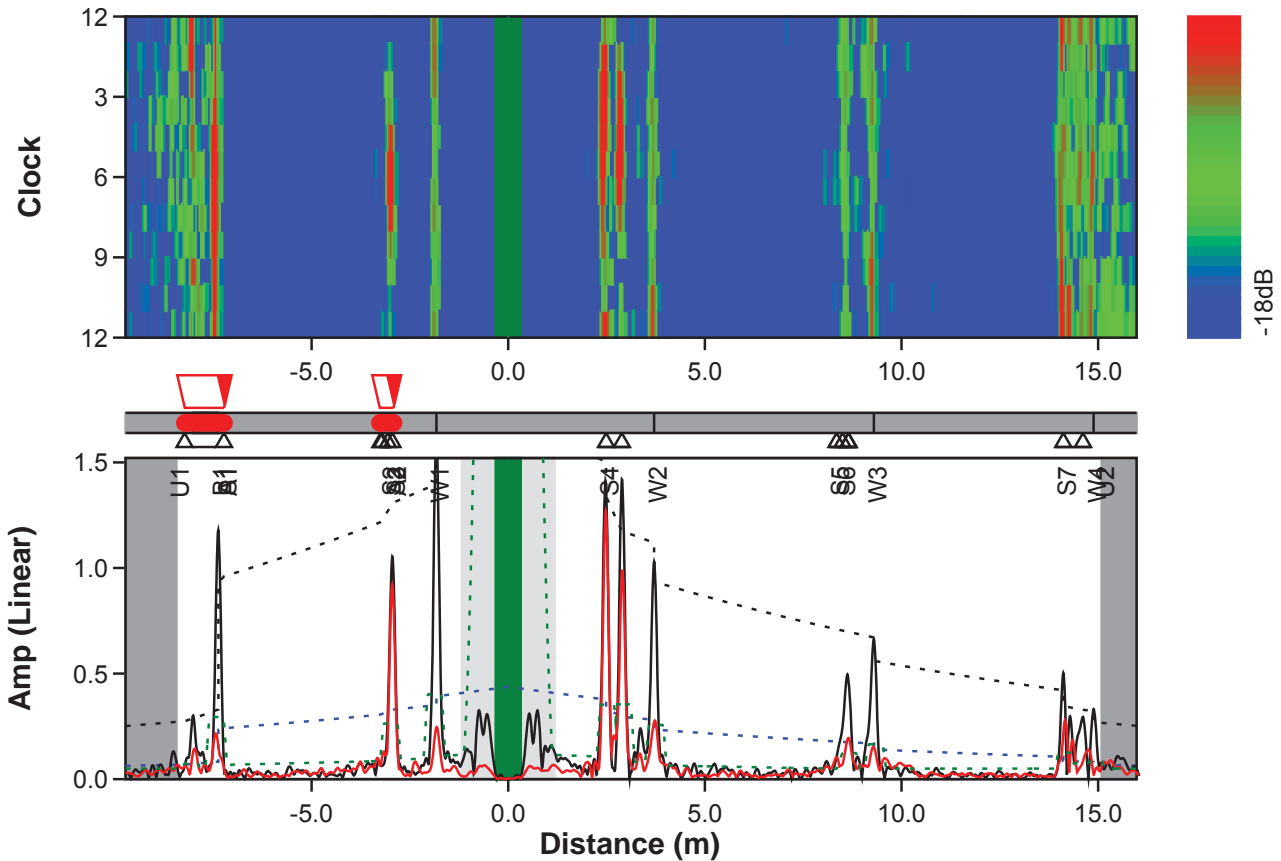
General Notes: 8" RFO-No.6 - Test Point No.: S2
Positive direction with product flow.
Found external corrosion at pipe support (refer class, note and location as table below).
Location of signals measuring from center of ring.
Thickness at ring position are (12 o'clock:7.32 mm), (3 o'clock:7.00 mm), (6 o'clock:7.00 mm), (9 o'clock:6.98 mm)

Feature	Location	ECL	Length	Extent	Class	Notes
U1	-8.43	-	~		End	
B1	-7.37	-	0	80	1D Bend	
S1	-7.23	-	1	80	Support	
A1	-7.22	11	1	80	Severe	Visually confirm external corrosion under pipe support (3-6H00) with max. pit depth approximately 0.22"@ 5.5 mm. UT reading adjacent to pit is 6.96 mm. Remaining wall thickness approximately 1.46 mm (79.0% wall loss)
S2	-3.06	-	0.15	12	Clamp	
S3	-2.94	-	0.3	13	Support	
A2	-2.91	18	0.35	13	Severe	Visually confirm external corrosion under pipe support (6H00) with max. pit depth approximately 0.20"@ 5.0 mm. UT reading adjacent to pit is 7.08 mm. Remaining wall thickness approximately 2.08 mm (70.6% wall loss)
W1	-1.82	-	0	80	Weld	Datum of screening
S4	2.48	-	0.4	10	Saddle	Patch plate at bottom side
W2	3.71	-	0	70	Weld	
S5	8.35	-	0.3	35	Support	
S6	8.5	-	0.15	70	Clamp	
W3	9.29	-	0	80	Weld	
S7	14.11	-	0.5	45	Saddle	Patch plate at bottom side
W4	14.88	-	0	70	Weld	
U2	15.08	-	~		End

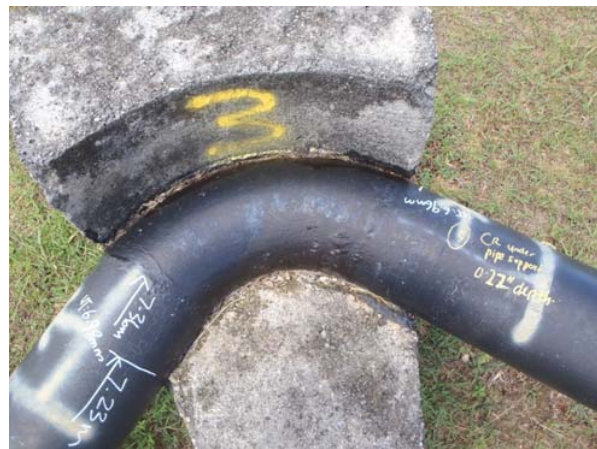
Corrosion under pipe support

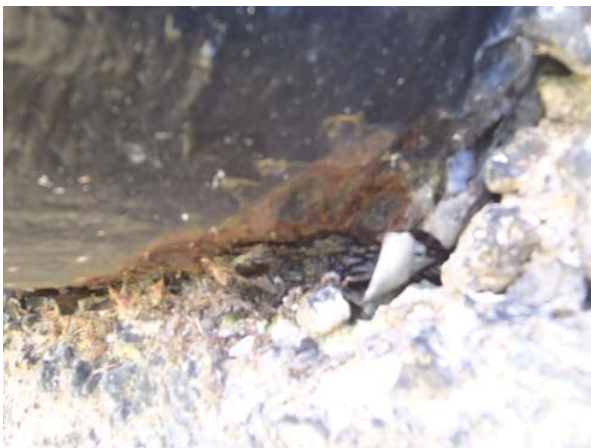
Closed view of corrosion

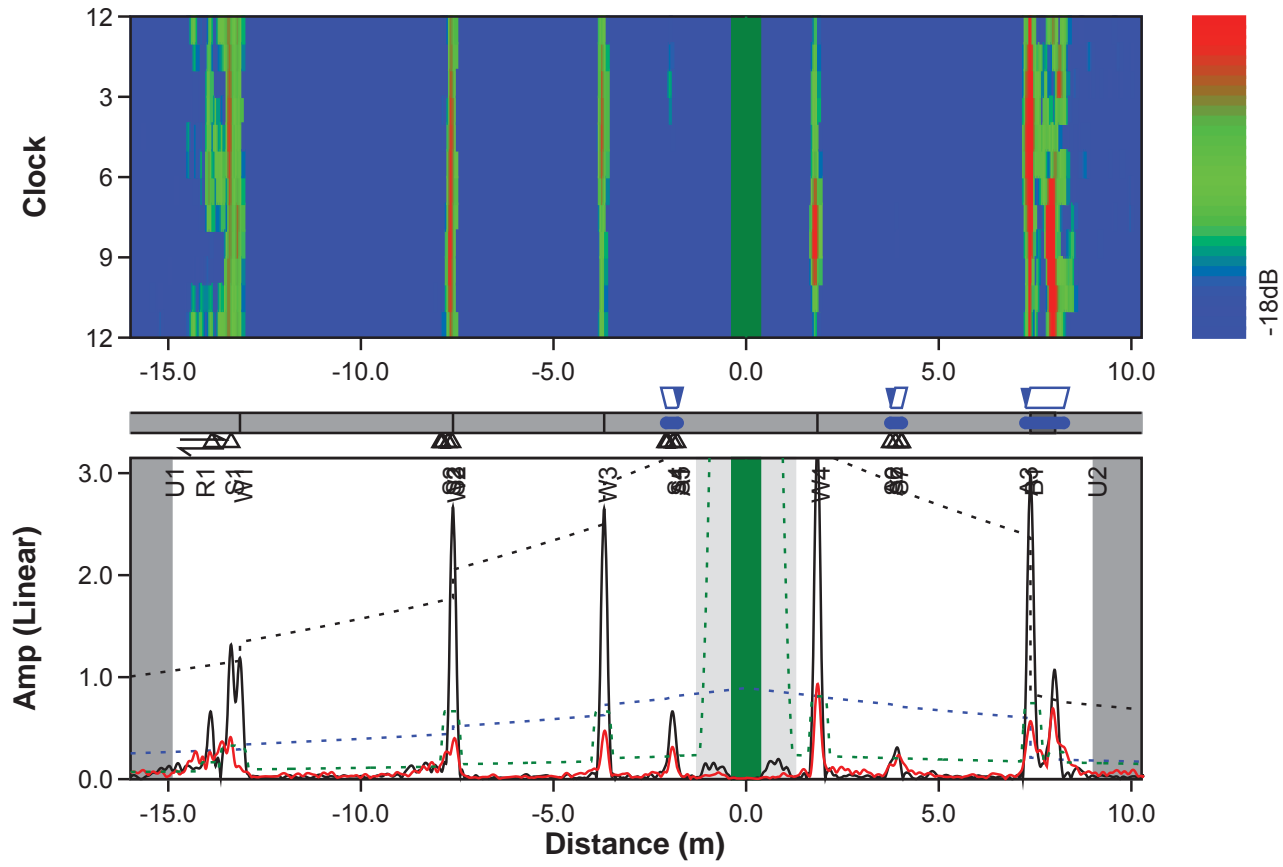
General Notes: 8" RFO-No.6 - Test Point No.: S3
Positive direction with product flow.
Found external corrosion at pipe support (refer class, note and location as table below).
Location of signals measuring from center of ring.
Thickness at ring position are (12 o'clock:7.02 mm), (3 o'clock:6.94 mm), (6 o'clock:6.99 mm), (9 o'clock:6.95 mm)

Feature	Location	ECL	Length	Extent	Class	Notes
U1	-14.91	-	~		End	
R1	-14.12	-	0	0	False Echo	Reverberation signals
S1	-13.36	-	0.5	70	Saddle	Patch plate at bottom side
W1	-13.13	-	0	90	Weld	
S2	-7.73	-	0.15	90	Clamp	
S3	-7.63	-	0.3	90	Support	
W2	-7.6	-	0	80	Weld	
W3	-3.68	-	0	80	Weld	
S4	-1.89	-	0.15	50	Clamp	
S5	-1.79	-	0.3	50	Support	
A1	-1.77	3	0.3	60	Medium	Visually confirm external corrosion under pipe support (3 - 6H00) with max. pit depth approximately 0.08"@ 2.0 mm. UT reading adjacent to pit is 7.21 mm. Remaining wall thickness approximately 5.21 mm (27.7% wall loss)
W4	1.85	-	0	70	Weld	Datum of screening
S6	3.74	-	0.3	25	Support	
A2	3.74	2	0.3	25	Medium	Visually confirm external corrosion under pipe support (6H00) with max. pit depth approximately 0.07"@ 1.8 mm. UT reading adjacent to pit is 7.35 mm. Remaining wall thickness approximately 5.55 mm (24.5% wall loss)
S7	3.88	-	0.15	25	Support	
A3	7.24	19	1	80	Medium	Visually confirm external corrosion under pipe support (6 - 9H00) with max. pit depth approximately 0.13"@ 3.3 mm. UT reading adjacent to pit is 7.35 mm. Remaining wall thickness approximately 4.05 mm (44.9% wall loss)

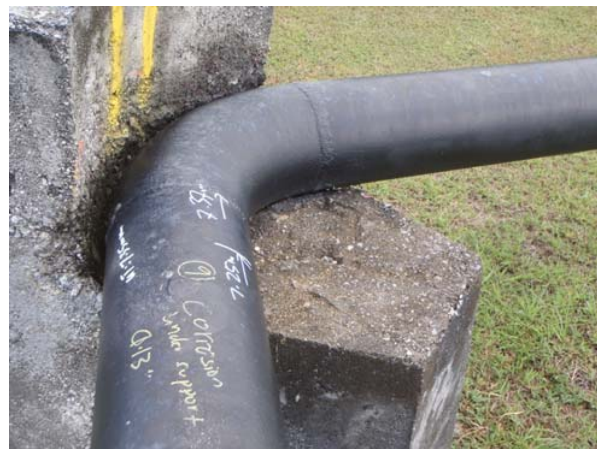
Corrosion under pipe support

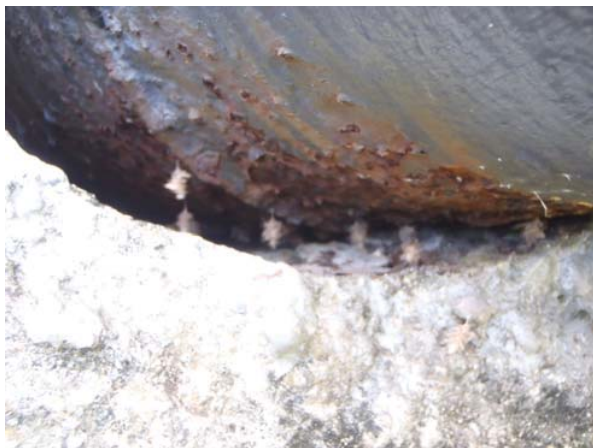
Closed view of corrosion

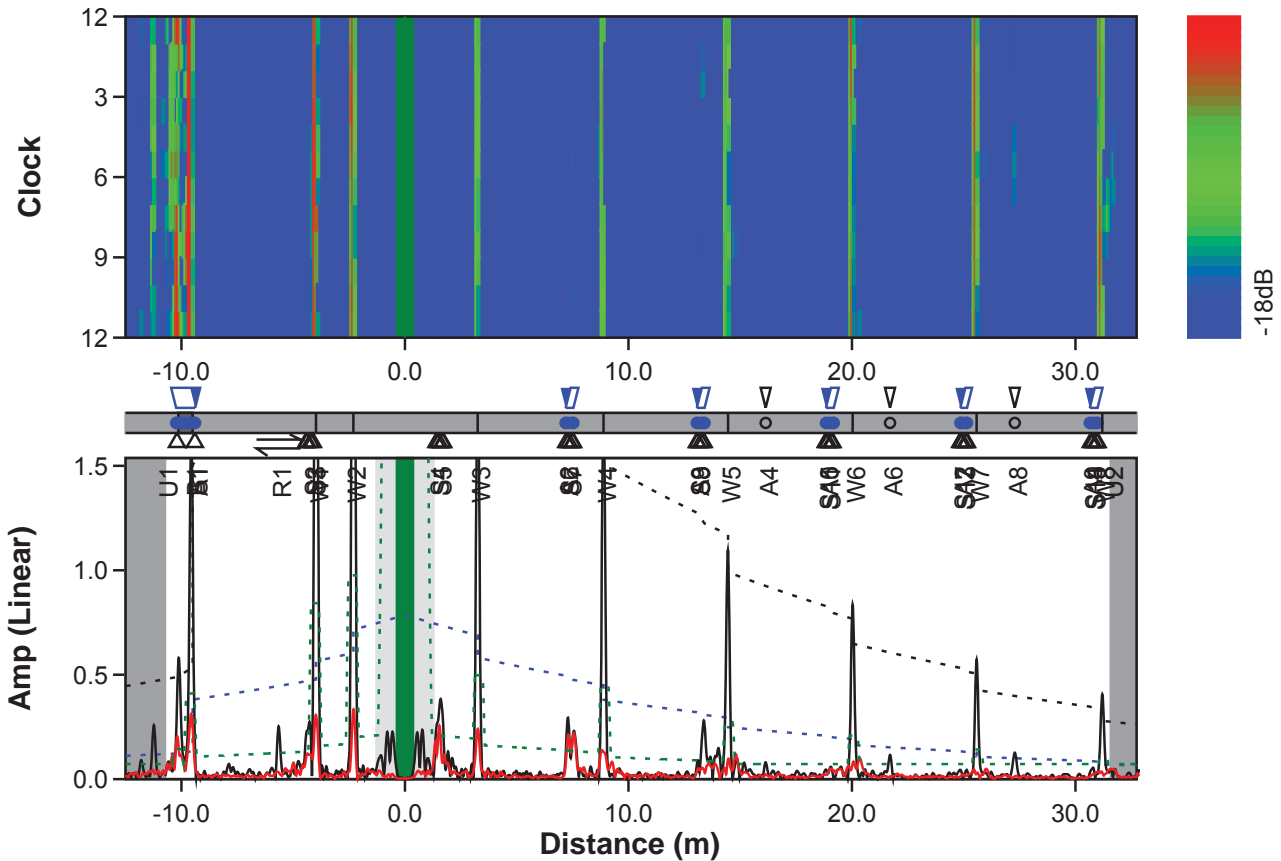
General Notes: 8" RFO-No.6 - Test Point No.: S4
 Positive direction with product flow.
 Found external corrosion at pipe support (refer class, note and location as table below).
 Location of signals measuring from center of ring.
 Thickness at ring position are (12 o'clock:7.02 mm), (3 o'clock:6.91 mm),
 (6 o'clock:7.05 mm), (9 o'clock: 7.12 mm)

Feature	Location	ECL	Length	Extent	Class	Notes
U1	-10.73	-	~		End	
B1	-9.5	-	0	80	1D Bend	
S1	-9.4	-	0.8	70	Support	Pedestal support
A1	-9.38	8	0.85	70	Medium	Visually confirm external corrosion under pipe support (6 - 9H00) with max. pit depth approximately 0.13"@ 3.3 mm. UT reading adjacent to pit is 7.35 mm. Remaining wall thickness approximately 4.05 mm (44.9% wall loss)
R1	-5.65	-	0	90	False Echo	Phantom effect (UT confirm no significant finding)
S2	-4.22	-	0.15	60	Clamp	U-blot type
S3	-4.12	-	0.3	90	Support	Pedestal support
W1	-3.98	-	0	90	Weld	
W2	-2.3	-	0	90	Weld	Datum of screening
S4	1.4	-	0.3	35	Support	Pedestal support
S5	1.52	-	0.15	35	Clamp	U-blot type
W3	3.25	-	0	90	Weld	
A2	7.18	3	0.35	35	Medium	Visually confirm external corrosion under pipe support (6H00) with max. pit depth approximately 0.08"@ 2.0 mm. UT reading adjacent to pit is 7.06 mm. Remaining wall thickness approximately 5.06 mm (28.3% wall loss)

S6	7.22	-	0.3	35	Support	Pedestal support
S7	7.34	-	0.15	30	Clamp	U-blot type
W4	8.88	-	0	90	Weld	
A3	13.05	2	0.35	45	Medium	Visually confirm external corrosion under pipe support (6H00) with max. pit depth approximately 0.07"@ 1.80 mm. UT reading adjacent to pit is 7.00 mm. Remaining wall thickness approximately 5.20 mm (25.7% wall loss)
