GUAM POWER AUTHORITY

GUAM POWER AUTHORITY
MTM Pipeline Spill
February 23, 2005 THU

**GPA TOTO TANGUISSON PIPELINE
EMERGENCY RESPONSE AND CLEANUP SERVICES REPORT**

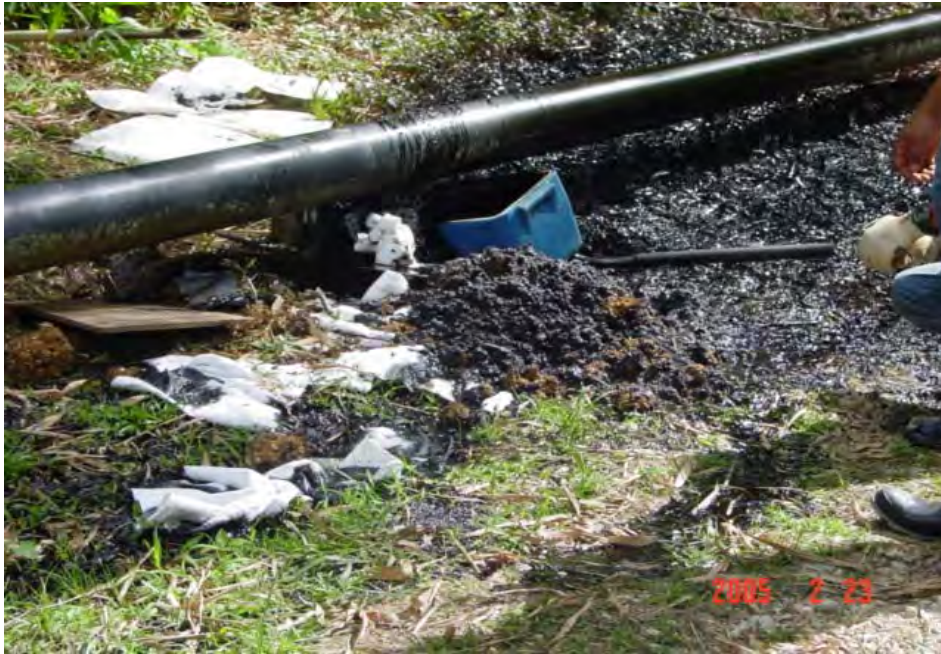
4644

FAILURE ANALYSIS OF CAUSE OF SPILL: Corrosion at pedestal area of pipe.

The oil spill was caused by a failure from a corroded point where the pipeline sits on a support.

Spill Point. Defect located at the saddle area.

At about 9:50 pm, Central Maintenance began work on repairing the defective part of the pipeline. They put a metal plate around the defective area and proceeded to weld the plate and seal the pipeline. They finished welding at about 1:00 am, Feb. 24, 2005 THU.

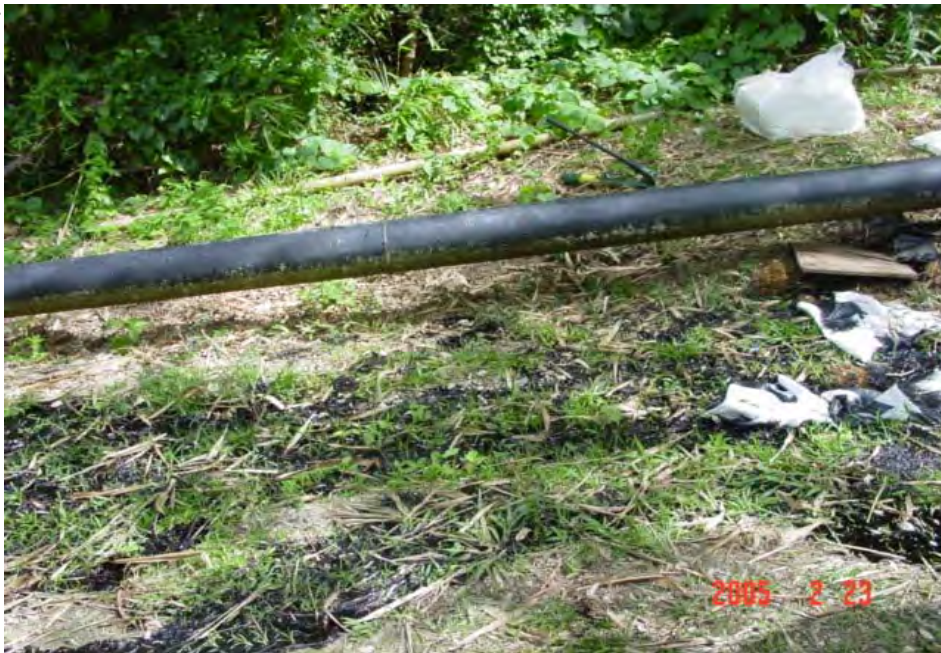
4647

Oil flowing downhill.

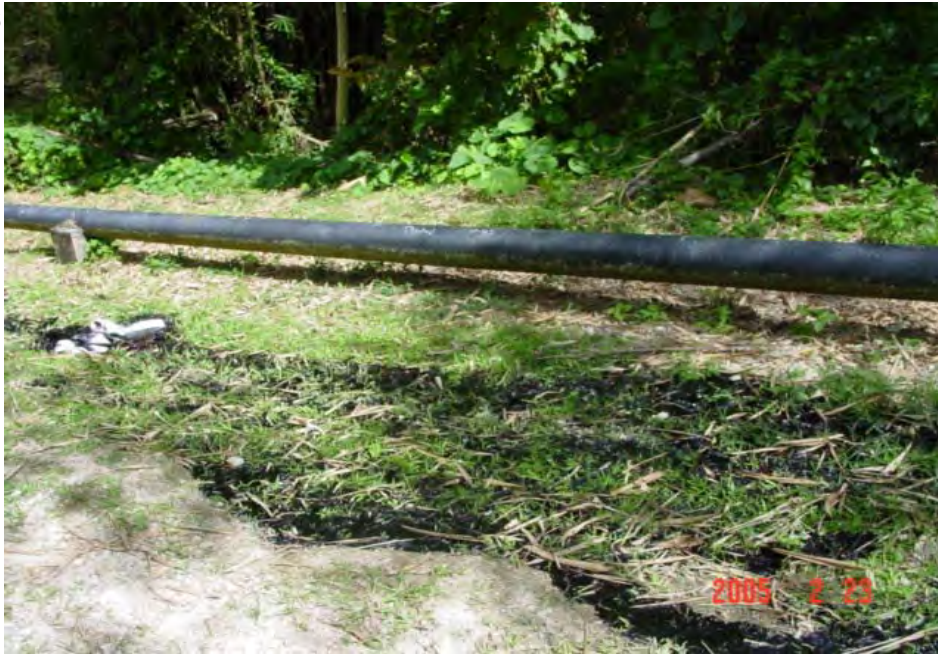
4646

Oil flowing downhill.

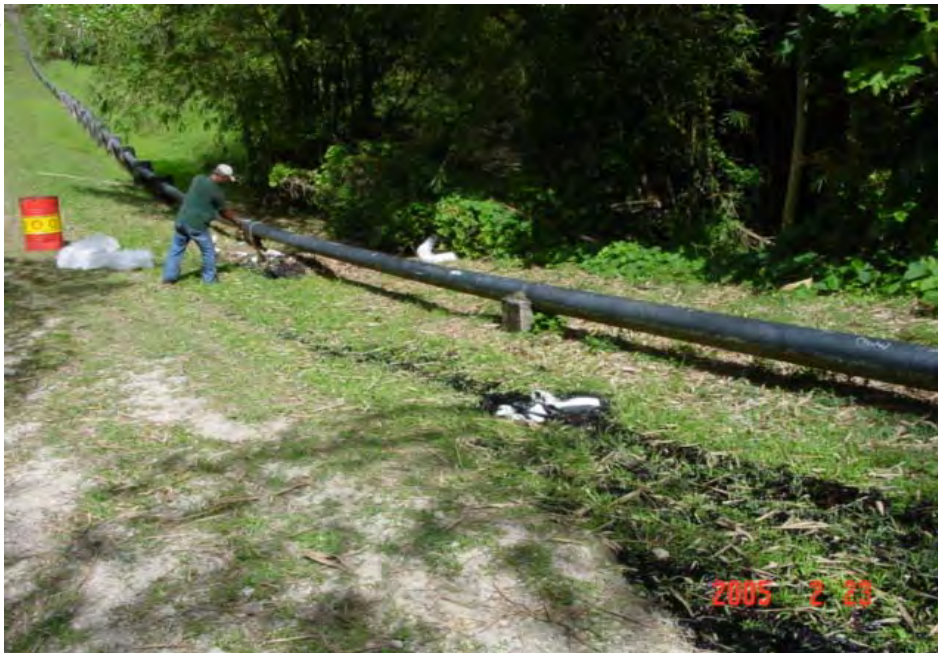
4645

Oil flowing downhill. Greg Quitana on the scene. Booms were placed at the end of the flow about 80 ft downhill from the Spill Point.

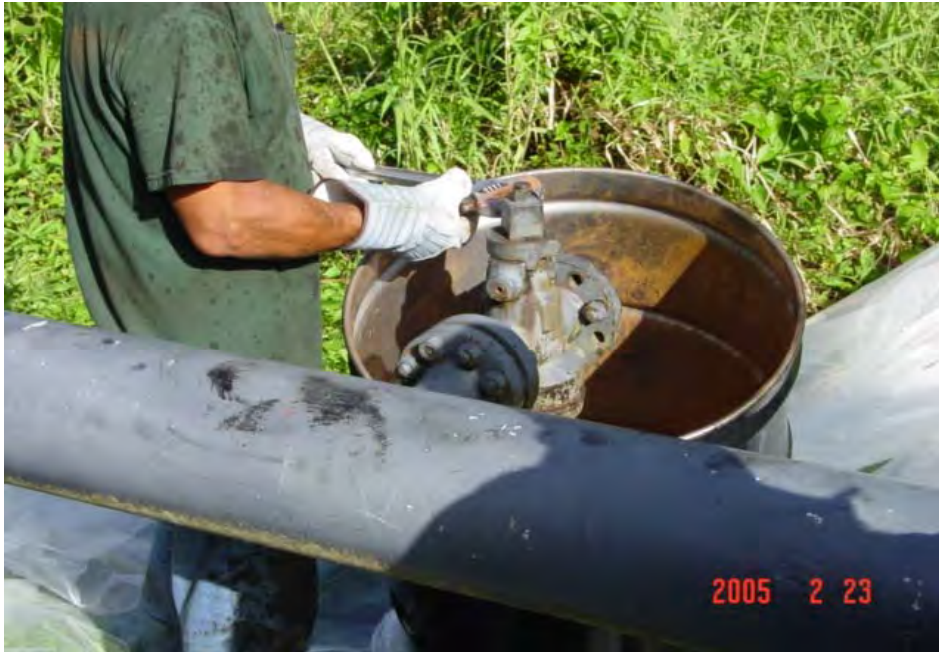
4661

Low Point Drain Valve to be opened to relieve pressure at Spill Point.

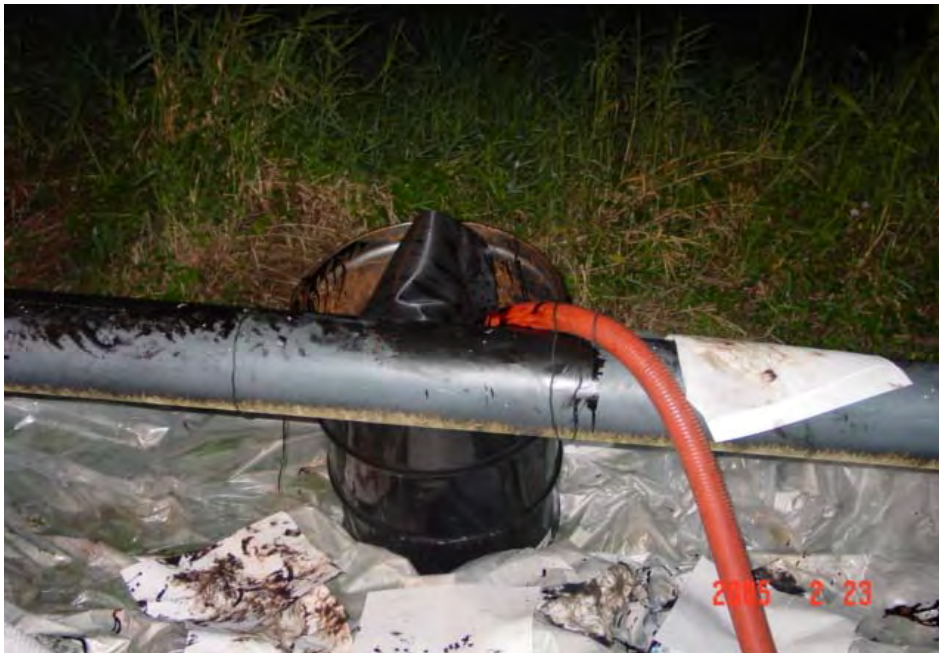
4662

Low Point Drain Valve opened oil being pumped out into Tanker Truck.

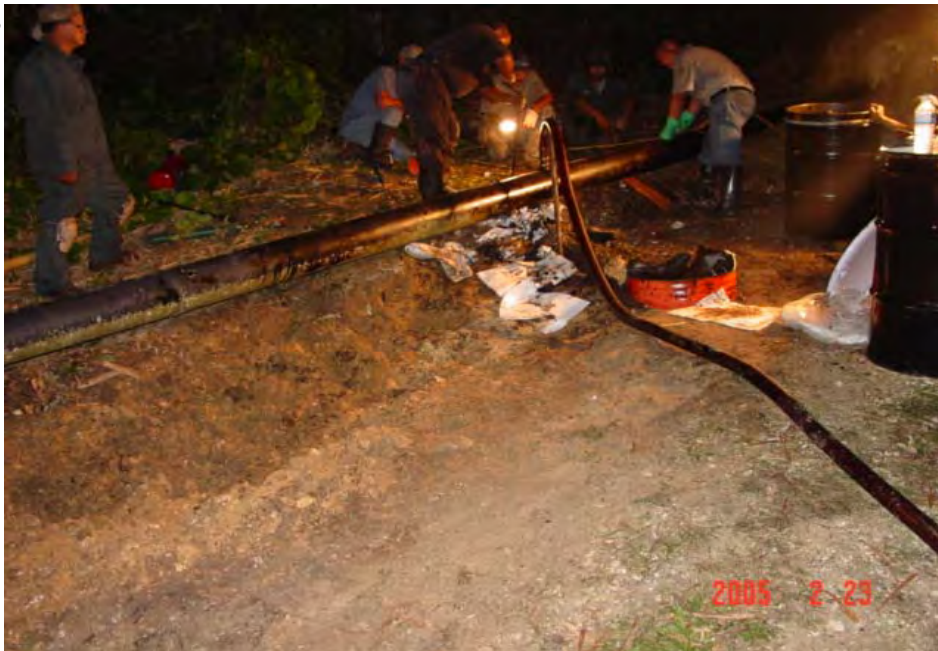
4673

Central Maintenance crews preparing to weld a metal plate around the leak. Contaminated soil has been removed.

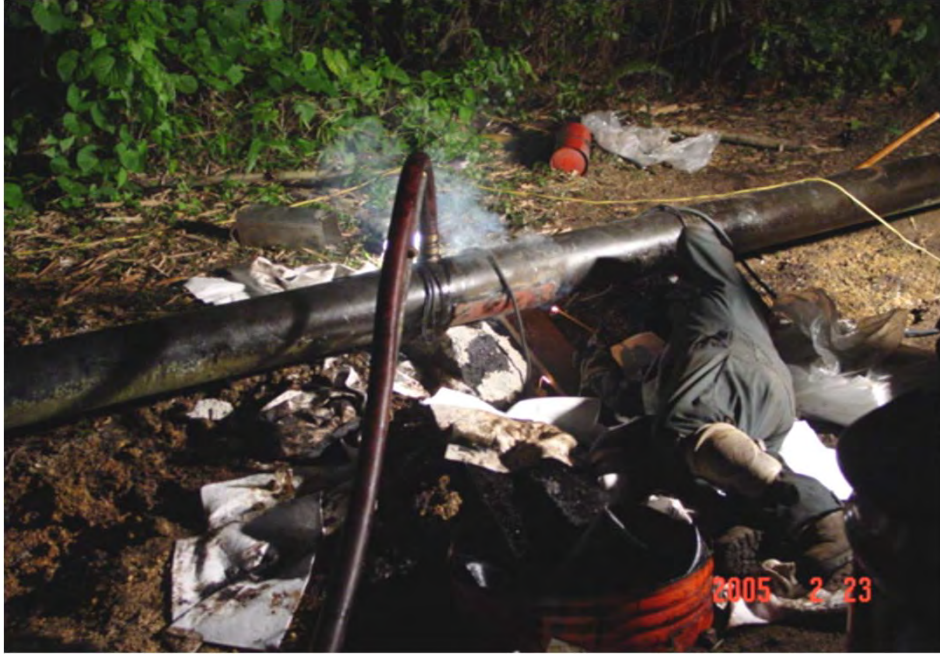
4675

Central Maintenance Crew welding plate over the leak.

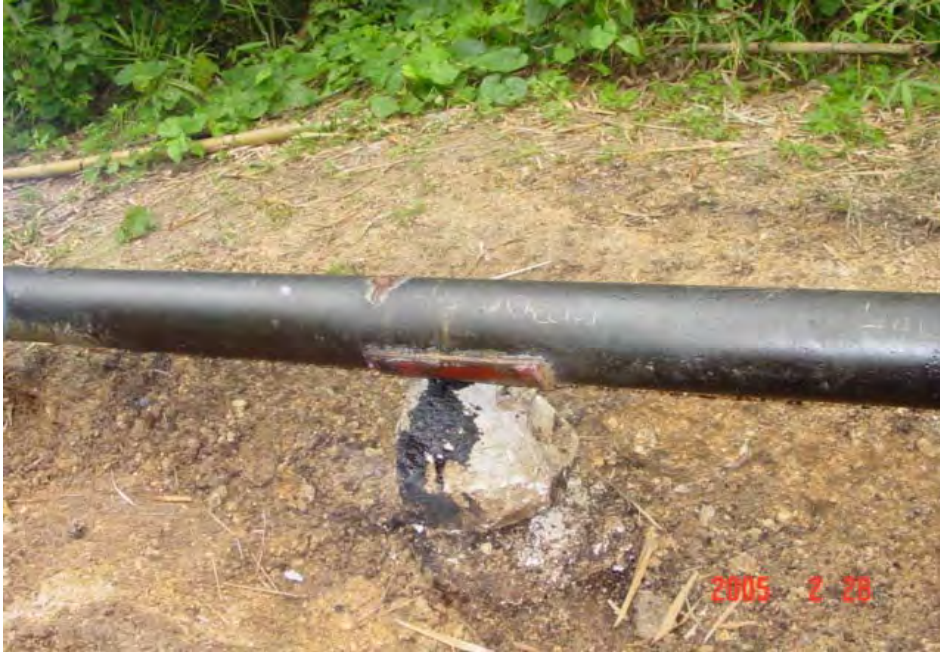
4696

Leak has been repaired

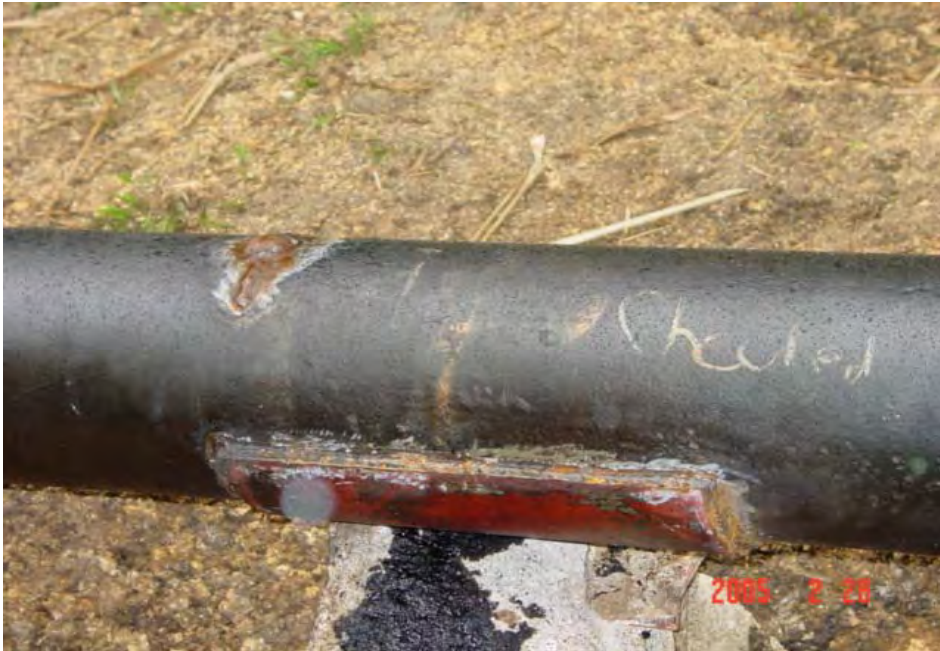
4697

Close-up.

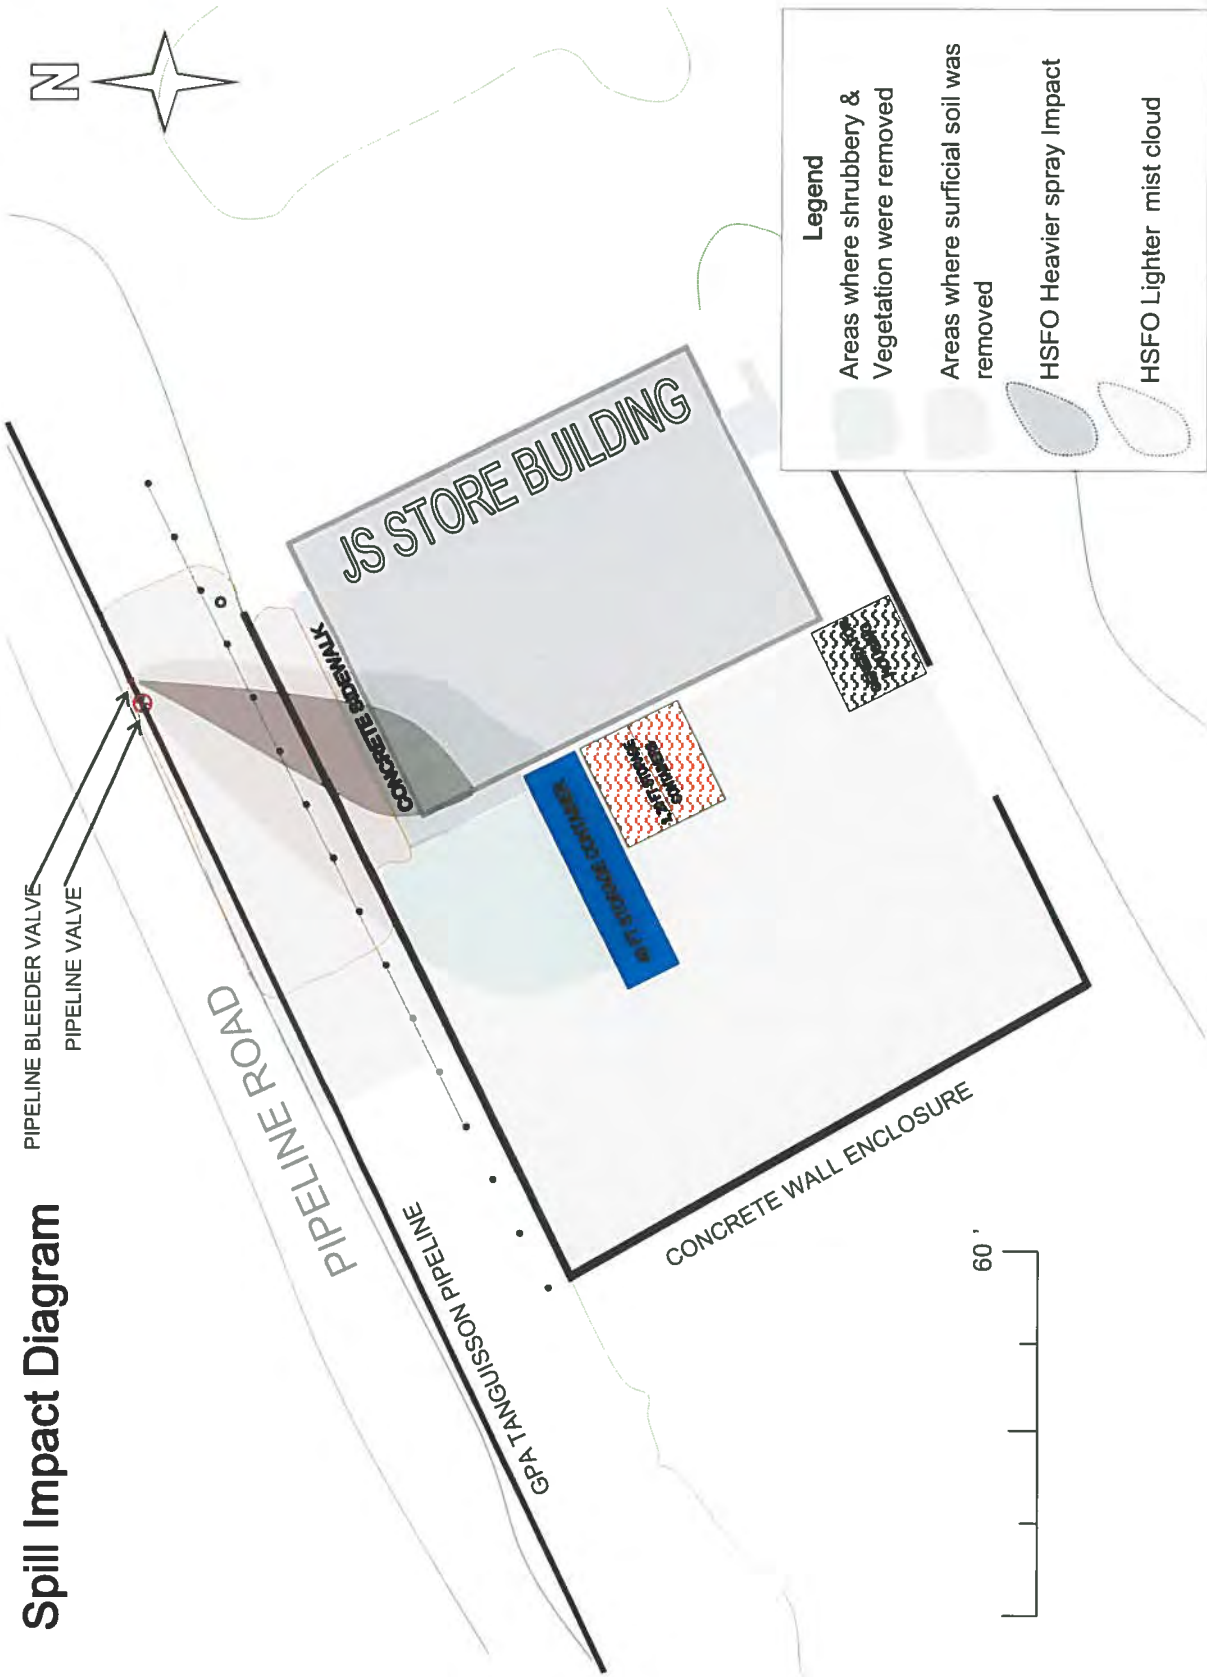
Spill Impact Diagram

Prevailing winds at the time of the spill had caused a combination of heavier HSFO spray and a lighter oily mist cloud to migrate at a southwesterly trend and was carried into the JS store property. Areas of the heavier spray impact that were readily discernible at the time of the spill was a section of soil/grassy area immediately adjacent to the pipeline. This had included the northern sections of the property's concrete perimeter wall, the store building northern wall, and a northern segment of the rooftop to include a blue storage container at store's backyard. The lighter mist cloud of the oil was carried further can only be identified via a close inspection of an extended area surrounding the easily discernible heavier HSFO spray delineation. The oily mist was present on vegetation and a grassy area outside the concrete enclosure. This was also present on the grassy area that dominates the store's backyard as well as the inner side of the northern concrete perimeter wall. (*Please refer to Appendix B Diagrams A & B*)

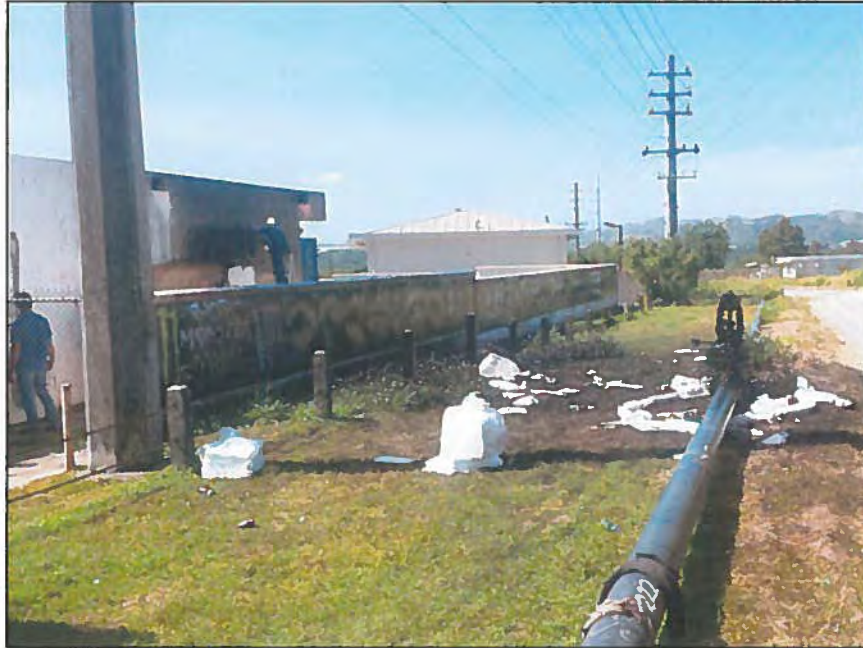
Photo 1 of 6

Photo taken during the initial response to the spill. Note the impact on the soil areas, the northern concrete enclosure wall of the facility as well as the northern wall of the store as shown on the picture.

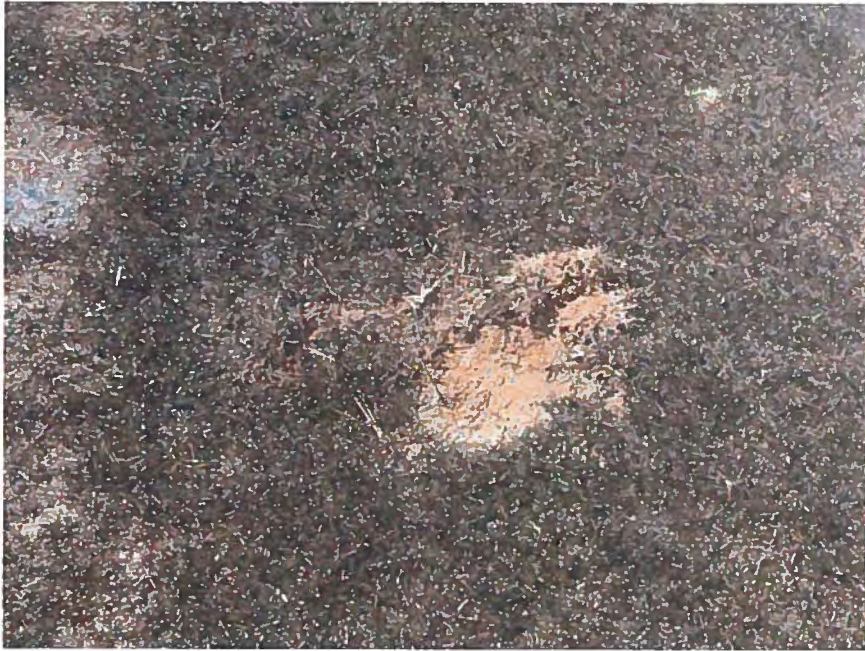
Photo 3 of 6
February 10 2015

Closer view of the spill on the soil and shrubbery within the immediate area of the pipeline reveals surficial impact

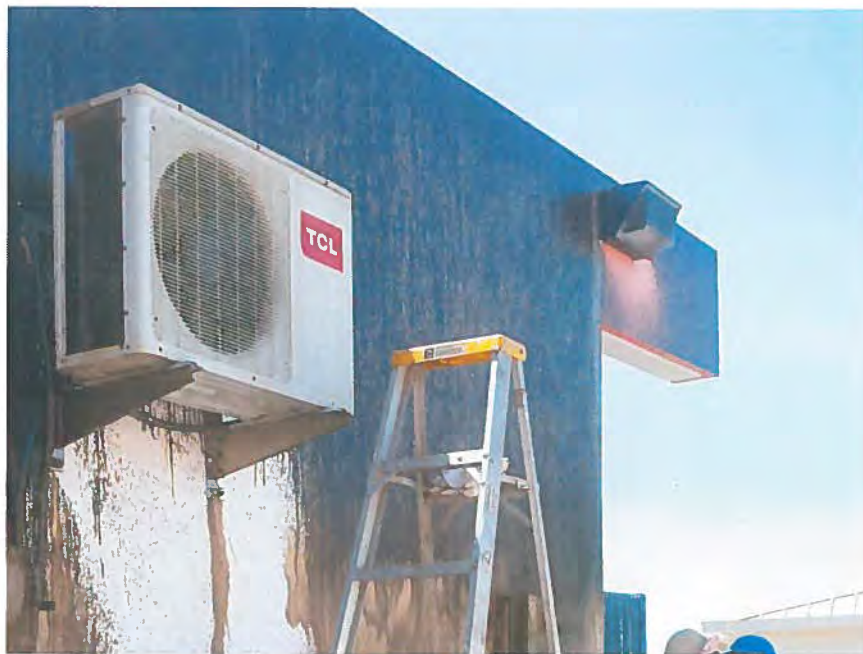
Photo 4 of 6
February 10 2015

Closer view of the spill impact on the northern wall of JS Store

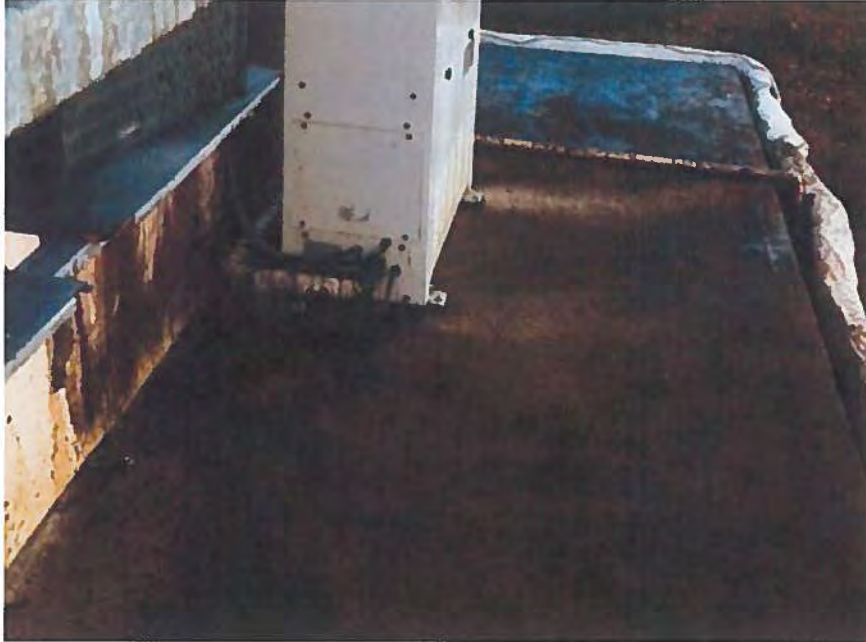
Photo 5 of 6
February 10 2015

Closer view of the spill impact on the concrete sidewalk at the northern Area of JS Store that is lined with sorbent booms to contain free flowing spill materials within concrete pavement and prevent any migration into surrounding soil areas

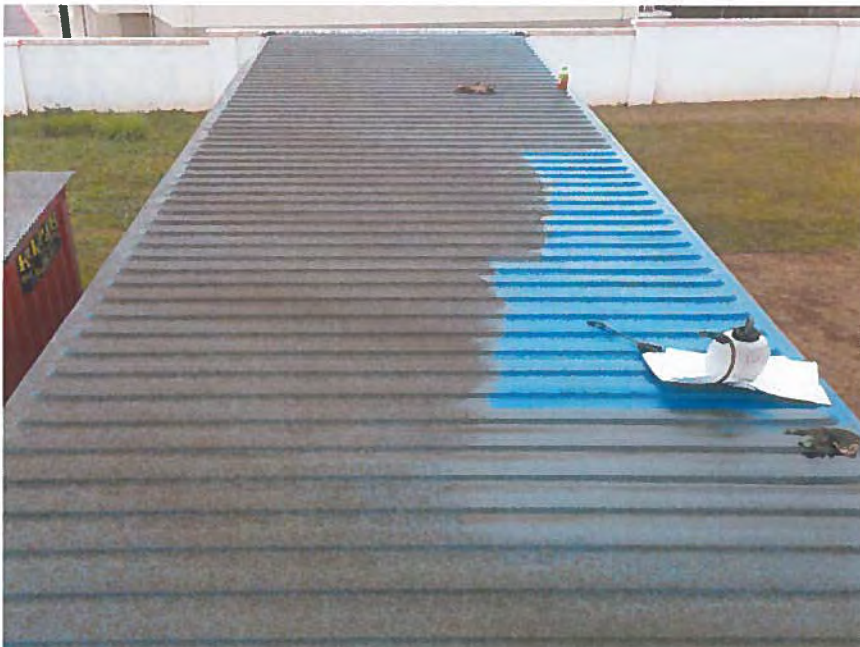
Photo 6 of 6
February 16 2015

Closer view of the spill impact on top of the 40 foot storage container within contrasting reference to cleaned areas.
