Test ID: G4-214#2237	Result: Medium Concern
Pipe: 8" RFO (S4)	Ring: R2B08(1499)
Site: Inside Terminal	Config: 5.2FR, T(0,1)
Location: Weld -2.30 m	Calibration: Automatic (1213.96 mV)
Size: 8 inch (7.05mm)	Version: 3.103, Wavemaker G4-214
	GPS: 13°27.7336'N, 144°41.2378'E
Tested: 20 Jun 2014 13:50	Client: Vital Energy
Tested by: Khairul Anuar Husain [SGS]	Procedure: WI-TM-065/Ver.00/27.04.2011
	DACs: Call=6%, Weld=23%

3.5 6"RESIDUAL FUEL OIL (RFO)

4.0 PIPELINE ISOMETRIC DRAWING

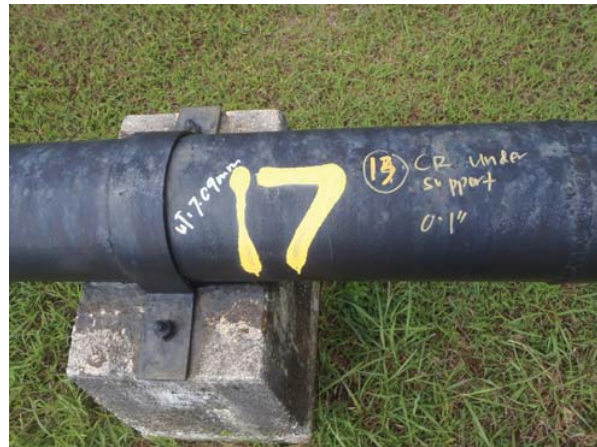
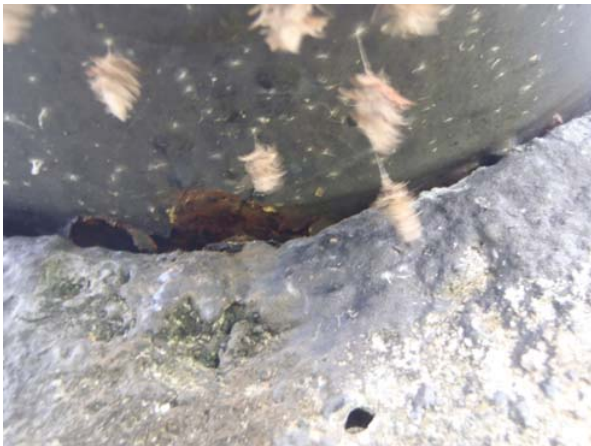
Feature	Location	ECL	Length	Extent	Class	Notes
A9	30.64	3	0.35	60	Medium	Visually confirm external corrosion under pipe support (6H00) with max. pit depth approximately 0.08" @ 2.0 mm. UT reading adjacent to pit is 7.04 mm. Remaining wall thickness approximately 5.04 mm (28.4% wall loss)
S14	30.68	-	0.3	60	Support	Pedestal support
S15	30.78	-	0.15	60	Clamp	U-blot type
W8	31.2	-	0	90	Weld	
U2	31.57	-	~		End

Corrosion under pipe support

Closed view of corrosion

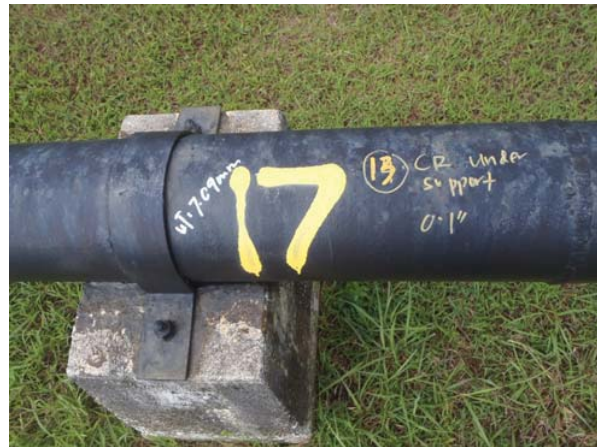
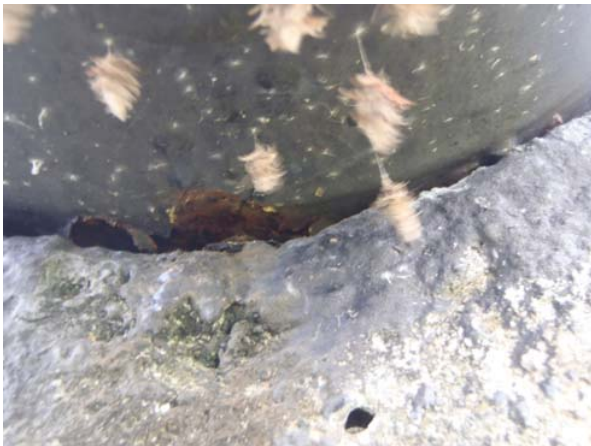
Feature	Location	ECL	Length	Extent	Class	Notes
A5	6.4	7	0.4	25	Severe	Visually confirm external corrosion under pipe support (6H00) with max. pit depth approximately 0.22" @ 5.5 mm. UT reading adjacent to pit is 7.01 mm. Remaining wall thickness approximately 1.51 mm (78.5% wall loss)
S11	6.48	-	0.3	25	Support	Pedestal support
S12	6.6	-	0.15	25	Clamp	U-bolt type
W11	9.61	-	0	90	Weld	
S13	11.04	-	0.2	60	Saddle	Patch plate at bottom side
A6	12.2	2	0.38	20	Severe	Visually confirm external corrosion under pipe support (6H00) with max. pit depth approximately 0.20" @ 5.0 mm. UT reading adjacent to pit is 7.01 mm. Remaining wall thickness approximately 2.01 mm (71.3% wall loss)
S14	12.24	-	0.3	50	Support	Pedestal support
S15	12.38	-	0.15	60	Clamp	U-bolt type
W12	15.22	-	0	80	Weld	
S16	15.57	-	0.36	45	Saddle	Patch plate at bottom side
U2	16.13	-	~		End

Corrosion under pipe support

Closed view of corrosion

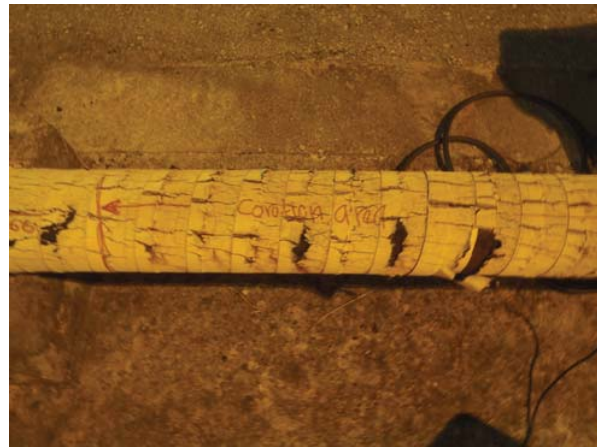
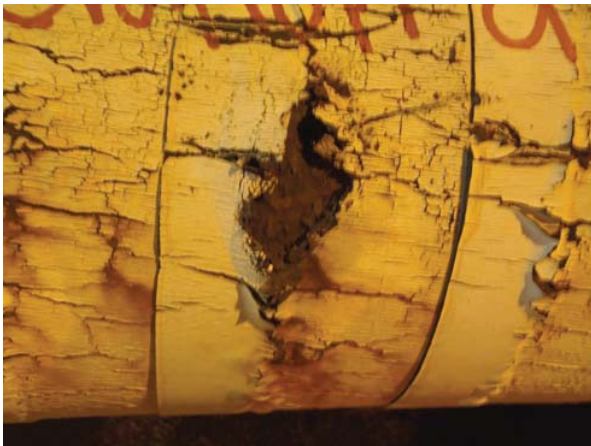
Corrosion under wrapping area

Closed view of corrosion

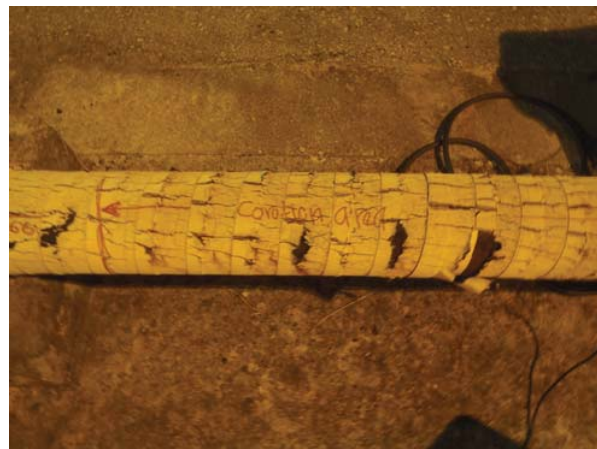
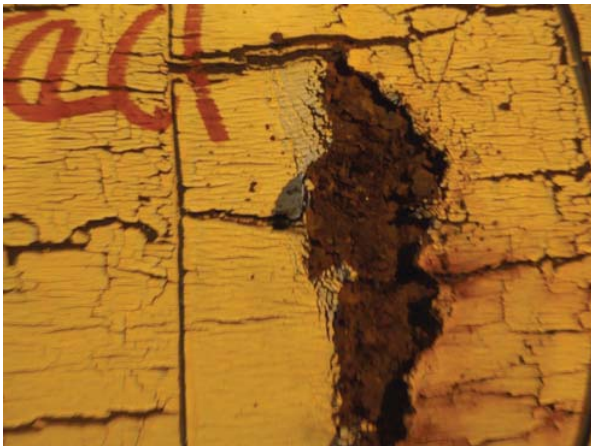
Corrosion under wrapping area

Closed view of corrosion

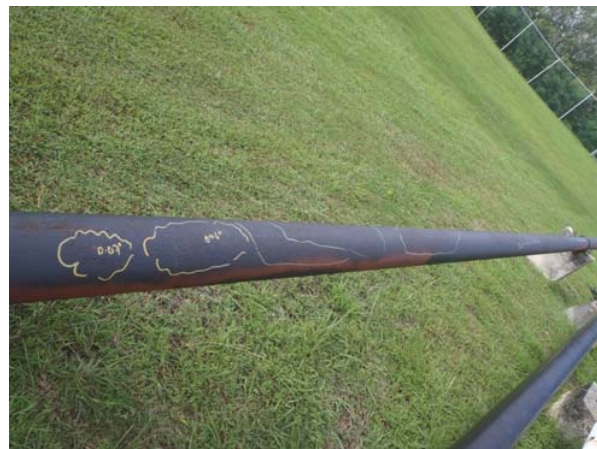
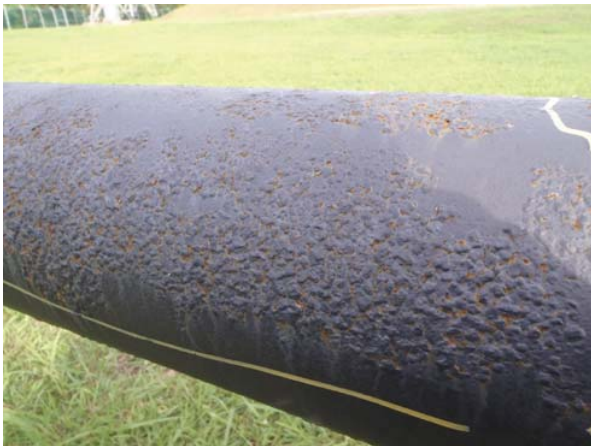
General corrosion

Closed view of corrosion

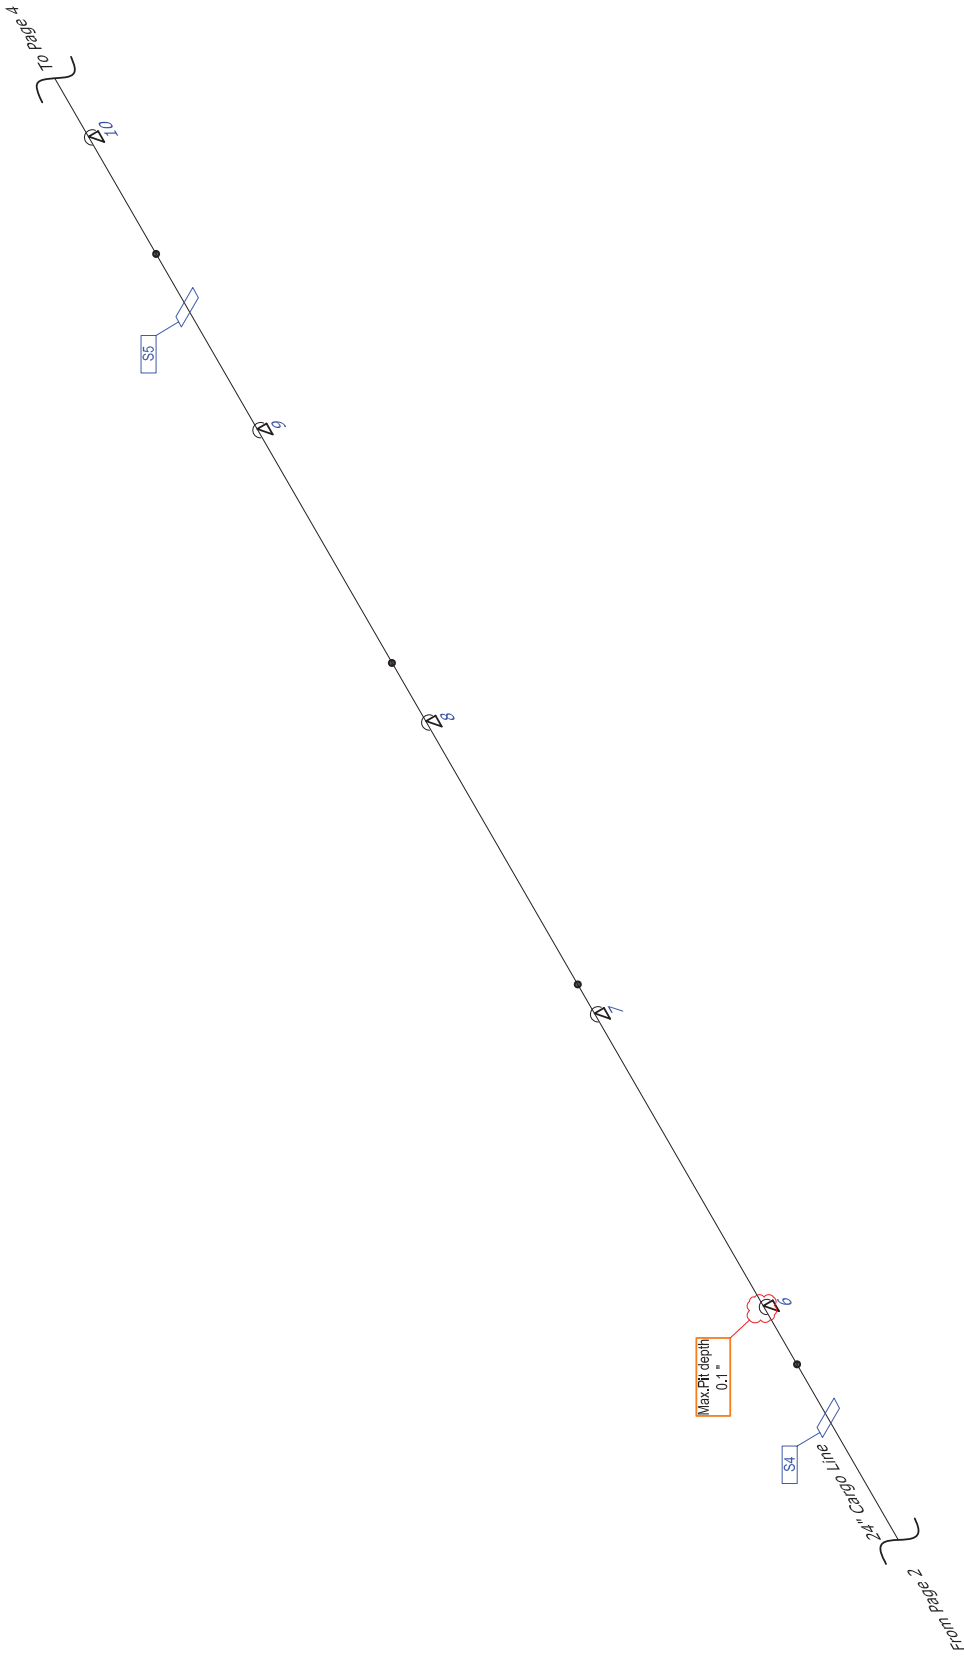
Max. Pit depth
0.1"
