# GUAM POWER AUTHORITY

AMENDMENT NO.: XV

INVITATION FOR MULTI-STEP BID NO.: GPA-034-18

BUILD, OPERATE & TRANSFER CONTRACT FOR 180MW OF NEW GENERATION CAPACITY  
STEP 2 – TECHNICAL SPECIFICATIONS

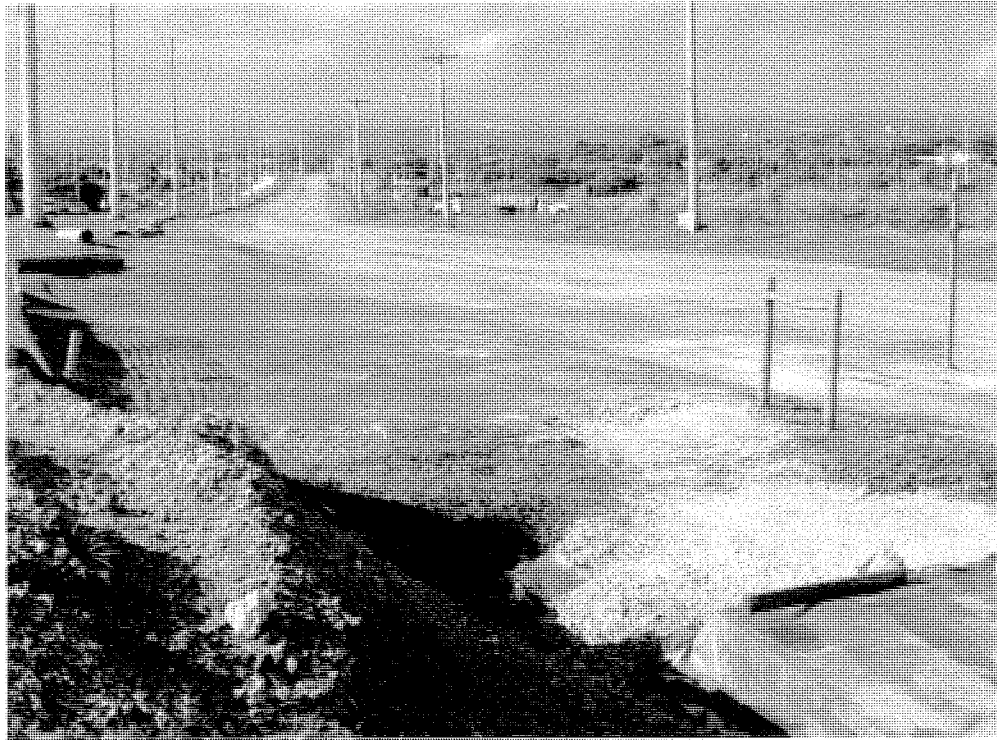
1A

1A: View from north end of subject easement towards the south along  
Perimeter Road

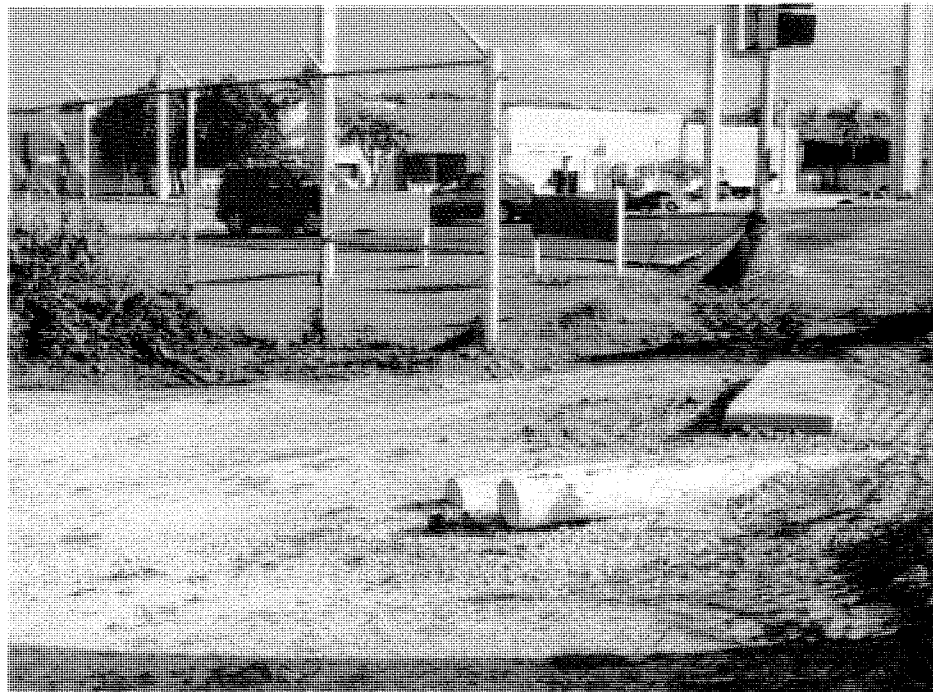
1B

1B: Barrigada Main facility Post Office, northern end of subject easement

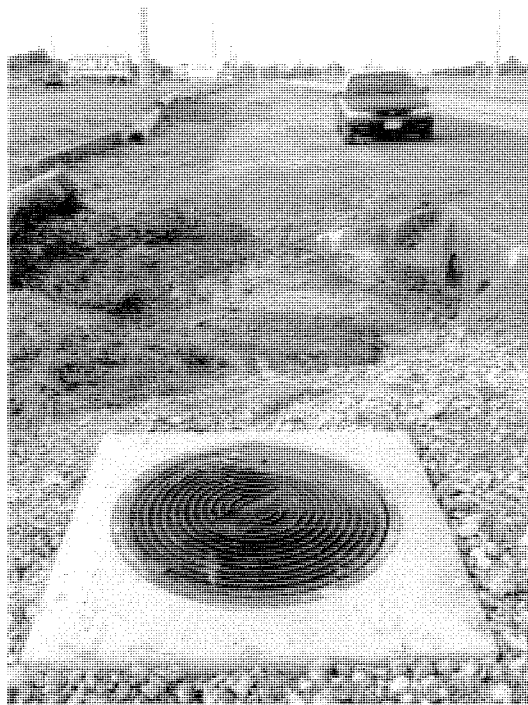
4A

4A: Fuel pipeline vault near storm water drainage feature

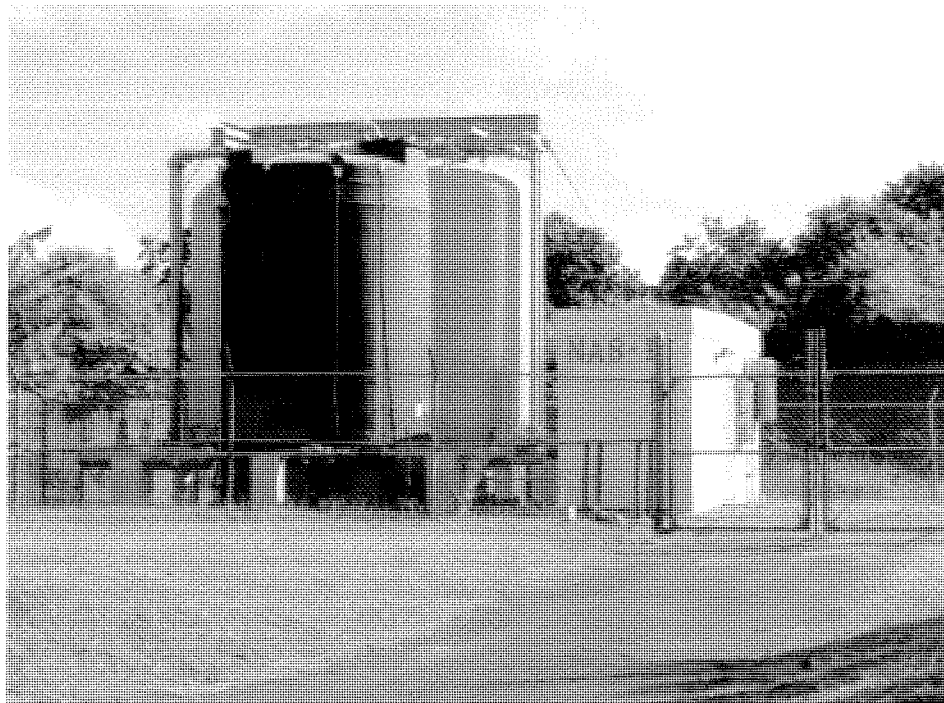
4B

4B: NAS-1 water well with granulated activated carbon filter

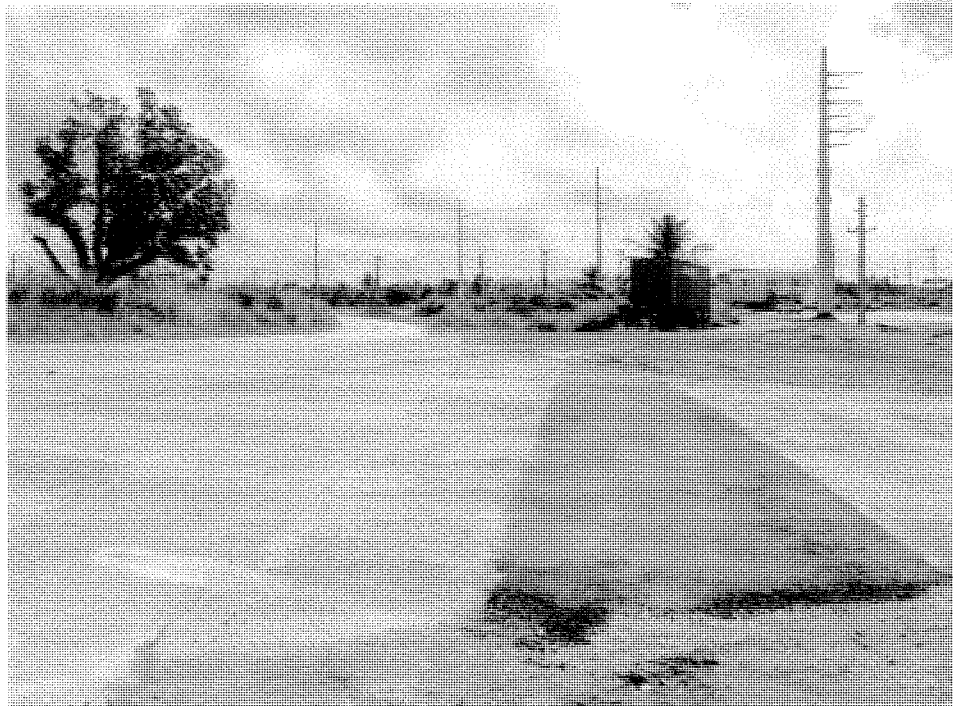
5A

5A: Pavement crossing for underground pipeline Rt. 10-8-16 access to Tiyan

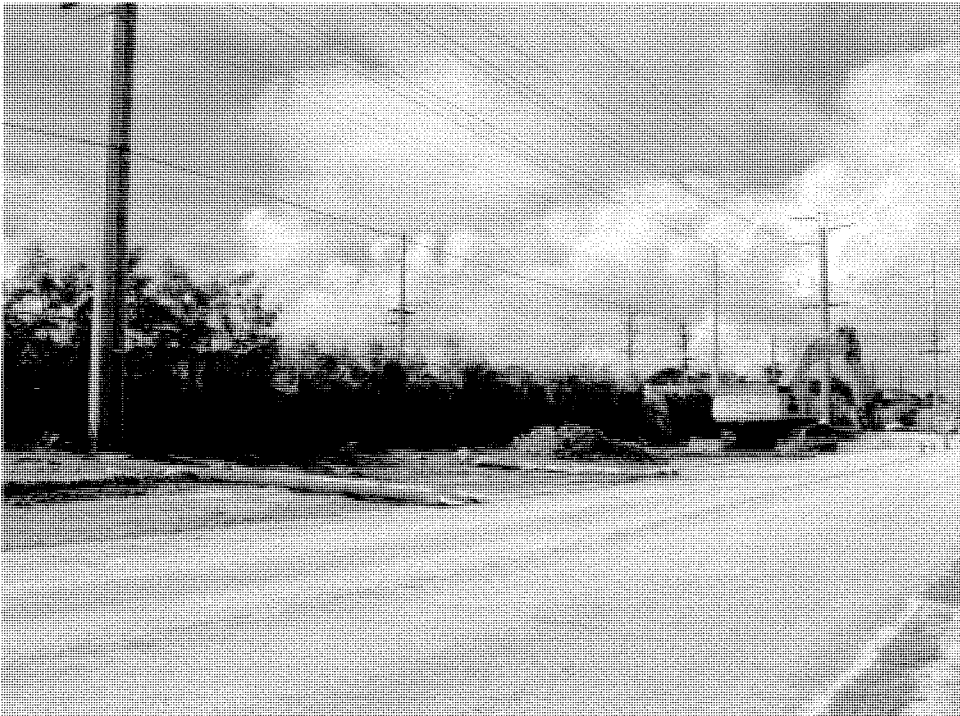
6B

6B: Contractor cutting and sealing last few sections of aboveground pipeline near the Tiyan Fuel Pump Station (outside of subject easement)
