**INSIDE TERMINAL**  
**Circuit 3**  
**- Transfer line -**

**INSIDE TERMINAL**  
**Circuit 3**  
**- Fuel supply line -**

INSIDE TERMINAL  
Circuit 4  
- Tango line -

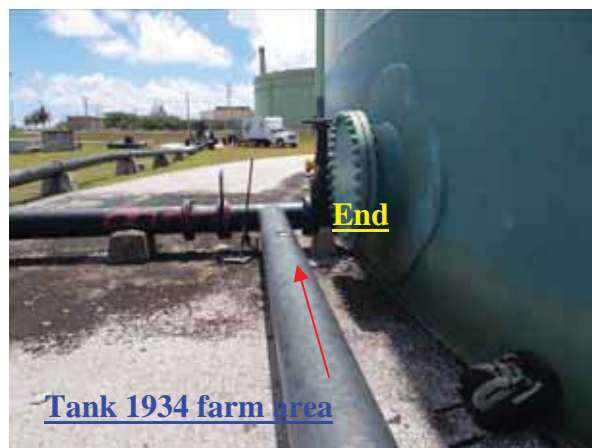
LINE SERVICE	DRAWING REFERENCE
12" Residual Fuel Oil No. 6 (RFO no. 6)	ISO drawing no. 11, 12 & 13
DESCRIPTION	LOCATION
Circuit 3 - Transfer line	Inside Terminal – Diesel pump house and tank 1934 farm area <i>*Please refer Appendix 3 for detail location</i>
FINDING	RECOMMENDATIONS
General view of 12" RFO no. 6 transfer line from diesel Pump discharge line to tank 1934.	Nil.

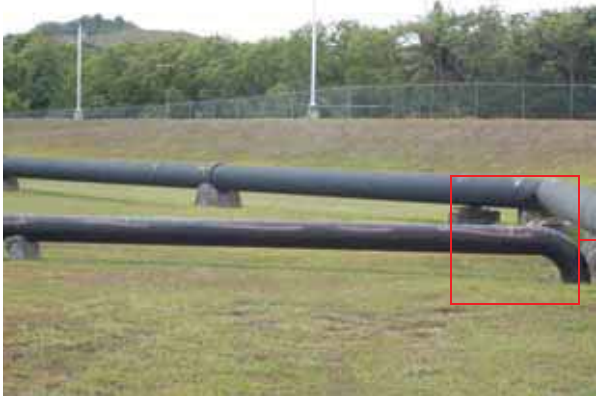
Location 2

LINE SERVICE	DRAWING REFERENCE
12" Residual Fuel Oil No. 6 (RFO no. 6)	ISO drawing no. 11
DESCRIPTION	LOCATION
Circuit 3 - Transfer line	Inside Terminal – Tank 1934 Farm Area <i>*Please refer Appendix 3 for detail location</i>
FINDING	RECOMMENDATIONS
Corrosion under wrapping was noted at soil to air interface area due to wrap failure and gives a path to water ingress inside, marked as location 2 in ISO drawing. No sign of corrosion propagate deeper after the wrapping end. <i>*Please refer Appendix 2 for ½ remaining life calculation at pits area.</i>	Consideration to perform permanent repair at this area with remove the corrosion, restore with weld metal deposited/insert weld patch, apply coal tar enamel and re-wrap with proper procedure and suitable wrapping for buried piping up to 6" from soil to air interface.

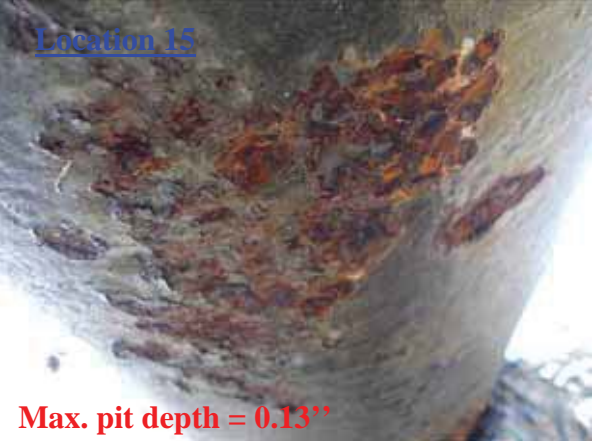
<p><b>Max. pit depth = 0.13"</b></p>

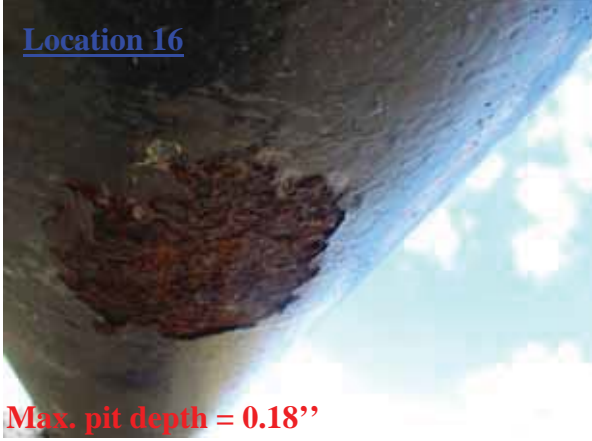
<p><b>Max. pit depth = 0.18"</b></p>
 	  <p><b>Max. pit depth = 0.10"</b></p>
<p><b>LINE SERVICE</b></p>	<p><b>DRAWING REFERENCE</b></p>
<p>12" Residual Fuel Oil No. 6 (RFO no. 6)</p>	<p>ISO drawing no. 12</p>
<p><b>DESCRIPTION</b></p>	<p><b>LOCATION</b></p>
<p>Circuit 3 - Transfer line</p>	<p>Inside Terminal – Tank 1934 Farm Area <i>*Please refer Appendix 3 for detail location</i></p>
<p><b>FINDING</b></p>	<p><b>RECOMMENDATIONS</b></p>
<p>1. Localized corrosion with scaling/pits was noted at bottom section of piping, marked as locations 15, and 16 in ISO drawing. 2. Corrosion with scaling was noted at contact area between piping and support, marked as location 17 in ISO drawing. <i>*Please refer Appendix 2 for ½ remaining life calculation at pits area.</i></p>	<p>1. To perform surface preparation and follows by maintenance painting as per client's specification for location 15. Consideration to perform permanent repair at locations 16 with remove the corrosion, restore with weld metal deposited/insert weld patch, follow by NDE and re-painting as per client's specification. 2. To lift the piping and perform surface preparation and follows by maintenance painting as per client's specification. Note:-Pits depth measurement at contact area between piping and support based on estimation due to inaccessible area.</p>

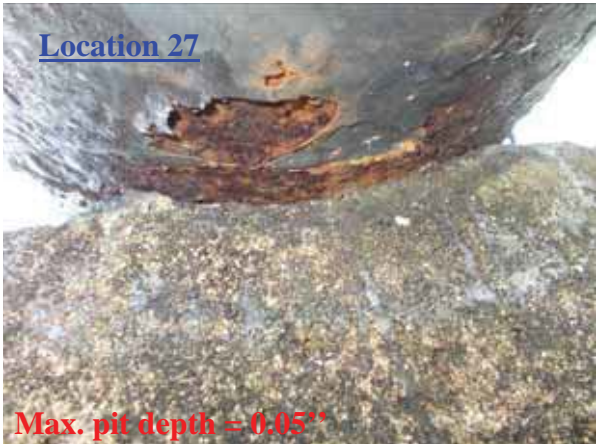
<p><u>Location 27</u></p> <p>Max. pit depth = 0.05"</p>
<p><b>LINE SERVICE</b></p>	<p><b>DRAWING REFERENCE</b></p>
<p>12" Residual Fuel Oil No. 6 (RFO no. 6)</p>	<p>ISO drawing no. 12 &amp; 13</p>
<p><b>DESCRIPTION</b></p>	<p><b>LOCATION</b></p>
<p>Circuit 3 - Transfer line</p>	<p>Inside Terminal – Tank 1934 Farm Area <i>*Please refer Appendix 3 for detail location</i></p>
<p><b>FINDING</b></p>	<p><b>RECOMMENDATIONS</b></p>
<p>Localized corrosion with/pits was noted at bottom section of piping, marked as locations 24, 25, 26 and 27 in ISO drawing. <i>*Please refer Appendix 2 for ½ remaining life calculation at pits area.</i></p>	<p>To perform surface preparation and follows by maintenance painting as per client's specification.</p>

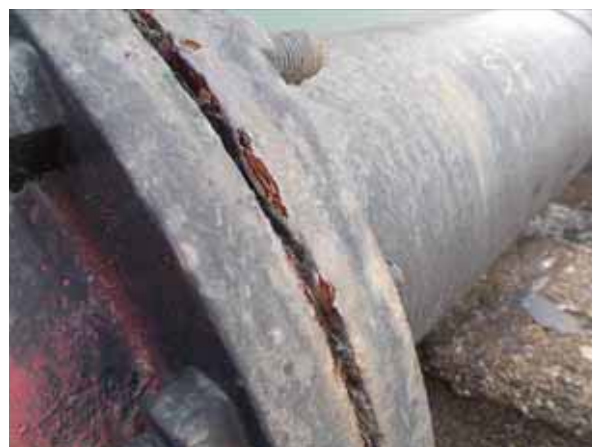
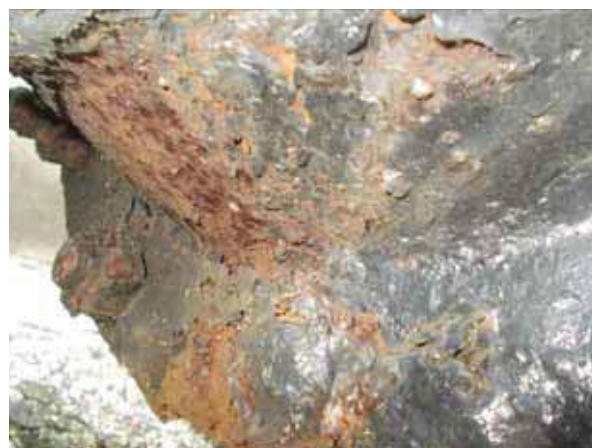
LINE SERVICE	DRAWING REFERENCE
12" Residual Fuel Oil No. 6 (RFO no. 6)	ISO drawing no. 13
DESCRIPTION	LOCATION
Circuit 3 - Transfer line	Inside Terminal – Tank 1934 Farm Area <i>*Please refer Appendix 3 for detail location</i>
FINDING	RECOMMENDATIONS
<ol style="list-style-type: none"> <li>1. Stud bolts of flange was noted not extend out through their nut.</li> <li>2. Paint failure with surface was noted at some section of V-143 valve.</li> </ol>	<ol style="list-style-type: none"> <li>1. To replace with longer stud bolt with the same material and specification.</li> <li>2. To perform surface preparation and follows by maintenance painting as per client's specification.</li> </ol>

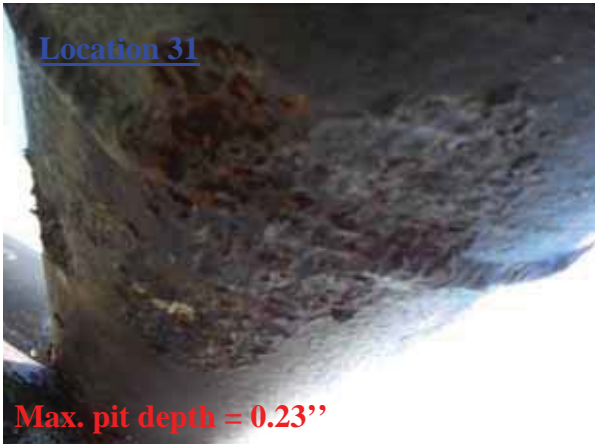
<p>Max. pit depth = 0.23"</p>
<p><b>LINE SERVICE</b></p>	<p><b>DRAWING REFERENCE</b></p>
<p>12" Residual Fuel Oil No. 6 (RFO no. 6)</p>	<p>ISO drawing no. 13</p>
<p><b>DESCRIPTION</b></p>	<p><b>LOCATION</b></p>
<p>Circuit 3 - Transfer line</p>	<p>Inside Terminal – Tank 1934 Farm Area <i>*Please refer Appendix 3 for detail location</i></p>
<p><b>FINDING</b></p>	<p><b>RECOMMENDATIONS</b></p>
<p>1. Localized corrosion with scaling/pits was noted at bottom section of piping, marked as locations 29, and 31 in ISO drawing. 2. Corrosion with scaling was noted at contact area between piping and support, marked as locations 28 and 30 in ISO drawing. <i>*Please refer Appendix 2 for ½ remaining life calculation at pits area.</i></p>	<p>1. Consideration to perform permanent repair at this area with remove the corrosion, restore with weld metal deposited/insert weld patch, follow by NDE and re-painting as per client's specification. 2. To lift the piping and perform surface preparation and follows by maintenance painting as per client's specification for location 28 and permanent repair as above for location 30. Note:-Pits depth measurement at contact area between piping and support based on estimation due to inaccessible area.</p>

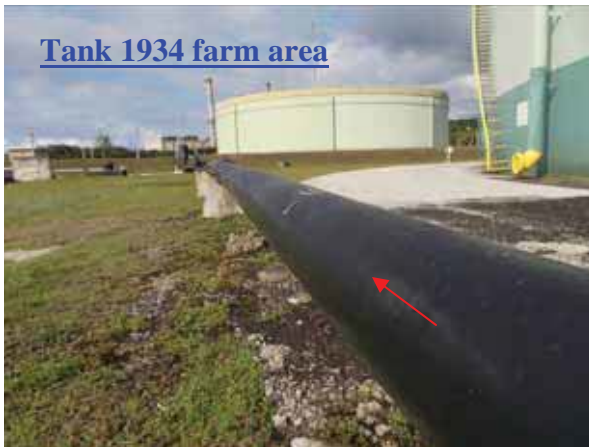
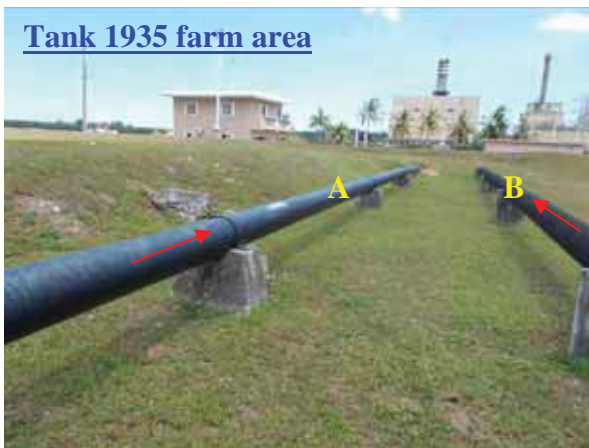
LINE SERVICE	DRAWING REFERENCE
12" Residual Fuel Oil No. 6	ISO drawing no. 14 to 18
DESCRIPTION	LOCATION
Circuit 3 - Fuel supply line	Inside Terminal – Tank 1934, 1935 farm and pump area <i>*Please refer Appendix 3 for detail location</i>
FINDING	RECOMMENDATIONS
General view of fuel supply line from tank 1934 & 1935 to pump.	Nil.

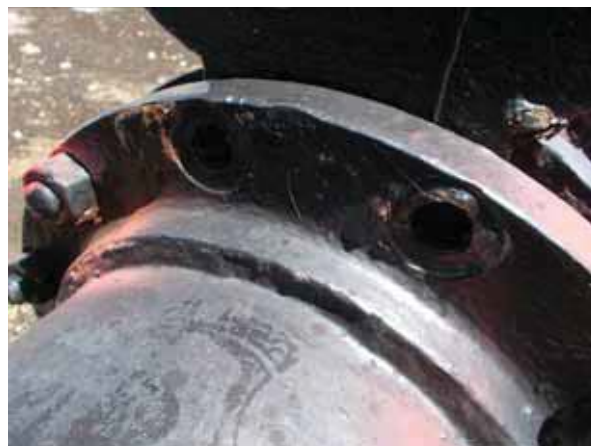
LINE SERVICE	DRAWING REFERENCE
12" Residual Fuel Oil No. 6 (RFO no. 6)	ISO drawing no. 14
DESCRIPTION	LOCATION
Circuit 3 - Transfer line	Inside Terminal – Tank 1934 Farm Area <i>*Please refer Appendix 3 for detail location</i>
FINDING	RECOMMENDATIONS
<ol style="list-style-type: none"> <li>1. General view of small bore piping (<math>\frac{3}{4}</math>" drain line).</li> <li>2. Stud bolts of flange was noted not extend out through their nut.</li> <li>3. Stud bolts of flanges was noted to be missing.</li> </ol>	<ol style="list-style-type: none"> <li>1. Consideration to perform profile Radiographic Testing (RT) for thickness measurement at small bore piping.</li> <li>2. To replace with longer stud bolt with the same material and specification.</li> <li>3. To replace the missing stud bolt with the same material and specification</li> </ol>

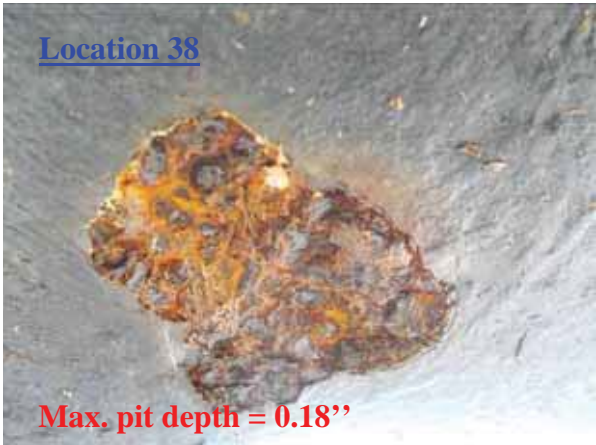
<p><b>Location 38</b></p> <p><b>Max. pit depth = 0.18"</b></p>	  <p><b>Location 39</b></p> <p><b>Max. pit depth = 0.14"</b></p>
  <p><b>Location 40</b></p> <p><b>Max. pit depth = 0.05"</b></p>	  <p><b>Location 41</b></p> <p><b>Max. pit depth = 0.12"</b></p>
<p><b>LINE SERVICE</b></p>	<p><b>DRAWING REFERENCE</b></p>
<p>12" Residual Fuel Oil No. 6</p>	<p>ISO drawing no. 14</p>
<p><b>DESCRIPTION</b></p>	<p><b>LOCATION</b></p>
<p>Circuit 3 - Fuel supply line</p>	<p>Inside Terminal – Tank 1934 Farm Area <i>*Please refer Appendix 3 for detail location</i></p>
<p><b>FINDING</b></p>	<p><b>RECOMMENDATIONS</b></p>
<p>1. Localized corrosion/pits was noted at bottom section of piping, marked as locations 38, and 39 in ISO drawing.</p> <p>2. Corrosion was noted at contact area between piping and support, marked as locations 40 and 41 in ISO drawing.</p> <p><i>*Please refer Appendix 2 for ½ remaining life calculation at pits area.</i></p>	<p>1. To perform surface preparation and follows by maintenance painting as per client's specification for location 38. Consideration to perform permanent repair at location 39 with remove the corrosion, restore with weld metal deposited/insert weld patch, follow by NDE and re-painting as per client's specification.</p> <p>2. To lift the piping, perform surface preparation and follows by maintenance painting as per client's specification for location 40 and permanent repair as above for location 41.</p> <p>Note:-Pits depth measurement at contact area between piping and support based on estimation due to inaccessible area.</p>

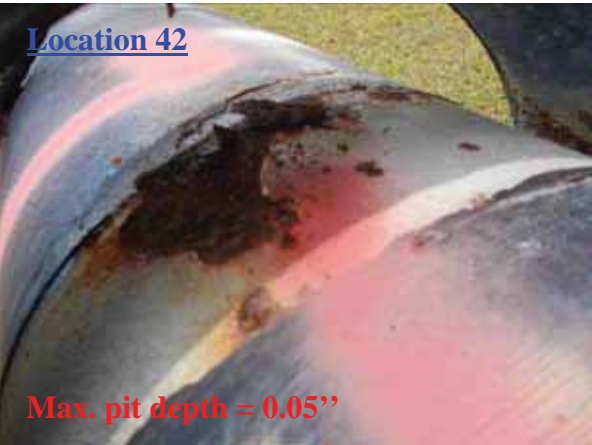
<p>Max. pit depth = 0.05"</p>	<p><u>Location 43</u></p>

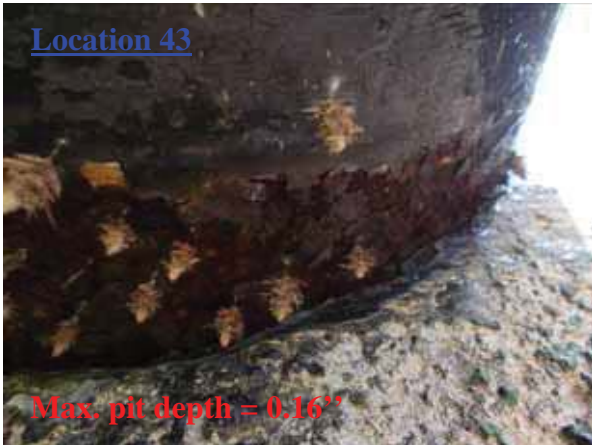
<p>Max. pit depth = 0.16"</p>
<p><u>Location 44</u></p>

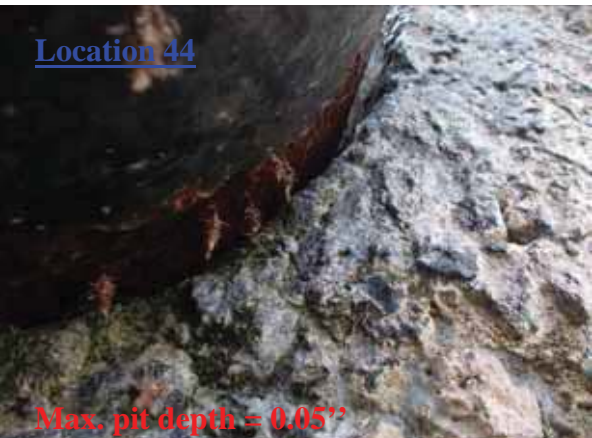
<p>Max. pit depth = 0.05"</p>	<p><u>Location 45</u></p>

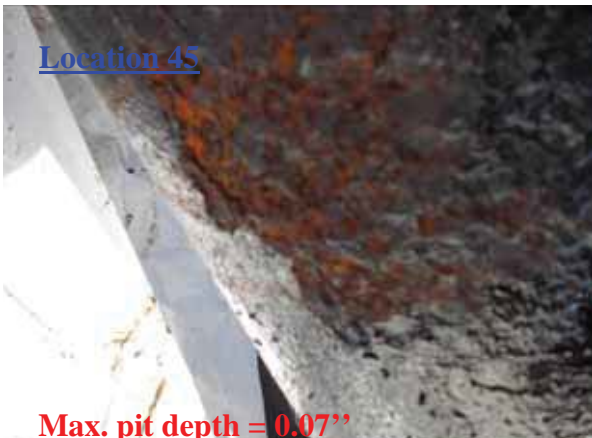
<p>Max. pit depth = 0.07"</p>
<p><b>LINE SERVICE</b></p>	<p><b>DRAWING REFERENCE</b></p>
<p>12" Residual Fuel Oil No. 6</p>	<p>ISO drawing no. 14</p>
<p><b>DESCRIPTION</b></p>	<p><b>LOCATION</b></p>
<p>Circuit 3 - Fuel supply line</p>	<p>Inside Terminal – Tank 1934 Farm Area <i>*Please refer Appendix 3 for detail location</i></p>
<p><b>FINDING</b></p>	<p><b>RECOMMENDATIONS</b></p>
<p>1. Localized corrosion/pits was noted at bottom section of piping, marked as locations 42, and 45 in ISO drawing. 2. Corrosion was noted at contact area between piping and support, marked as locations 43 and 44 in ISO drawing. <i>*Please refer Appendix 2 for ½ remaining life calculation at pits area.</i></p>	<p>1. To perform surface preparation and follows by maintenance painting as per client's specification. 2. To lift the piping, perform surface preparation and follows by maintenance painting as per client's specification for location 43 and permanent repair at location 43 with remove the corrosion, restore with weld metal deposited/insert weld patch, follow by NDE and re-painting as per client's specification. Note:-Pits depth measurement at contact area between piping and support based on estimation due to inaccessible area.</p>

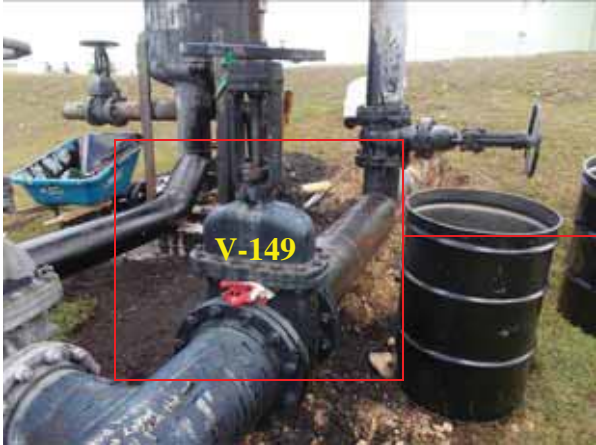
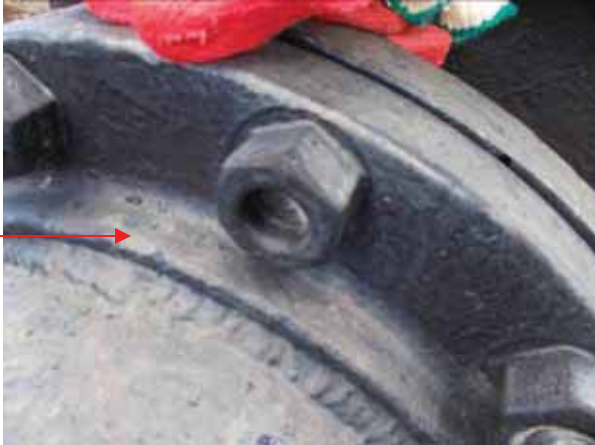
<b>LINE SERVICE</b>	<b>DRAWING REFERENCE</b>
12" Residual Fuel Oil No. 6	ISO drawing no. 14
<b>DESCRIPTION</b>	<b>LOCATION</b>
Circuit 3 - Fuel supply line	Inside Terminal – Tank 1934 Farm Area <i>*Please refer Appendix 3 for detail location</i>
<b>FINDING</b>	<b>RECOMMENDATIONS</b>
1. Stud bolts of flanges V-149 was noted not extend out through their nut. 2. Stud bolts of flanges V-152 was noted to be missing.	1. To replace with longer stud bolt with the same material and specification. 2. To replace the missing stud bolt with the same material and specification

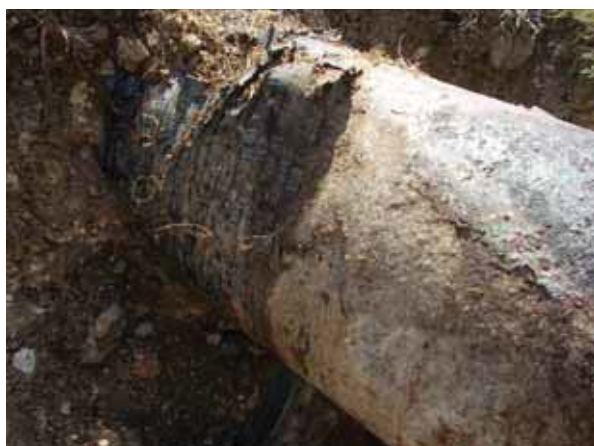
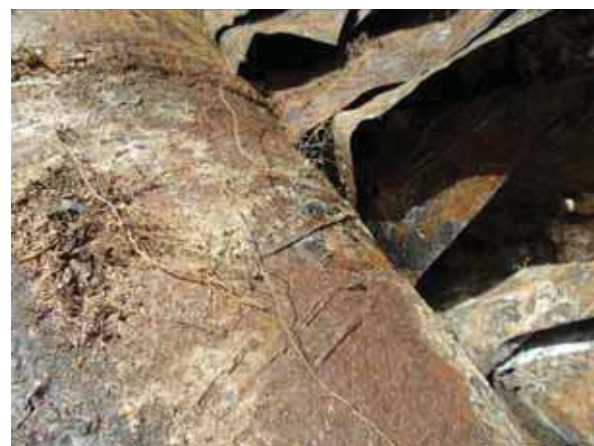
LINE SERVICE	DRAWING REFERENCE
12" Residual Fuel Oil No. 6	ISO drawing no. 15
DESCRIPTION	LOCATION
Circuit 3 - Fuel supply line	Inside Terminal – Tank 1935 Farm Area <i>*Please refer Appendix 3 for detail location</i>
FINDING	RECOMMENDATIONS
Corrosion under wrapping was noted at soil to air interface area due to wrap failure and gives a path to water ingress inside, marked as location 46 in ISO drawing. No sign of corrosion propagate deeper after the wrapping end. <i>*Please refer Appendix 2 for ½ remaining life calculation at pits area.</i>	To perform surface preparation extend to the last corrosion, apply coal tar enamel and re-wrap with proper procedure and suitable wrapping for buried piping up to 6" from soil to air interface.

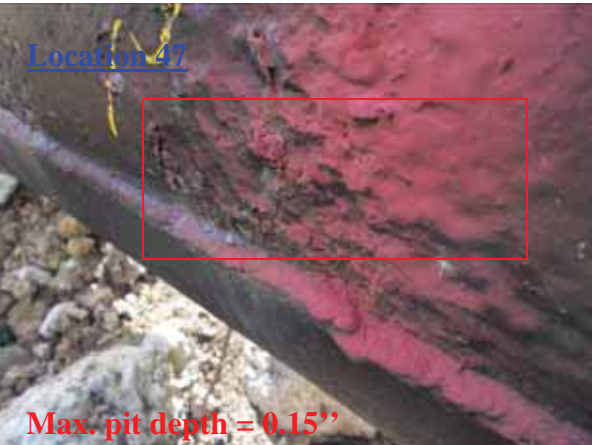
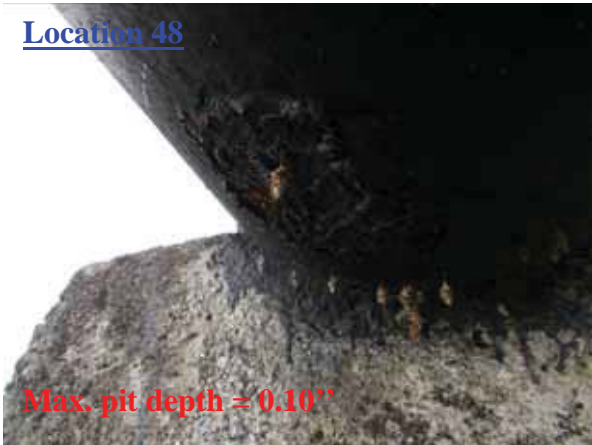
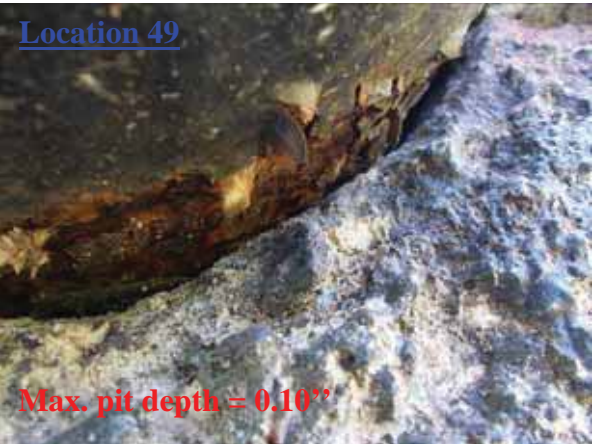
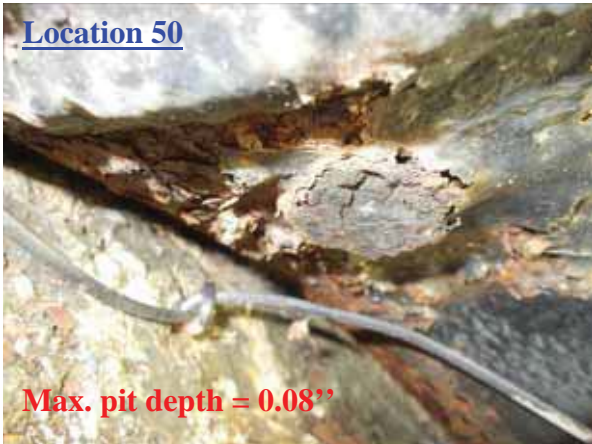
<p><b>LINE SERVICE</b></p>	<p><b>DRAWING REFERENCE</b></p>
<p>12" Residual Fuel Oil No. 6</p>	<p>ISO drawing no. 15</p>
<p><b>DESCRIPTION</b></p>	<p><b>LOCATION</b></p>
<p>Circuit 3 - Fuel supply line</p>	<p>Inside Terminal – Tank 1935 Farm Area <i>*Please refer Appendix 3 for detail location</i></p>
<p><b>FINDING</b></p>	<p><b>RECOMMENDATIONS</b></p>
<p>1. Localized corrosion/pits was noted at side and bottom section of piping, marked as locations 47 and 48 in ISO drawing. 2. Corrosion was noted at contact area between piping and support, marked as location 49 and 50 in ISO drawing. <i>*Please refer Appendix 2 for ½ remaining life calculation at pits area.</i></p>	<p>1. Consideration to perform permanent repair in accordance to API 570, restore with weld metal deposited/insert weld patch follows by NDE and painting as per client's specification. 2. To lift the piping, perform surface preparation and follows by maintenance painting as per client's specification for location 50 and permanent repair as above for location 49. Note:-Pits depth measurement at contact area between piping and support based on estimation due to inaccessible area.</p>

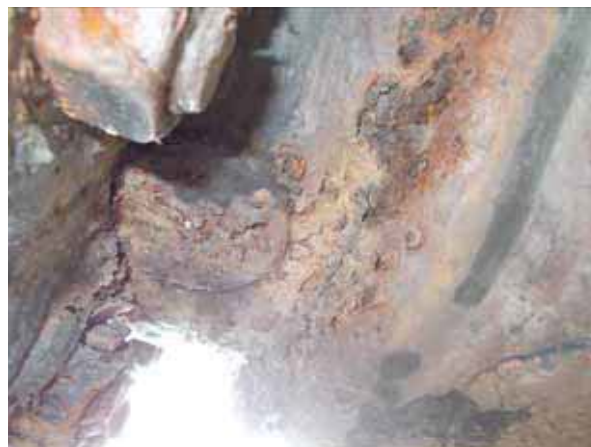
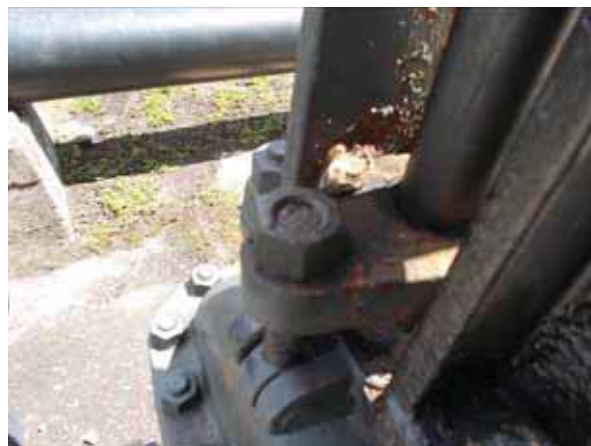
LINE SERVICE	DRAWING REFERENCE
12" (B) Residual Fuel Oil No. 6	ISO drawing no. 16
DESCRIPTION	LOCATION
Circuit 3 - Fuel supply line	Inside Terminal – Tank 1935 Farm Area <i>*Please refer Appendix 3 for detail location</i>
FINDING	RECOMMENDATIONS
<ol style="list-style-type: none"> <li>1. Stud bolts of valve was noted corroded.</li> <li>2. Paint failure with surface rust was noted at some section of the valve.</li> </ol>	<ol style="list-style-type: none"> <li>1. To replace the corroded stud bolts with the same material and specification.</li> <li>2. To perform surface preparation and follows by maintenance painting as per client's specification.</li> </ol>

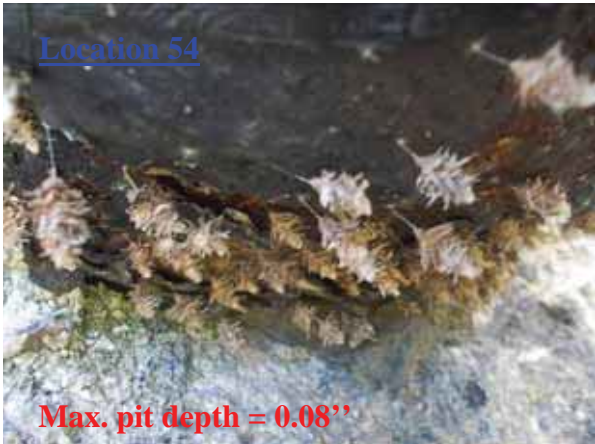
<p><u>Location 54</u></p> <p>Max. pit depth = 0.08''</p>
<p><b>LINE SERVICE</b></p> <p>12" (A) Residual Fuel Oil No. 6</p>	<p><b>DRAWING REFERENCE</b></p> <p>ISO drawing no. 16</p>
<p><b>DESCRIPTION</b></p> <p>Circuit 3 - Fuel supply line</p>	<p><b>LOCATION</b></p> <p>Inside Terminal – Tank 1935 Farm Area <i>*Please refer Appendix 3 for detail location</i></p>
<p><b>FINDING</b></p> <p>Corrosion was noted at contact area between piping and support, marked as locations 51, 52, 53 and 54 in ISO drawing. <i>*Please refer Appendix 2 for ½ remaining life calculation at pits area.</i></p>	<p><b>RECOMMENDATIONS</b></p> <p>To lift the piping and perform surface preparation and follows by maintenance painting as per client's specification for location 51 and 54. Consideration to perform permanent repair at locations 52 and 53 with remove the corrosion, restore with weld metal deposited/insert weld patch, follow by NDE and re-painting as per client's specification.</p>

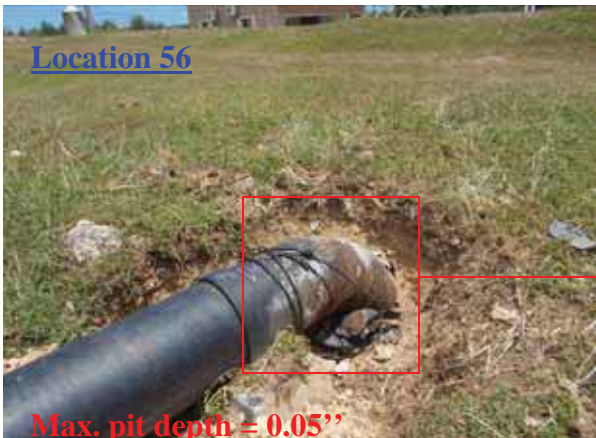
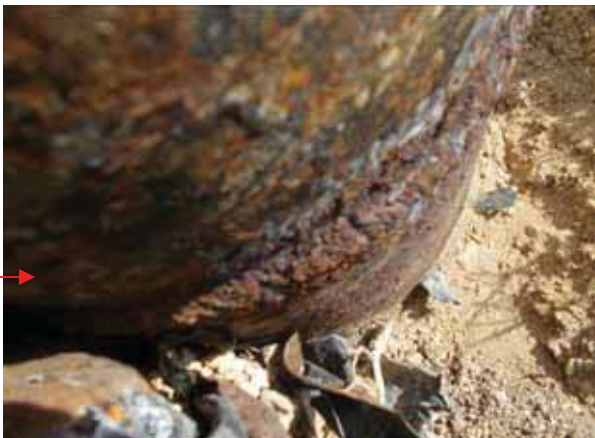
<p><u>Location 56</u></p>

<p>Max. pit depth = 0.05"</p>

<p><b>LINE SERVICE</b></p>	<p><b>DRAWING REFERENCE</b></p>
<p>12" (A) Residual Fuel Oil No. 6</p>	<p>ISO drawing no. 16</p>
<p><b>DESCRIPTION</b></p>	<p><b>LOCATION</b></p>
<p>Circuit 3 - Fuel supply line</p>	<p>Inside Terminal – Tank 1935 Farm Area <i>*Please refer Appendix 3 for detail location</i></p>
<p><b>FINDING</b></p>	<p><b>RECOMMENDATIONS</b></p>
<p>1. Corrosion was noted at contact area between piping and support, marked as location 55 in ISO drawing. 2. Corrosion under wrapping was noted at soil to air interface area due to wrap failure and gives a path to water ingress inside, marked as location 56 in ISO drawing. No sign of corrosion propagate deeper after the wrapping end. <i>*Please refer Appendix 2 for ½ remaining life calculation at pits area.</i></p>	<p>1. To lift the piping and consideration to perform permanent repair at locations with remove the corrosion, restore with weld metal deposited/insert weld patch, follow by NDE and re-painting as per client's specification. 2. To perform surface preparation extend to the last corrosion, apply coal tar enamel and re-wrap with proper procedure and suitable wrapping for buried piping up to 6" from soil to air interface.</p>

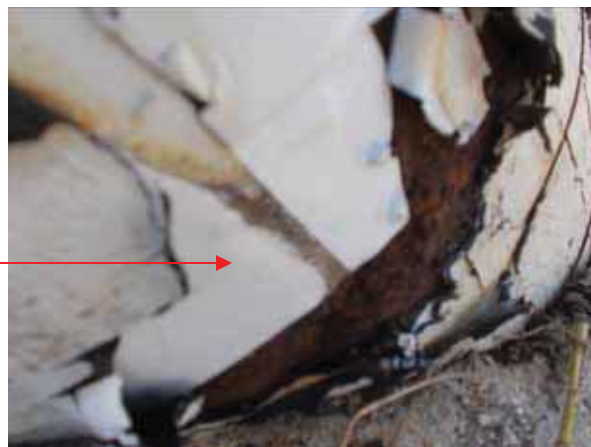
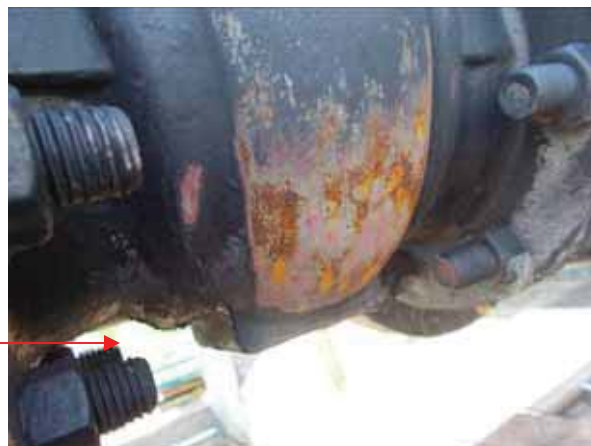
LINE SERVICE	DRAWING REFERENCE
12" (B) Residual Fuel Oil No. 6	ISO drawing no. 17
DESCRIPTION	LOCATION
Circuit 3 - Fuel supply line	Inside Terminal – Pump Area <i>*Please refer Appendix 3 for detail location</i>
FINDING	RECOMMENDATIONS
<ol style="list-style-type: none"> <li>1. Wrapping tape at concrete to air interface was observed deteriorated and minor corrosion under wrapping was noted at the area.</li> <li>2. Paint failure with surface rust was noted at some section of 6" valve.</li> <li>3. Small bore piping (gauge line) was noted without gusset plates.</li> </ol>	<ol style="list-style-type: none"> <li>1. To un-install the wrapping, perform surface preparation, painting as per client's specification and re-wrap at concrete to air interface area (6" above from ground level) with proper procedure.</li> <li>2. To perform surface preparation and follows by maintenance painting as per client's specification.</li> <li>3. To install 2 gusset plates on the piping to strengthen the pressure line.</li> </ol> <p><i>Please refer ISO Drawing for detail location base on reference support/area as stated above.</i></p>

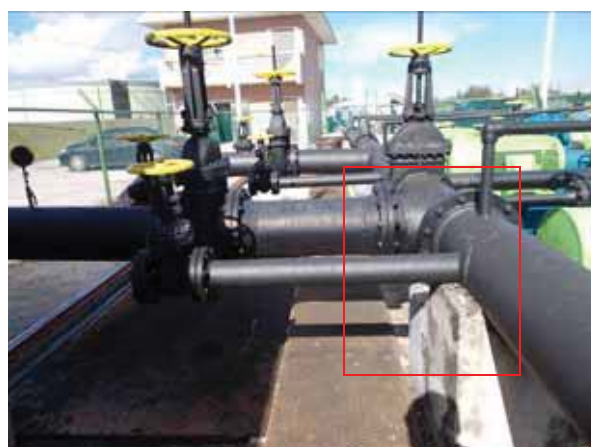
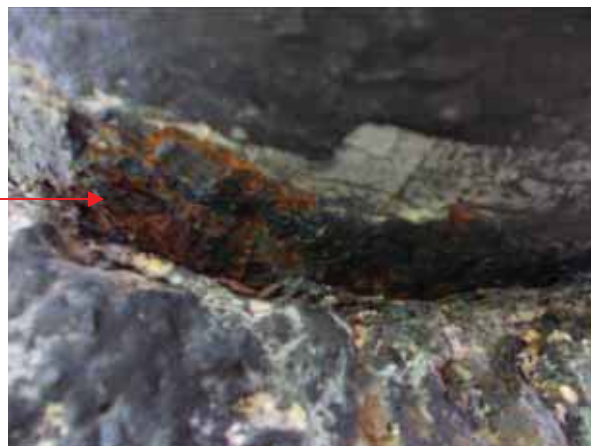
LINE SERVICE	DRAWING REFERENCE
12" Residual Fuel Oil No. 6	ISO drawing no. 17
DESCRIPTION	LOCATION
Circuit 3 - Fuel supply line	Inside Terminal – Pump Area <i>*Please refer Appendix 3 for detail location</i>
FINDING	RECOMMENDATIONS
Excessive in contact between piping and support. Crevice corrosion was noted at support 2.	To lift the piping, perform surface preparation and follows by maintenance painting as per client's specification. Consideration to modify existing support and to install rounded/angle bar or other materials to give single contact point between piping and support. Single contact point is to prevent moisture or water sitting against the piping surface and promote to corrosion.

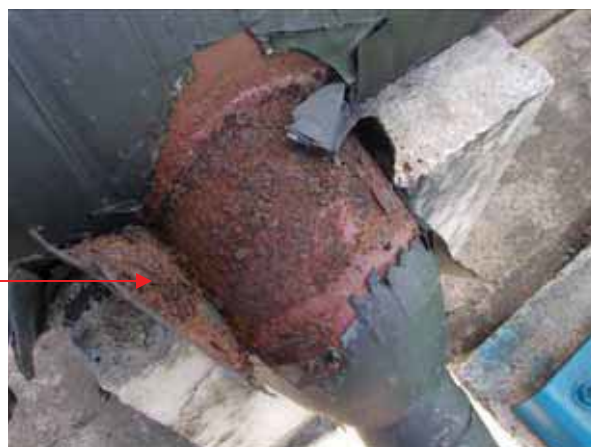
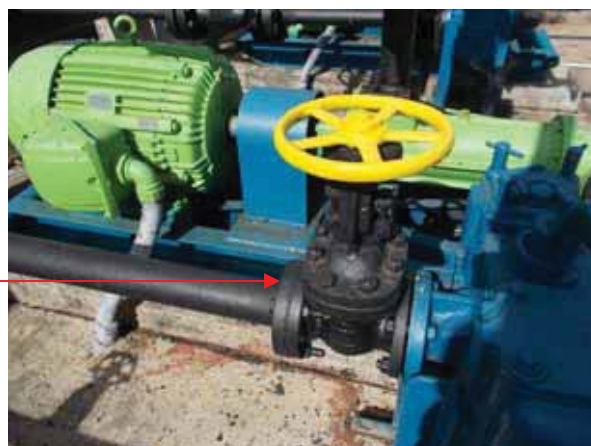
LINE SERVICE	DRAWING REFERENCE
3" Residual Fuel Oil No. 6	ISO drawing no. 17
DESCRIPTION	LOCATION
Circuit 3 - Fuel supply line	Inside Terminal – Pump Area <i>*Please refer Appendix 3 for detail location</i>
FINDING	RECOMMENDATIONS
<ol style="list-style-type: none"> <li>1. Wrapping tape at 5"x3" was observed deteriorated and minor corrosion under wrapping was noted at the area.</li> <li>2. Stud bolts and nuts at 3" valve inlet to Tango 2 pump was noted corroded.</li> </ol>	<ol style="list-style-type: none"> <li>1. To un-install the wrapping, perform surface preparation, painting as per client's specification.</li> <li>2. To replace the corroded stud bolts and nuts with the same material and specification.</li> </ol>

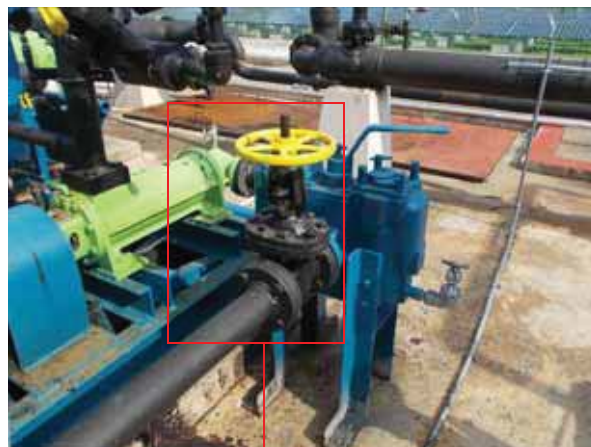
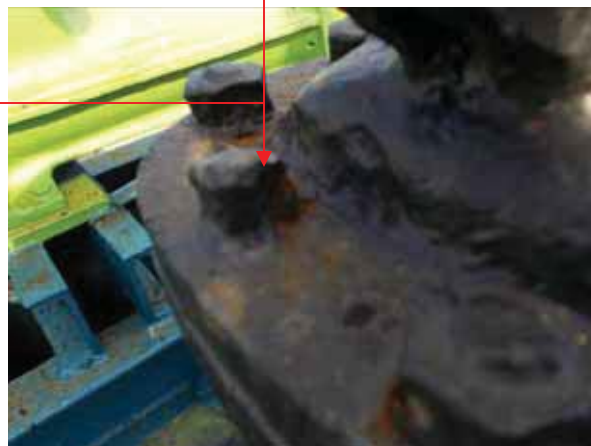
LINE SERVICE	DRAWING REFERENCE
3" Residual Fuel Oil No. 6	ISO drawing no. 17
DESCRIPTION	LOCATION
Circuit 3 - Fuel supply line	Inside Terminal – Pump Area <i>*Please refer Appendix 3 for detail location</i>
FINDING	RECOMMENDATIONS
Stud bolts of 3" valve was noted not extend out from their nuts and corroded.	To replace the stud bolts and nuts with the same material and specification.

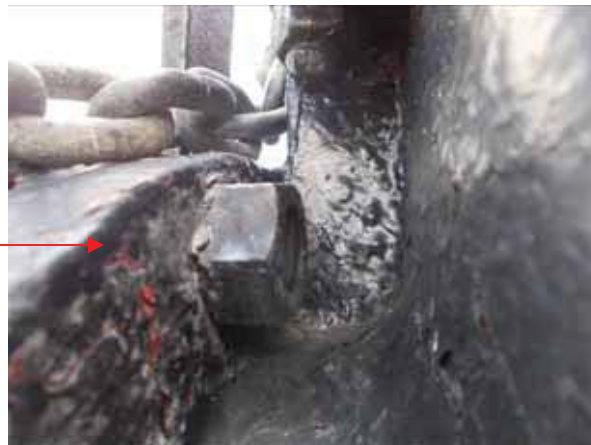
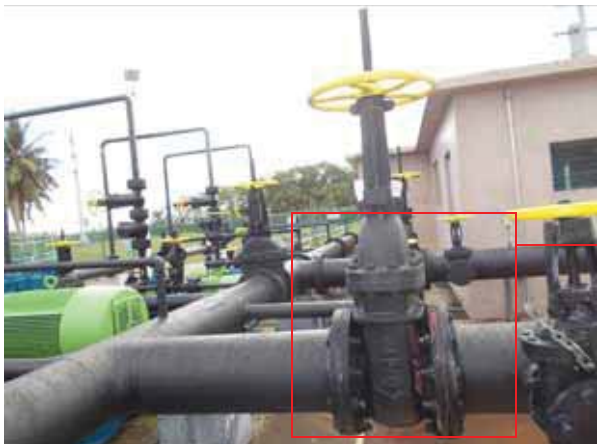
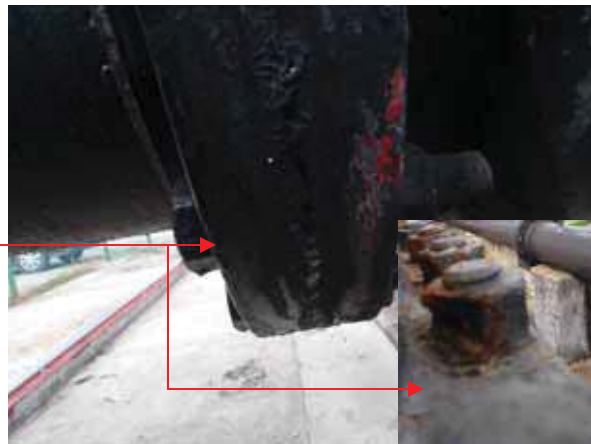
LINE SERVICE	DRAWING REFERENCE
12" (A) Residual Fuel Oil No. 6	ISO drawing no. 18
DESCRIPTION	LOCATION
Circuit 3 - Fuel supply line	Inside Terminal – Pump Area <i>*Please refer Appendix 3 for detail location</i>
FINDING	RECOMMENDATIONS
1. Product stain sign of leak was noted at flanges joint to 12" valve. 2. Stud bolts of 6" valve was noted not extend out from their nuts and corroded at 12" valve.	1. Consideration to dismantle the valve to check for corrosion at raise face and to replace with new gasket. 2. To replace with longer stud bolt for 6" valve and to replace corroded nuts at 12" valve. <i>Please refer ISO Drawing for detail location base on reference support/area as stated above.</i>

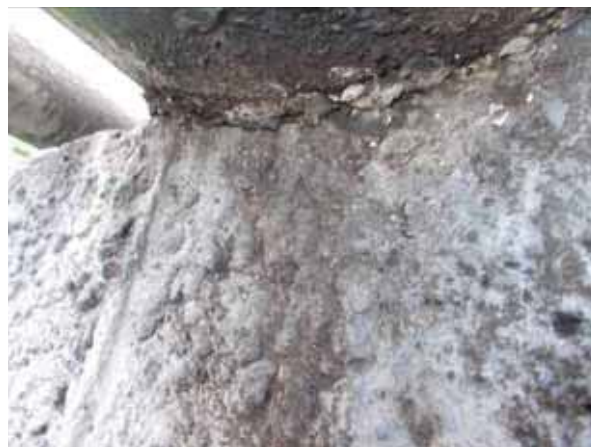
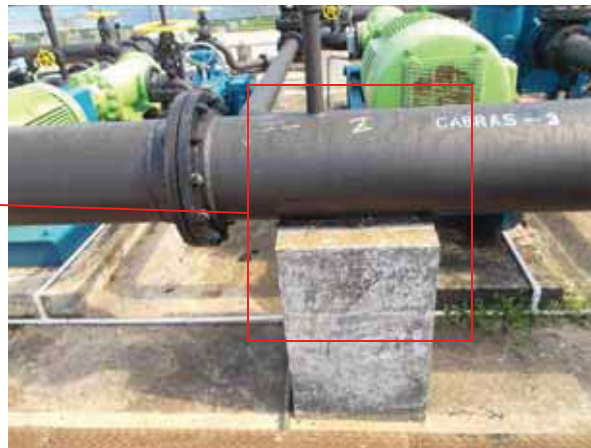
LINE SERVICE	DRAWING REFERENCE
12" Residual Fuel Oil No. 6	ISO drawing no. 18
DESCRIPTION	LOCATION
Circuit 3 - Fuel supply line	Inside Terminal – Pump Area <i>*Please refer Appendix 3 for detail location</i>
FINDING	RECOMMENDATIONS
Excessive in contact between piping and support. Crevice corrosion was noted at support 5.	To lift the piping, perform surface preparation and follows by maintenance painting as per client's specification. Consideration to modify existing support and to install rounded/angle bar or other materials to give single contact point between piping and support. Single contact point is to prevent moisture or water sitting against the piping surface and promote to corrosion. <i>Please refer ISO Drawing for detail location base on reference support/area as stated above.</i>

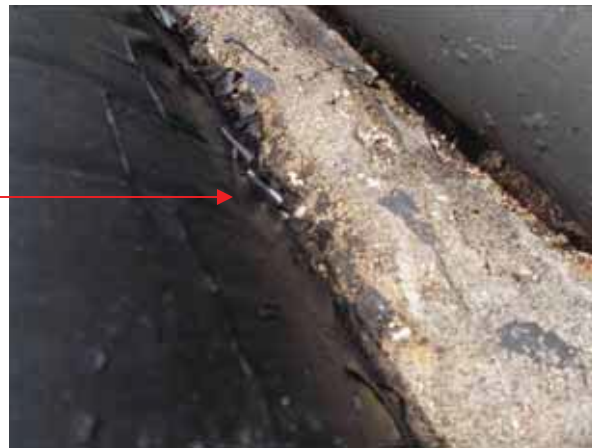
LINE SERVICE	DRAWING REFERENCE
12" Residual Fuel Oil No. 6	ISO drawing no. 18
DESCRIPTION	LOCATION
Circuit 3 - Fuel supply line	Inside Terminal – Pump Area <i>*Please refer Appendix 3 for detail location</i>
FINDING	RECOMMENDATIONS
<ol style="list-style-type: none"> <li>1. Wrapping tape at support was noted deteriorated.</li> <li>2. Excessive in contact between piping and support.</li> </ol>	<ol style="list-style-type: none"> <li>1. To uninstall the wrap for preventing water ingress inside and promote to corrosion.</li> <li>2. Consideration to modify existing support and to install rounded/angle bar or other materials to give single contact point between piping and support. Single contact point is to prevent moisture or water sitting against the piping surface and promote to corrosion.</li> </ol>

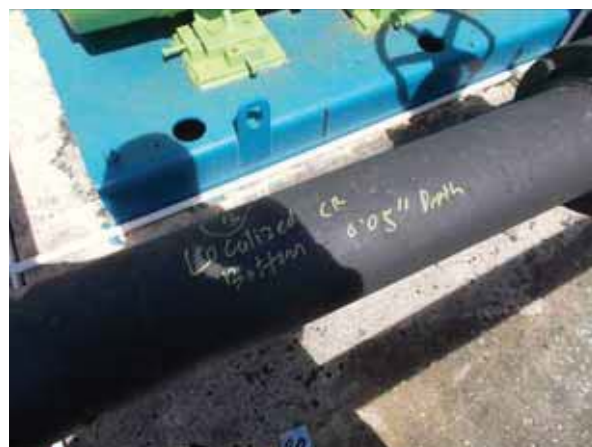
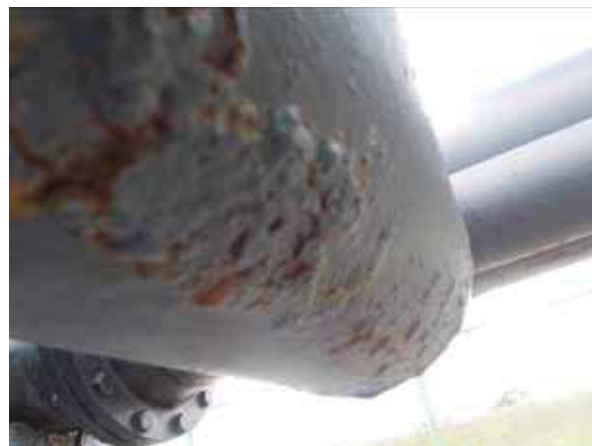
LINE SERVICE	DRAWING REFERENCE
6" Residual Fuel Oil No. 6	ISO drawing no. 18
DESCRIPTION	LOCATION
Circuit 3 - Fuel supply line	Inside Terminal – Pump Area <i>*Please refer Appendix 3 for detail location</i>
FINDING	RECOMMENDATIONS
Localized corrosion/pits was noted at bottom section of piping, marked as location 57 in ISO drawing. <i>*Please refer Appendix 2 for ½ remaining life calculation at pits area.</i>	To perform surface preparation and follows by maintenance painting as per client's specification.

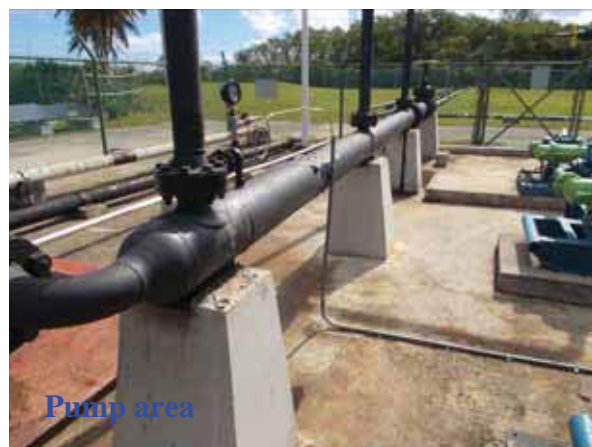
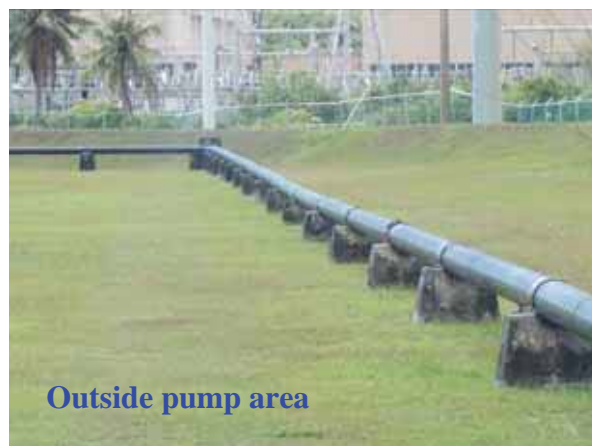
LINE SERVICE	DRAWING REFERENCE
14" Residual Fuel Oil No. 6	ISO drawing no. 19 to 23
DESCRIPTION	LOCATION
Circuit 4 - Tango Line	Inside Terminal – Pump and outside pump area <i>*Please refer Appendix 3 for detail location</i>
FINDING	RECOMMENDATIONS
1. General view of 8" Tango line outlet from T -1, T - 2 and T 3 pump. 2. Excessive in contact between piping and all pedestals support.	1. Nil. 2. Consideration to modify existing support and to install rounded/angle bar or others material to give single contact point between piping and support. Single contact point is to prevent moisture or water sitting against the piping surface and promote to corrosion.

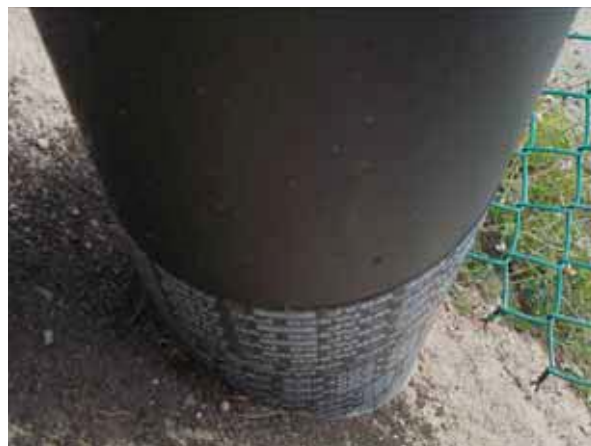
LINE SERVICE	DRAWING REFERENCE
4", 8" Residual Fuel Oil No. 6	ISO drawing no. 19
DESCRIPTION	LOCATION
Circuit 4 - Tango line	Inside Terminal – Pump Area <i>*Please refer Appendix 3 for detail location</i>
FINDING	RECOMMENDATIONS
<ol style="list-style-type: none"> <li>1. Pipe support modification was noted from support 4 to 7 and surface rust was noted at the area.</li> <li>2. Wrapping tape at underground piping was observed intact, no sign of corrosion was noted at the wrapping area.</li> </ol>	<ol style="list-style-type: none"> <li>1. To perform surface preparation and follows by maintenance painting as per client's specification.</li> <li>2. Nil.</li> </ol>
