LINE SERVICE	DRAWING REFERENCE
14" Residual Fuel Oil No. 6	ISO drawing no. 20
DESCRIPTION	LOCATION
Circuit 4 - Tango line	Inside Terminal – Outside pump area <i>*Please refer Appendix 3 for detail location</i>
FINDING	RECOMMENDATIONS
Corrosion under wrapping was noted at soil to air interface area due to wrap failure and gives a path to water ingress inside, marked as location 1 in ISO drawing. No sign of corrosion propagate deeper after the wrapping end. <i>*Please refer Appendix 2 for ½ remaining life calculation at pits area.</i>	Consideration to perform permanent repair at this area with remove the corrosion, restore with weld metal deposited/insert weld patch, apply coal tar enamel and re-wrap with proper procedure and suitable wrapping for buried piping up to 6" from soil to air interface.

INSIDE TERMINAL
Circuit 5
- Cabras line -

APPENDIX 3
- PIPELINE ISOMETRIC DRAWING -
(Support numbering for visual report reference location & corrosion location)

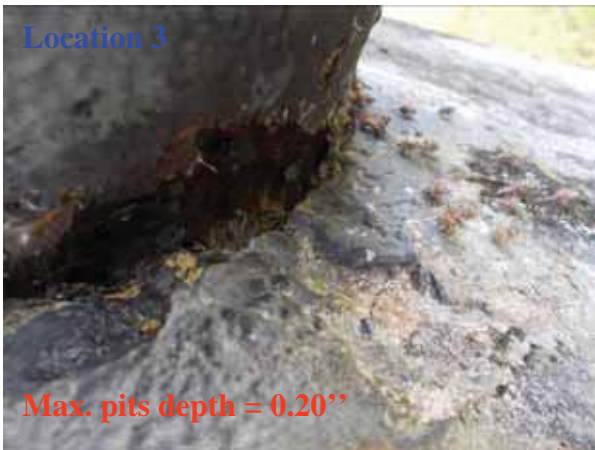
<p>Location 3</p> <p>Max. pits depth = 0.20''</p>

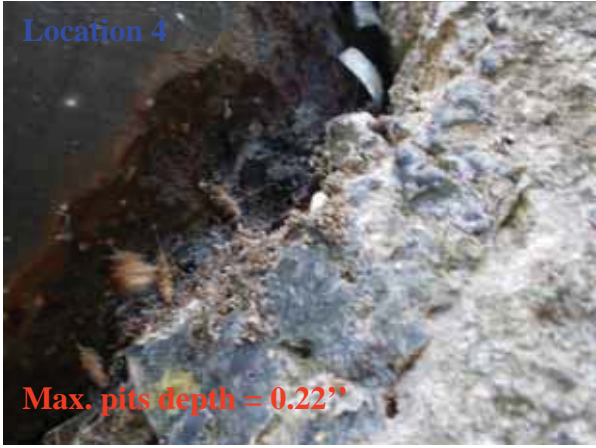
<p>Location 4</p> <p>Max. pits depth = 0.22''</p>

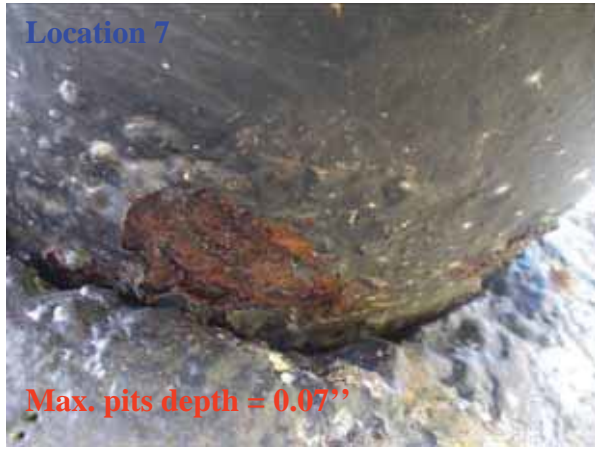
<p>Location 7</p> <p>Max. pits depth = 0.07"</p>

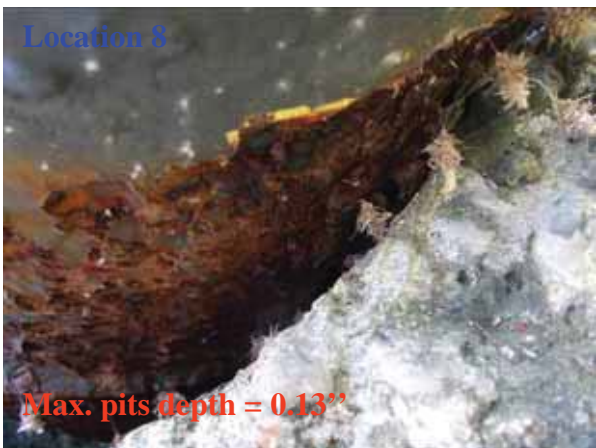
<p>Location 8</p> <p>Max. pits depth = 0.13"</p>

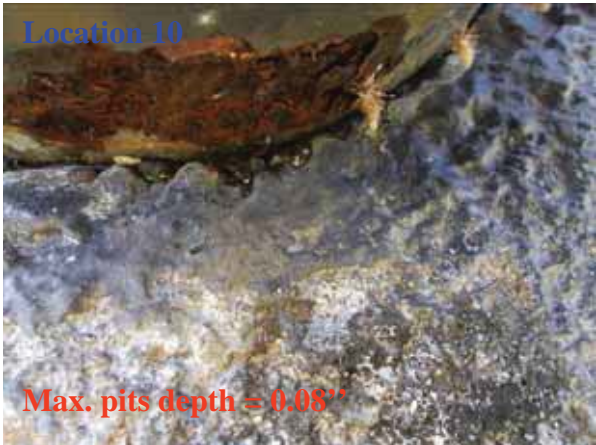
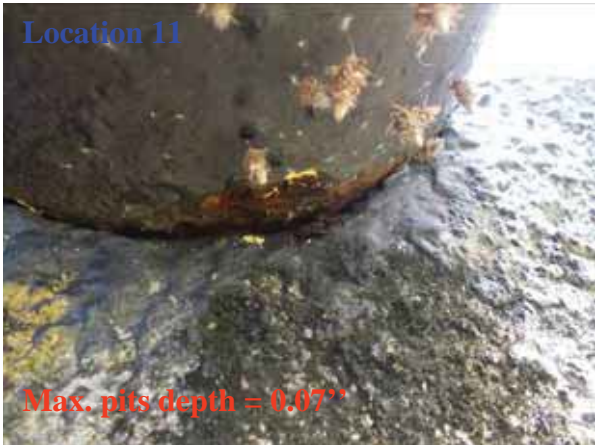
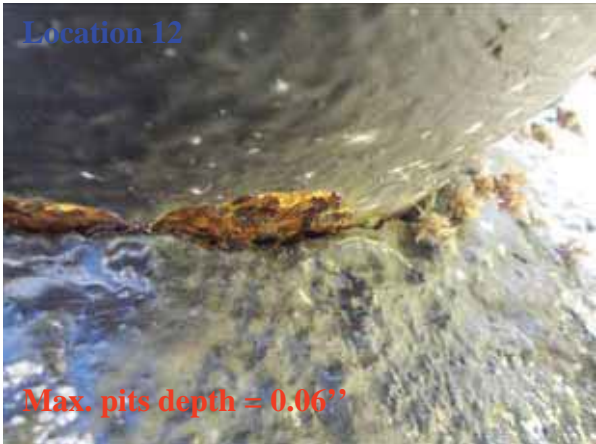
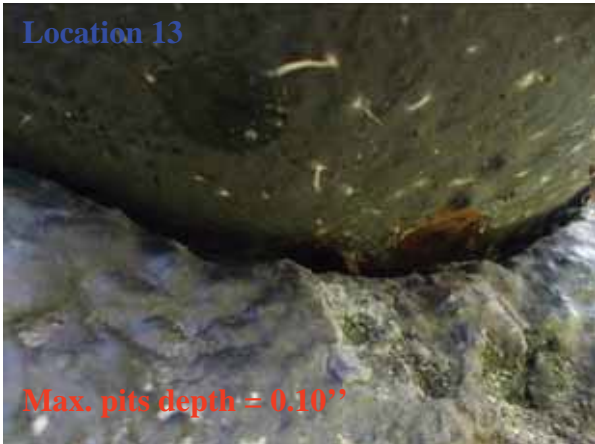
LINE SERVICE 14" Residual Fuel Oil No. 6	DRAWING REFERENCE ISO drawing no. 21
DESCRIPTION Circuit 4 - Tango line	LOCATION Inside Terminal – Outside pump area <i>*Please refer Appendix 3 for detail location</i>
FINDING Corrosion was noted at contact area between piping and support, marked as locations 10 to 13 in ISO drawing. <i>*Please refer Appendix 2 for ½ remaining life calculation at pits area.</i>	RECOMMENDATIONS To lift the piping and perform surface preparation and follows by maintenance painting as per client's specification. Note:-Pits depth measurement at contact area between piping and support based on estimation due to inaccessible area.

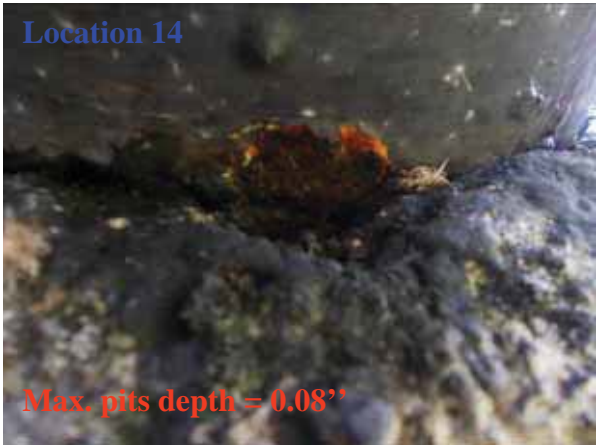
<p>Location 14</p>

<p>Max. pits depth = 0.08"</p>	<p>Location 15</p>

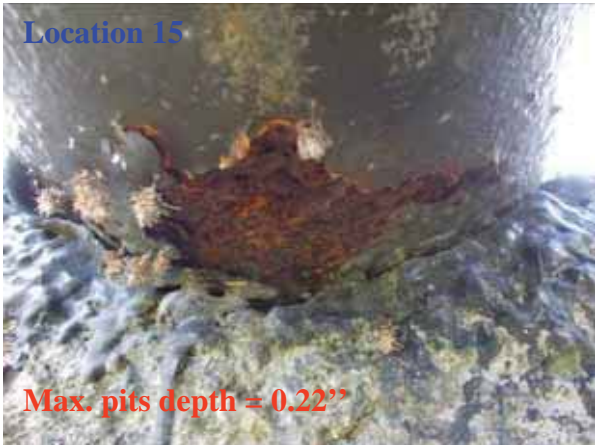
<p>Max. pits depth = 0.22"</p>
<p>Location 16</p>

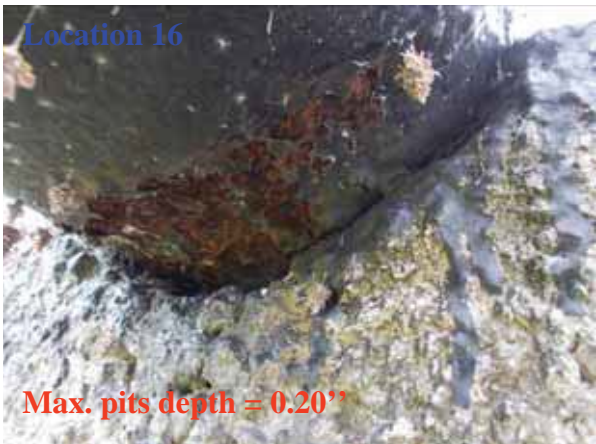
<p>Max. pits depth = 0.20"</p>	<p>Location 17</p>

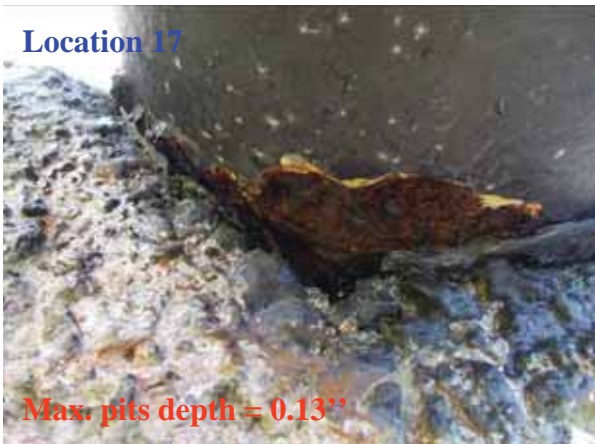
<p>Max. pits depth = 0.13"</p>
<p>LINE SERVICE</p>	<p>DRAWING REFERENCE</p>
<p>14" Residual Fuel Oil No. 6</p>	<p>ISO drawing no. 22</p>
<p>DESCRIPTION</p>	<p>LOCATION</p>
<p>Circuit 4 - Tango line</p>	<p>Inside Terminal – Outside pump area <i>*Please refer Appendix 3 for detail location</i></p>
<p>FINDING</p>	<p>RECOMMENDATIONS</p>
<p>Corrosion was noted at contact area between piping and support, marked as locations 14 to 17 in ISO drawing. <i>*Please refer Appendix 2 for ½ remaining life calculation at pits area.</i></p>	<p>To lift the piping and perform surface preparation and follows by maintenance painting as per client's specification for location 14 and consideration to perform permanent repair at location 15 to 17 with remove the corrosion, restore with weld metal deposited/insert weld patch, follow by NDE and re-painting as per client's specification. Note:-Pits depth measurement at contact area between piping and support based on estimation due to inaccessible area.</p>

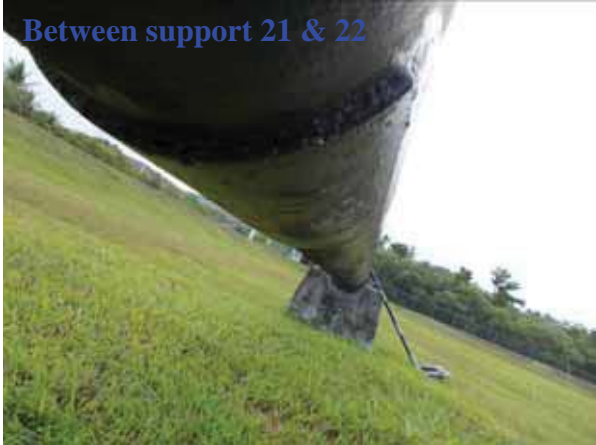
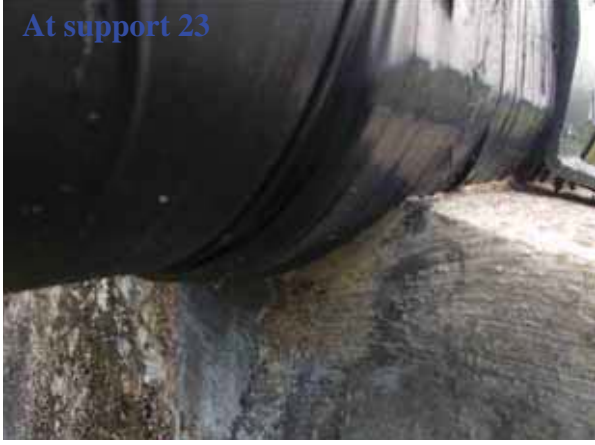
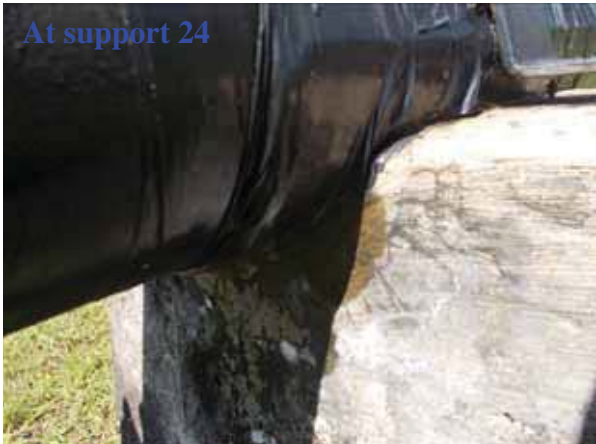
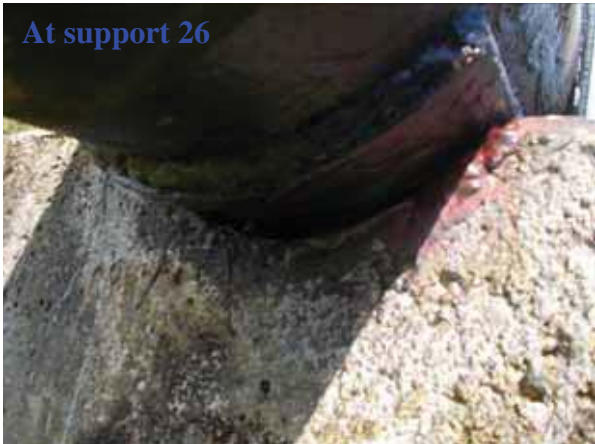
<p>LINE SERVICE</p> <p>14" Residual Fuel Oil No. 6</p>	<p>DRAWING REFERENCE</p> <p>ISO drawing no. 22</p>
<p>DESCRIPTION</p> <p>Circuit 4 - Tango line</p>	<p>LOCATION</p> <p>Inside Terminal – Outside pump area <i>*Please refer Appendix 3 for detail location</i></p>
<p>FINDING</p> <p>Temporary repair was noted at bottom section of piping. According to API 570 paragraph 8.1.4.1, <i>the design of temporary enclosures and repair shall be approved by piping engineer and temporary repairs should be removed and replaced with a suitable permanent repair at the next available maintenance opportunity.</i></p>	<p>RECOMMENDATIONS</p> <p>Consideration to perform permanent repair in accordance to API 570, restore with weld metal deposited/insert weld patch follows by NDE and painting as per client's specification.</p>

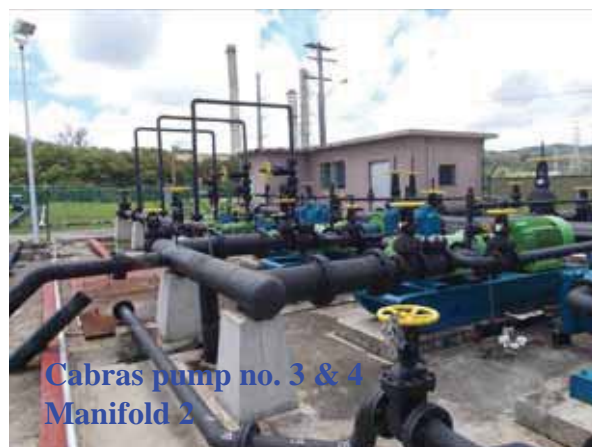
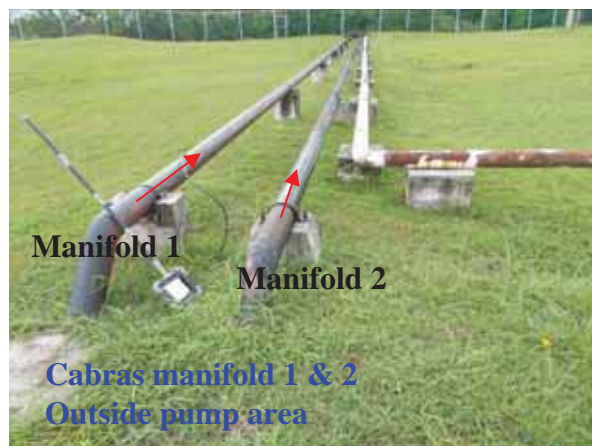
LINE SERVICE	DRAWING REFERENCE
Residual Fuel Oil No. 6	ISO drawing no. 24 to 26
DESCRIPTION	LOCATION
Circuit 5 – Cabras pump no. 1,2,3 & 4 discharge	Inside Terminal – Pump & outside pump area <i>*Please refer Appendix 3 for detail location</i>
FINDING	RECOMMENDATIONS
1. General view of 6" Cabras line outlet from C -1, C - 2 and C- 3 and C – 4 pumps. 2. Excessive in contact between piping and pedestal support at outside pump area.	1. Nil. 2. Consideration to modify existing support and to install rounded/angle bar or others material to give single contact point between piping and support. Single contact point is to prevent moisture or water sitting against the piping surface and promote to corrosion.

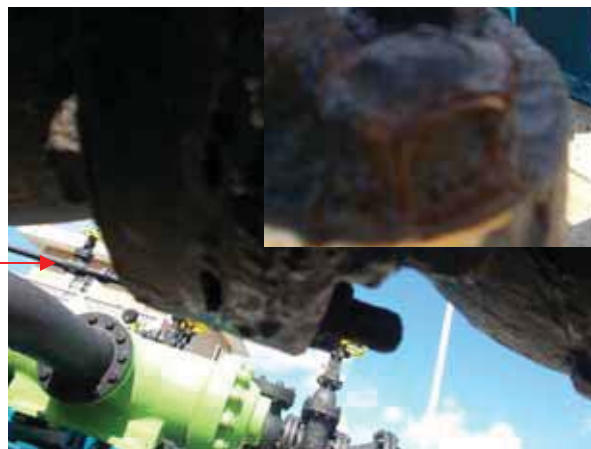
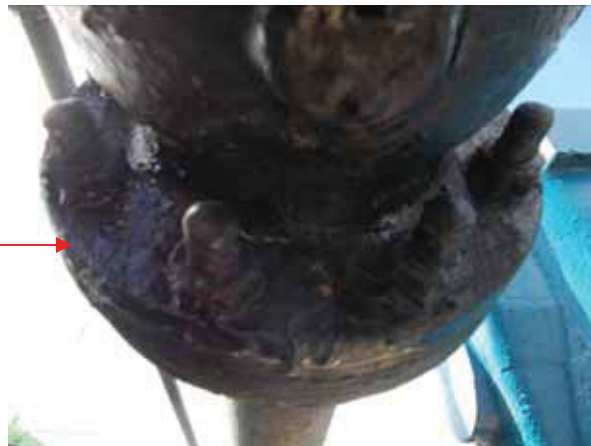
LINE SERVICE	DRAWING REFERENCE
4', 5" Residual Fuel Oil No. 6	ISO drawing no. 24
DESCRIPTION	LOCATION
Circuit 5 – Cabras Manifold 2	Inside Terminal – Pump area <i>*Please refer Appendix 3 for detail location</i>
FINDING	RECOMMENDATIONS
<ol style="list-style-type: none"> 1. Product stain sign of leak was noted on 4" and 5" valve (by pass line). 2. Stud bolts and nuts of the 5" valve was noted corroded. 	<ol style="list-style-type: none"> 1. Consideration to dismantle the valves to check for corrosion at raise face and replace with new gasket. 2. To replace the corroded stud bolts and nuts at the same material and specification.

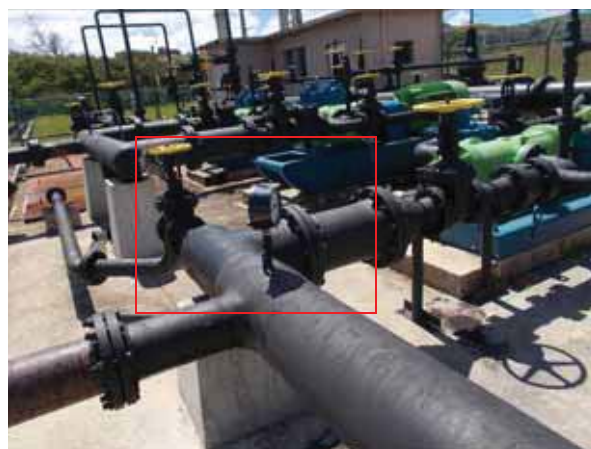
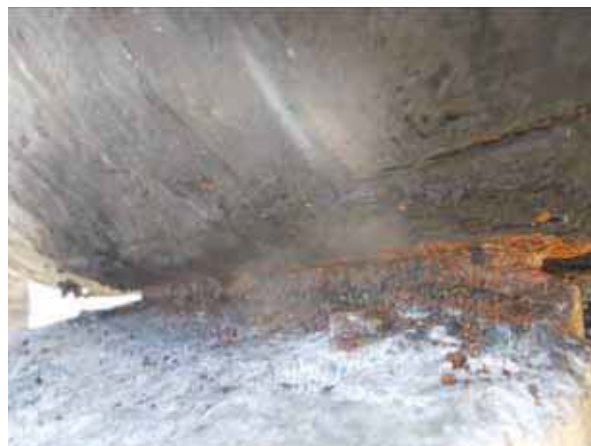
LINE SERVICE	DRAWING REFERENCE
10" Residual Fuel Oil No. 6	ISO drawing no. 24
DESCRIPTION	LOCATION
Circuit 5 – Cabras Manifold 1	Inside Terminal – Pump area <i>*Please refer Appendix 3 for detail location</i>
FINDING	RECOMMENDATIONS
<ol style="list-style-type: none"> 1. Small bore piping (gauge line) was noted without gusset plates. 2. Pipe support modification was noted at support 5 and 6 and surface rust was noted at the area. 	<ol style="list-style-type: none"> 1. To replace with longer stud bolts with the same material specification. 2. To install 2 gusset plates on the piping to strengthen the pressure line.

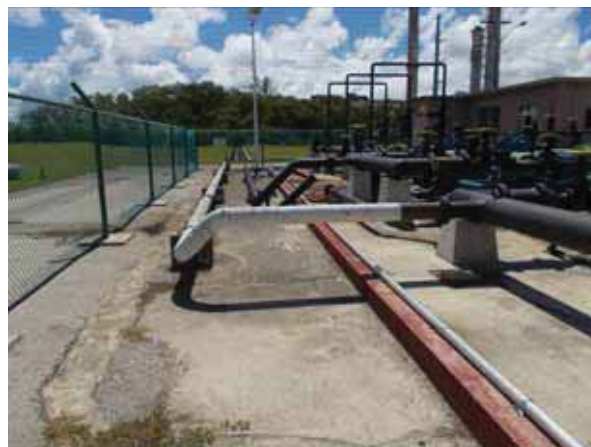
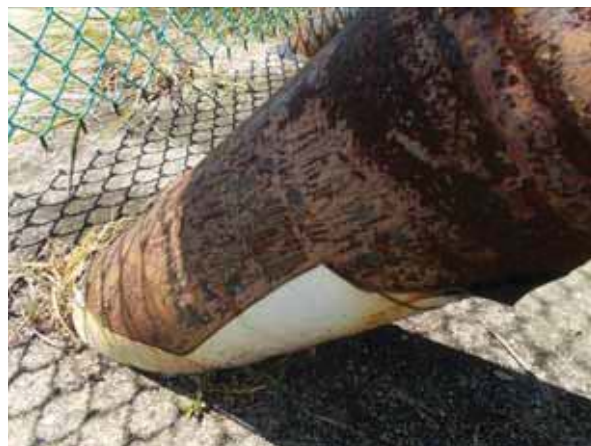
LINE SERVICE	DRAWING REFERENCE
4" & 6" Residual Fuel Oil No. 6	ISO drawing no. 25
DESCRIPTION	LOCATION
Circuit 5 – Cabras Manifold 1	Inside Terminal – Pump area <i>*Please refer Appendix 3 for detail location</i>
FINDING	RECOMMENDATIONS
<ol style="list-style-type: none"> 1. Wrapping tape was noted deteriorated at some locations and paint failure with surface rust was noted at the area. 2. Paint failure with surface was noted at soil to air interface Area. 	<ol style="list-style-type: none"> 1. To un-install the wrapping tape and perform surface preparation follows by maintenance painting as per client's specification. 2. To perform surface preparation and follows by maintenance painting as per client's specification.

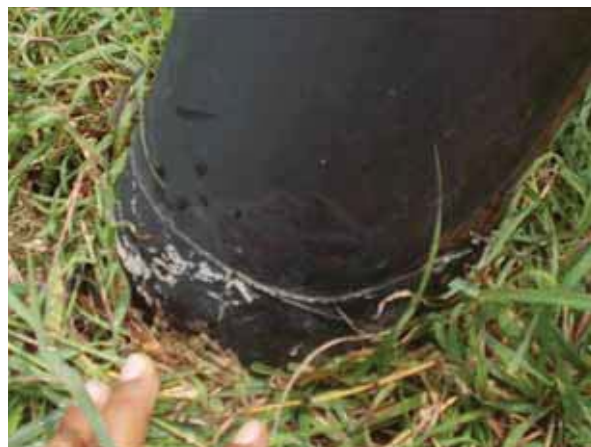
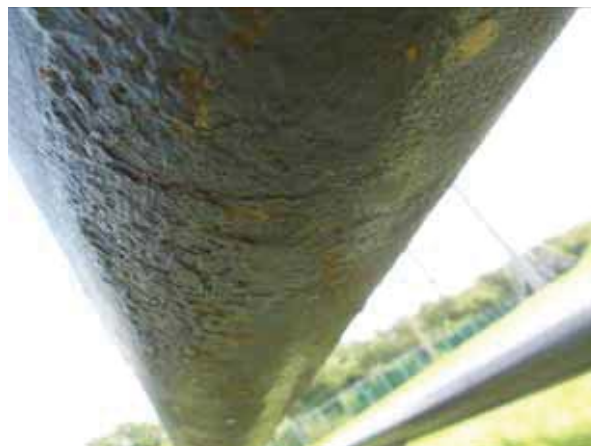
LINE SERVICE	DRAWING REFERENCE
6" Residual Fuel Oil No. 6	ISO drawing no. 26
DESCRIPTION	LOCATION
Circuit 5 – Cabras Manifold 1	Inside Terminal – Outside pump area <i>*Please refer Appendix 3 for detail location</i>
FINDING	RECOMMENDATIONS
<ol style="list-style-type: none"> 1. No sign of corrosion at soil to air interface area. 2. General corrosion with maximum pit depth below than 1mm was noted all along of piping. 	<ol style="list-style-type: none"> 1. Nil. 2. To perform surface preparation and follows by maintenance painting as per client's specification.

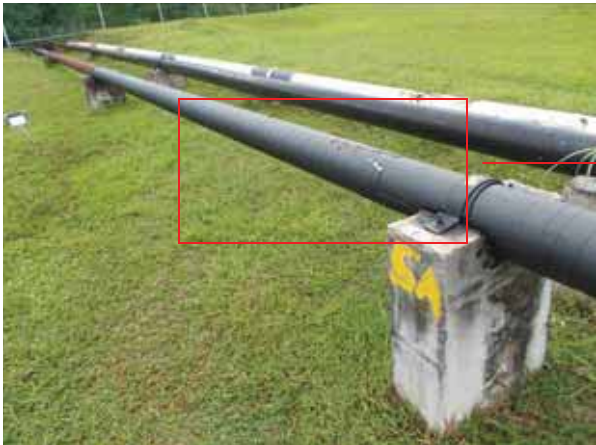
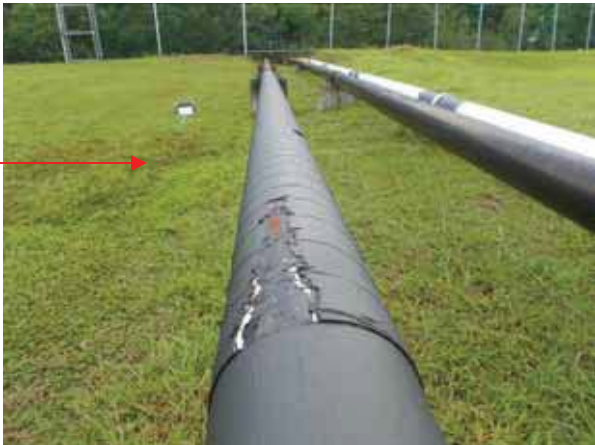
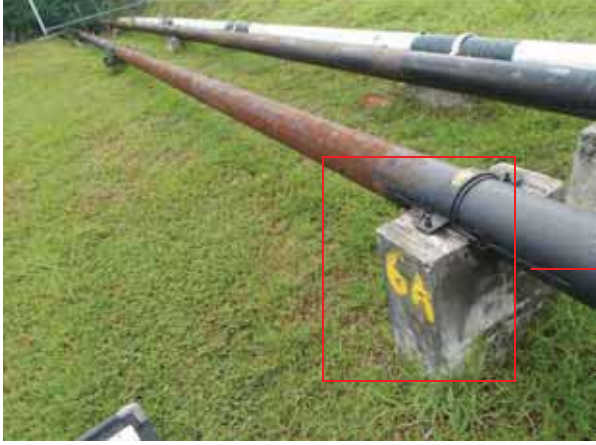
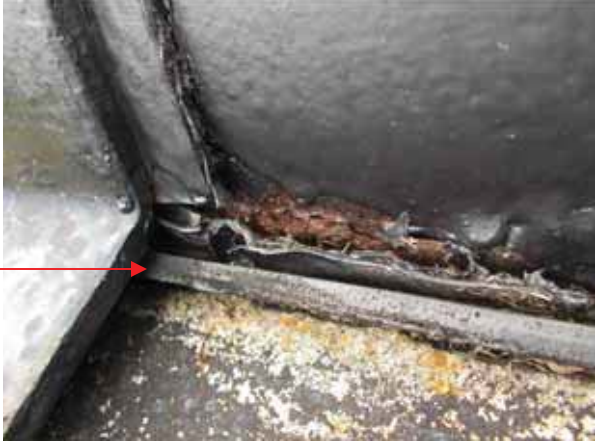
LINE SERVICE	DRAWING REFERENCE
6" Residual Fuel Oil No. 6	ISO drawing no. 26
DESCRIPTION	LOCATION
Circuit 5 – Cabras Manifold 1	Inside Terminal – Outside pump area <i>*Please refer Appendix 3 for detail location</i>
FINDING	RECOMMENDATIONS
Corrosion under wrapping with maximum pit depth below than 1mm due to wrap failure and gives a path to water ingress inside.	To un-install the wrapping tape and perform surface preparation follows by maintenance painting as per client's specification.

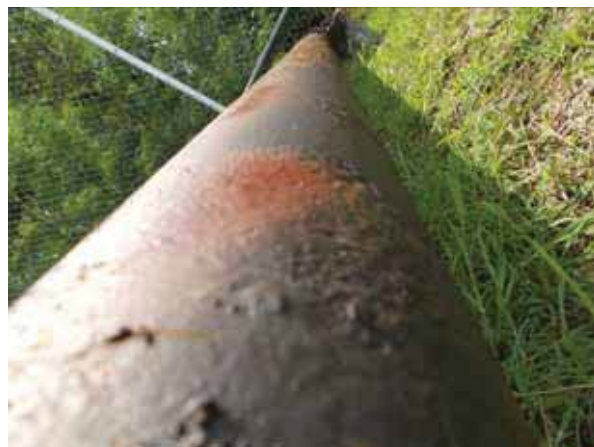
LINE SERVICE	DRAWING REFERENCE
6" Residual Fuel Oil No. 6	ISO drawing no. 26
DESCRIPTION	LOCATION
Circuit 5 – Cabras Manifold 1	Inside Terminal – Outside pump area <i>*Please refer Appendix 3 for detail location</i>
FINDING	RECOMMENDATIONS
General corrosion with maximum pit depth below than 1mm was noted all along of piping.	To perform surface preparation and follows by maintenance painting as per client's specification.
