3.0 GUIDED WAVE REPORT

3.1 24"RESIDUAL FUEL OIL (RFO)

Test ID: G4-214#2203	Result: Minor Concern
Pipe: 14" RFO (S0)	Ring: R2B14(1525)
Site: Outside Terminal	Config: 8.2FR, T(0,1)
Location: Weld bend -0.23m	Calibration: Automatic (2935.84 mV)
Size: 14 inch (6.35mm)	Version: 3.103, Wavemaker G4-214
	GPS: 13°27.4223'N, 144°40.9832'E
Tested: 12 Jun 2014 12:45	Client: Vital Energy
Tested by: Khairul Anuar Husain [SGS]	Procedure: WI-TM-065/Ver.00/27.04.2011
	DACs: Call=6%, Weld=23%

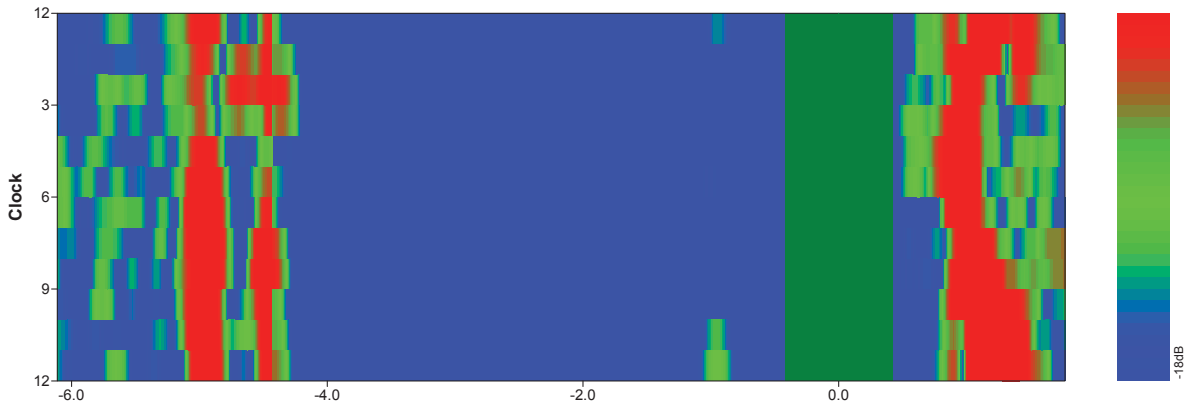
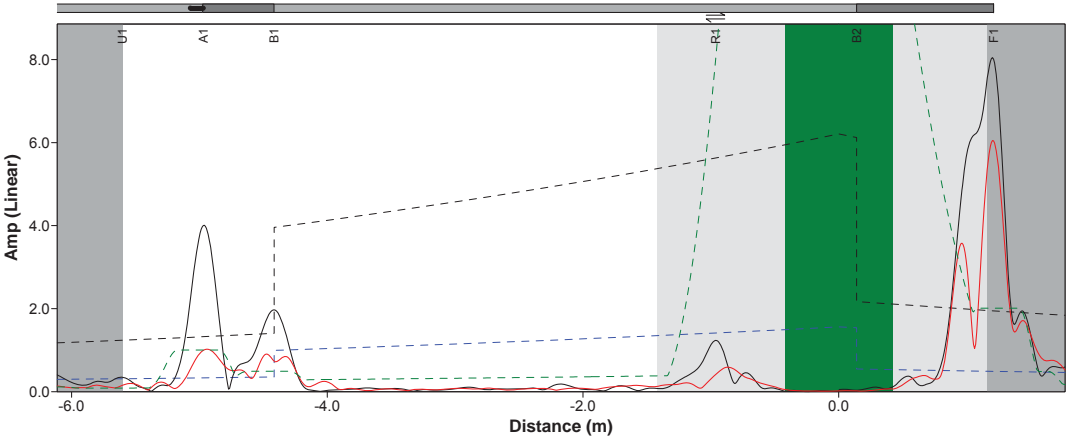
General Notes: 14" RFO-No.6 - Test Point No.: S0
 Positive direction with product flow.
 Found external localize corrosion at 6H00 closed to the bend weld.(refer class, note and location as table below).
 Location of signals measuring from center of ring.
 Thickness at ring position are (12 o'clock:6.70 mm), (3 o'clock:6.56 mm), (6 o'clock:6.42 mm), (9 o'clock: 6.29 mm)

Feature	Location	ECL	Length	Extent	Class	Notes
A1	-4.96	60	0.1	70	Minor	Visually confirm external corrosion closed to weld bend at 6H00 with max. pit depth is 0.06"@ 1.5 mm. UT reading adjacent to pit is 6.52 mm. Remaining wall thickness is 5.02 mm (23.0% wall loss)
R1	-0.96	-	0	60	Trailing Echoes	False echo
B1	-4.41	-	0	50	45 deg Bend	
B2	0.14	-	0	60	1D Bend	Datum of screening
F1	1.21	-	0	25	Flange	
U1	-5.6	-	~		End

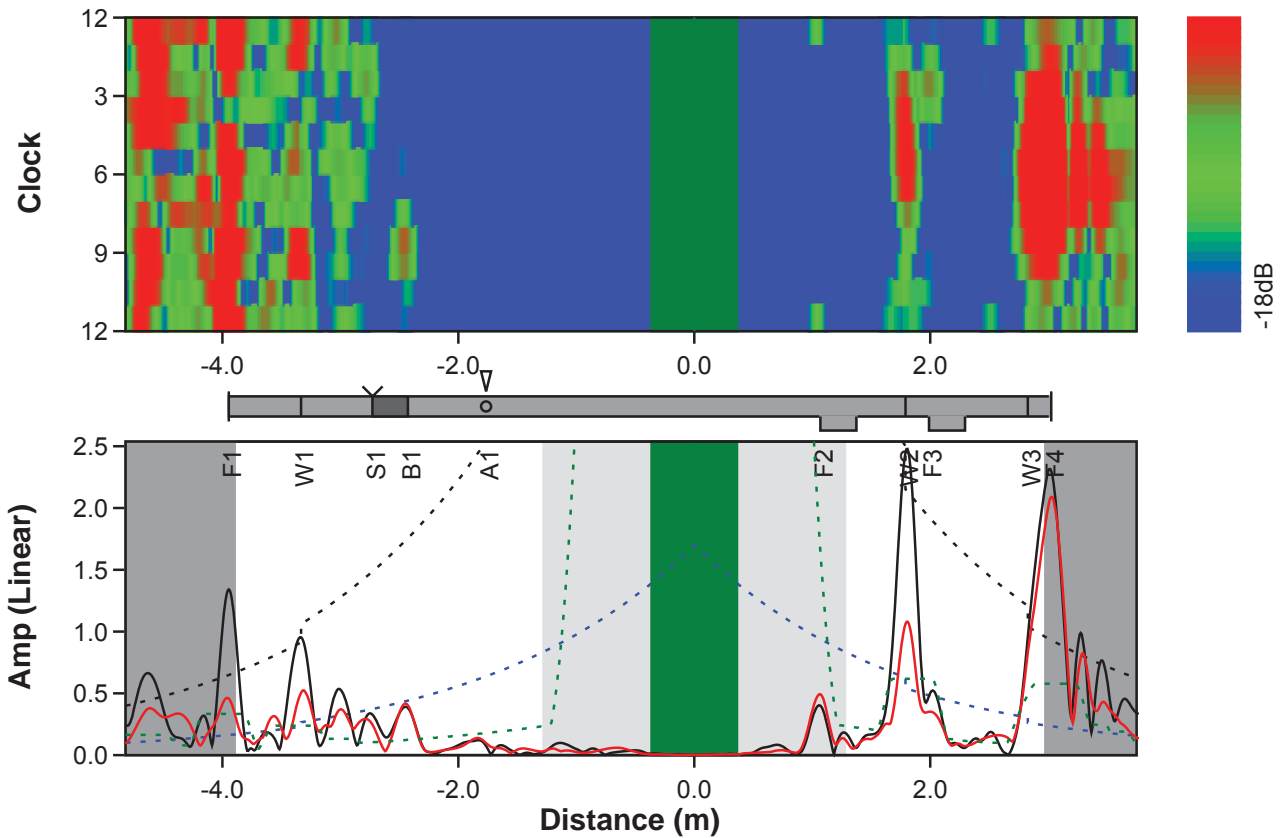
General Notes: 24" RFO No.6 - Test Point No.: S1
Positive direction with product flow.
No corrosion above the reporting level observed in the tested section of the pipe and found satisfactory.
(refer class, note and location as table below).
Location of signals measuring from center of ring.
Thickness at ring position are (12 o'clock:9.20 mm), (3 o'clock:9.15 mm), (6 o'clock:9.20 mm), (9 o'clock: 9.15 mm)

Feature	Location	ECL	Length	Extent	Class	Notes
F1	-3.94	-	0	70	Flange	
W1	-3.33	-	0	45	Weld	
S1	-2.72	-	0	13	Reducer	24"x16"
B1	-2.42	-	0.3	0	Bend	
A1	-1.76	1	0	0	Anomaly	UT confirm, no significant finding (minimum thickness is 9.03 mm)
F2	1.06	-	0	0	Branch	
W2	1.79	20	0	60	Weld	Datum of screening
F3	1.99	-	0	40	Branch	
W3	2.82	-	0	18	Weld	
F4	3.02	-	0	10	Flange

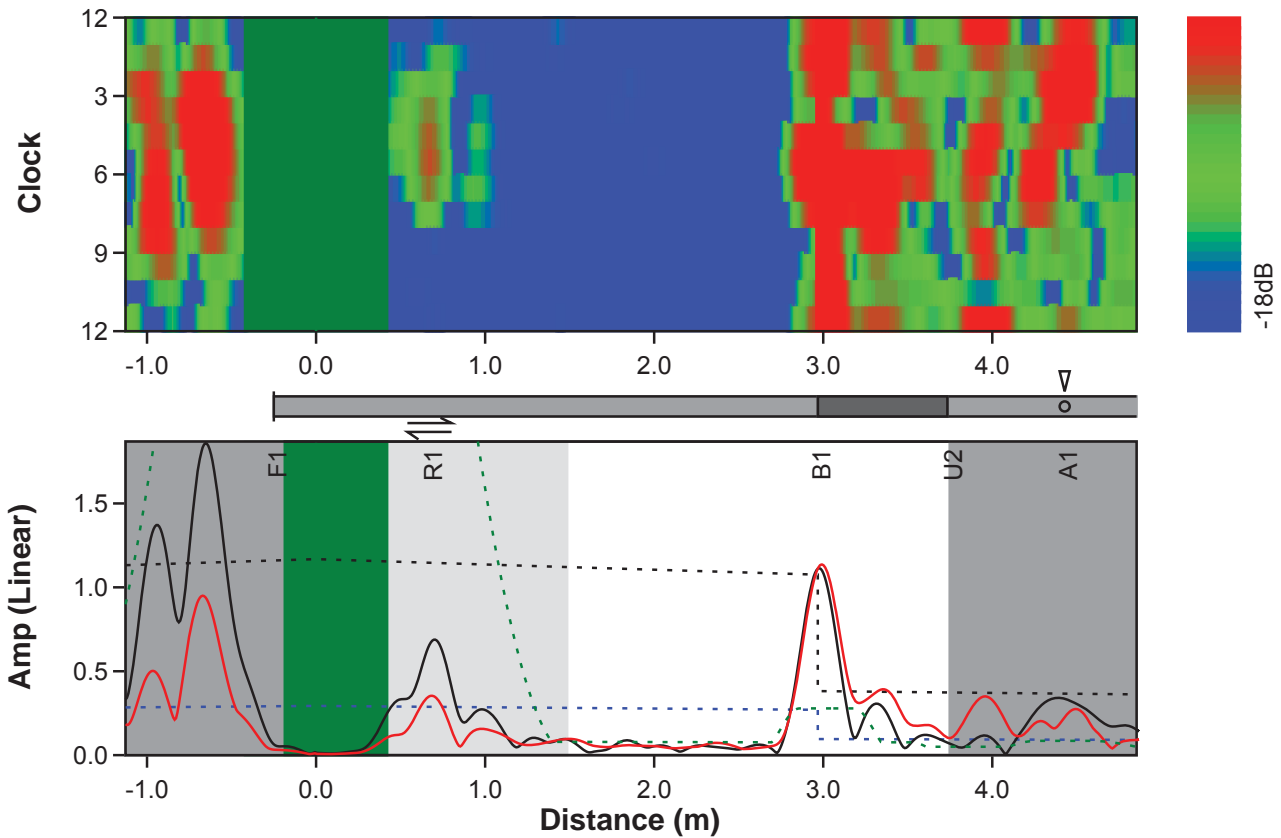
General Notes: 24" RFO No.6 - Test Point No.: S2
Positive direction with product flow.
No corrosion above the reporting level observed in the tested section of the pipe and found satisfactory.
(refer class, note and location as table below).
Location of signals measuring from center of ring.
Thickness at ring position are (12 o'clock:9.15 mm), (3 o'clock:9.07 mm), (6 o'clock:9.20 mm), (9 o'clock: 9.07 mm)

Feature	Location	ECL	Length	Extent	Class	Notes
F1	-0.25	-	0	60	Flange	Datum of screening
R1	0.67	-	0	50	False Echo	Mirror signal
B1	2.96	-	0	0	45 deg Bend	
U2	3.74	-	~		End	
A1	4.42	20	0	20	Anomaly

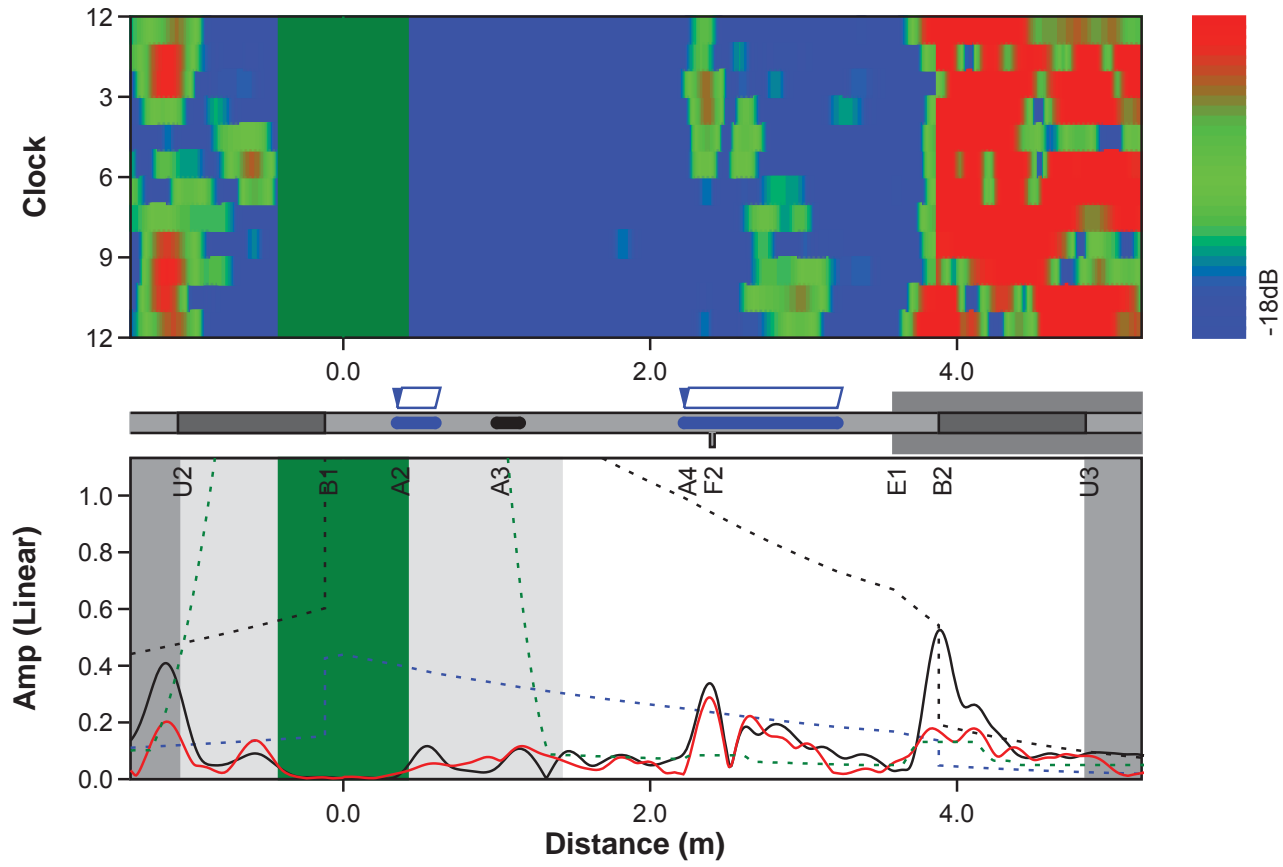
General Notes: 24" RFO-No.6 - Test Point No.: STA 1
 Positive direction with product flow.
 Found general external corrosion at several location. (refer class, note and location as table below).
 Location of signals measuring from center of ring.
 Thickness at ring position are (12 o'clock:9.28 mm), (3 o'clock:9.23 mm),
 (6 o'clock:9.35 mm), (9 o'clock: 9.27 mm)

Feature	Location	ECL	Length	Extent	Class	Notes
F1	-4.28	-	0	60	Flange	
U2	-1.07	-	~		End	
A1	-3.77	35	0	0	Anomaly	UT confirm no significant finding. Minimum remaining thickness is 9.25 mm.
B1	-0.12	-	0	15	45 deg Bend	Datum of screening
A2	0.35	1	0.25	30	Medium	Visually confirm external corrosion on the entire section with max. pit depth is 0.11"@ 2.8 mm. UT reading adjacent to pit is 9.28 mm. Remaining wall thickness is 6.48 mm (30.2% wall loss)
A3	1	1	0.15	0	Minor	Visually confirm external corrosion at 3H00 with max. pit depth is 0.08"@ 2.0 mm. UT reading adjacent to pit is 9.57 mm. Remaining wall thickness is 7.57 mm (20.9% wall loss)
A4	2.22	4	1	30	Medium	Visually confirm external corrosion on the entire section with max. pit depth is 0.14"@ 3.5 mm. UT reading adjacent to pit is 9.30 mm. Remaining wall thickness is 5.80 mm (37.6% wall loss)
F2	2.39	-	0	15	Drain	
E1	3.58	-	~	0	Earth	Underground
B2	3.88	-	0	70	45 deg Bend

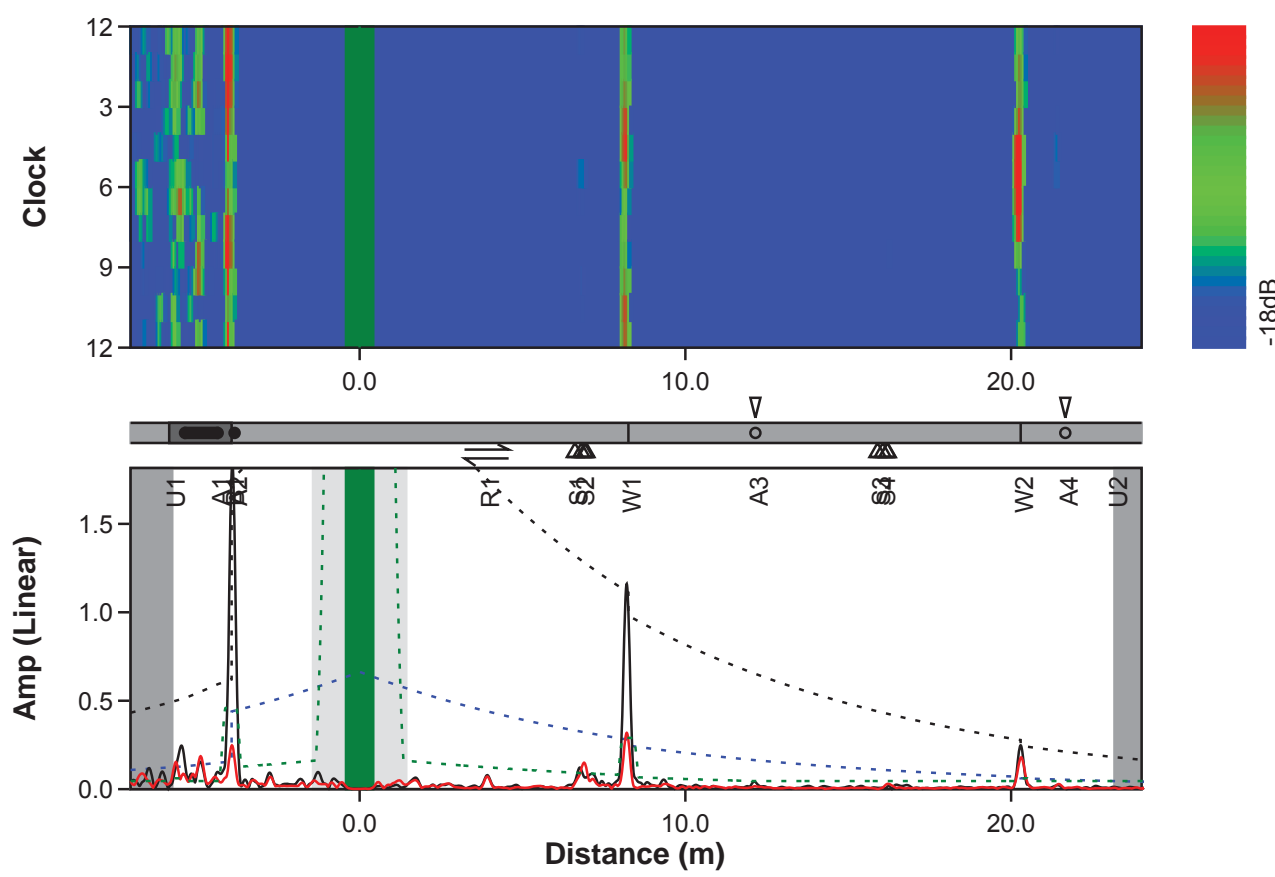
General Notes: 24" RFO-No.6 - Test Point No.: S3
Positive direction with product flow.
Found external corrosion closed to soil to air interface (refer class, note and location as table below).
Location of signals measuring from center of ring.
Thickness at ring position are (12 o'clock:9.35 mm), (3 o'clock:9.32 mm), (6 o'clock:9.41 mm), (9 o'clock:9.36 mm)

Feature	Location	ECL	Length	Extent	Class	Notes
U1	-5.75	-	~		End	
A1	-4.35	4	1	30	Minor	General corrosion at 12 and 6H00 with less than 0.5 mm depth.
B1	-3.93	-	0	90	1D Bend	Datum of screening
A2	-3.83	25	0	90	Minor	Visually confirm external corrosion at 6H00 with max. pit depth is 0.05" @ 1.3 mm. UT reading adjacent to pit is 9.35 mm. Remaining wall thickness is 8.05 mm (13.9% wall loss)
R1	3.89	-	0	10	Mirror	
S1	6.61	-	0.3	25	Support	
S2	6.81	-	0.15	0	Clamp	
W1	8.25	25	0	70	Weld	
A3	12.15	2	0	60	Anomaly	UT confirm, no significant finding (minimum thickness is 9.25 mm)
S3	15.89	-	0.3	40	Support	
S4	16.05	-	0.15	25	Clamp	
W2	20.29	-	0	25	Weld	
A4	21.66	2	0	0	Anomaly	UT confirm, no significant finding (minimum thickness is 9.25 mm)
U2	23.17	-	~		End	
S5	26.02	-	0.3	30	Support	
S6	26.15	-	0.15	0	Clamp

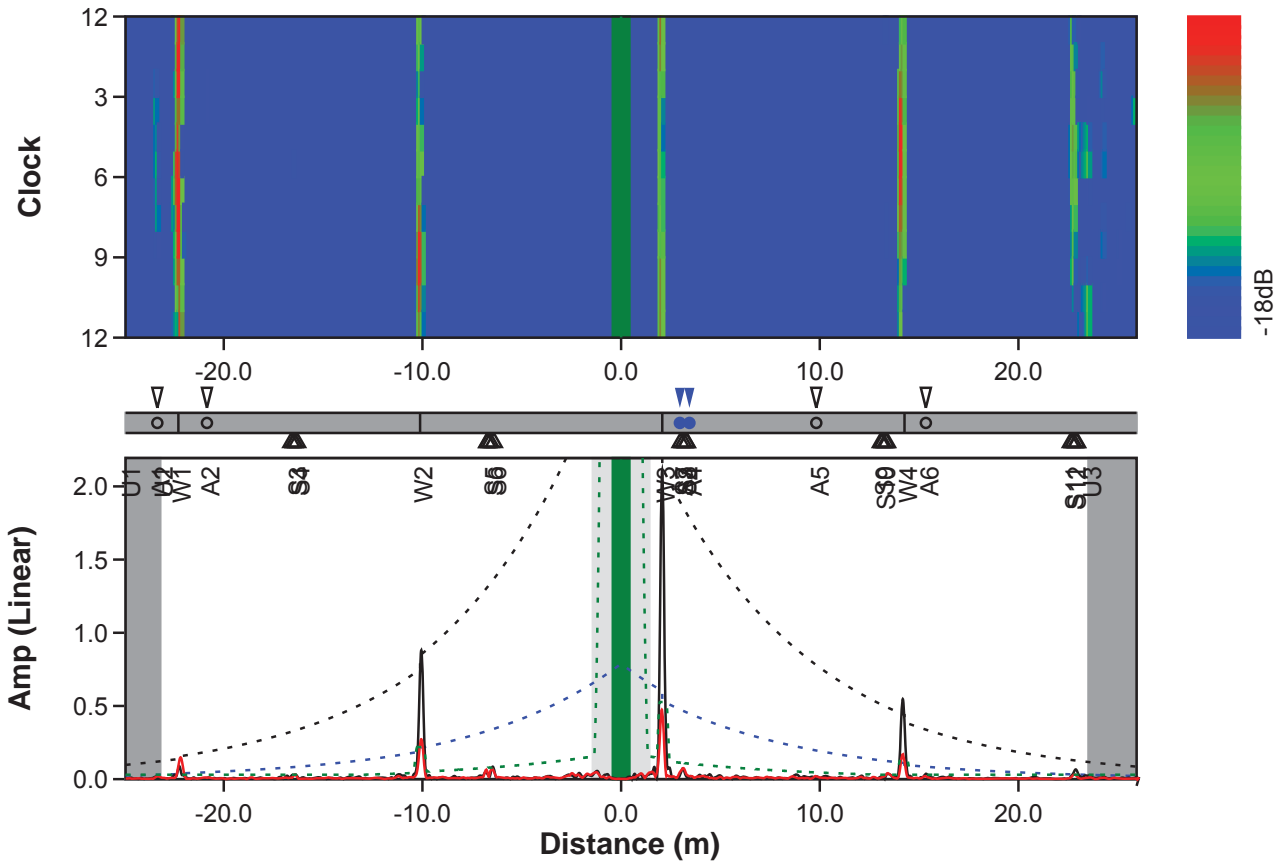
General Notes: 24" RFO-No.6 - Test Point No.: S4
 Positive direction with product flow.
 Found external localized corrosion closed to the pipe support (refer class, note and location as table below).
 Location of signals measuring from center of ring.
 Thickness at ring position are (12 o'clock:9.27 mm), (3 o'clock:9.38 mm), (6 o'clock:9.35 mm), (9 o'clock:9.32 mm)

Feature	Location	ECL	Length	Extent	Class	Notes
S1	-26.13	-	0.15	40	Clamp	
S2	-26	-	0.3	45	Support	
U1	-24.84	-	~		End	
A1	-23.34	4	0	0	Anomaly	UT confirm, no significant finding (minimum thickness is 9.30 mm)
U2	-23.19	-	~		End	
W1	-22.28	-	0	0	Weld	
A2	-20.84	1	0	4	Anomaly	UT confirm, no significant finding (minimum thickness is 9.25 mm)
S3	-16.44	-	0.15	3	Clamp	
S4	-16.31	-	0.15	12	Support	
W2	-10.11	25	0	70	Weld	
S5	-6.58	-	0.15	0	Clamp	
S6	-6.41	-	0.3	20	Saddle	
W3	2.07	20	0	80	Weld	Datum of screening
A3	2.95	1	0	0	Medium	Visually confirm external corrosion at 6H00 with max. pit depth is 0.10"@ 2.5 mm. UT reading adjacent to pit is 9.35 mm. Remaining wall thickness is 6.85 mm (26.7% wall loss)
S7	3	-	0.3	0	Support	
S8	3.14	-	0.15	0	Clamp	
A4	3.43	0	0	0	Medium	Visually confirm external corrosion at 6H00 with max. pit depth is 0.10"@ 2.5 mm. UT reading adjacent to pit is 9.35 mm. Remaining wall thickness is 6.85mm (26.7% wall loss)

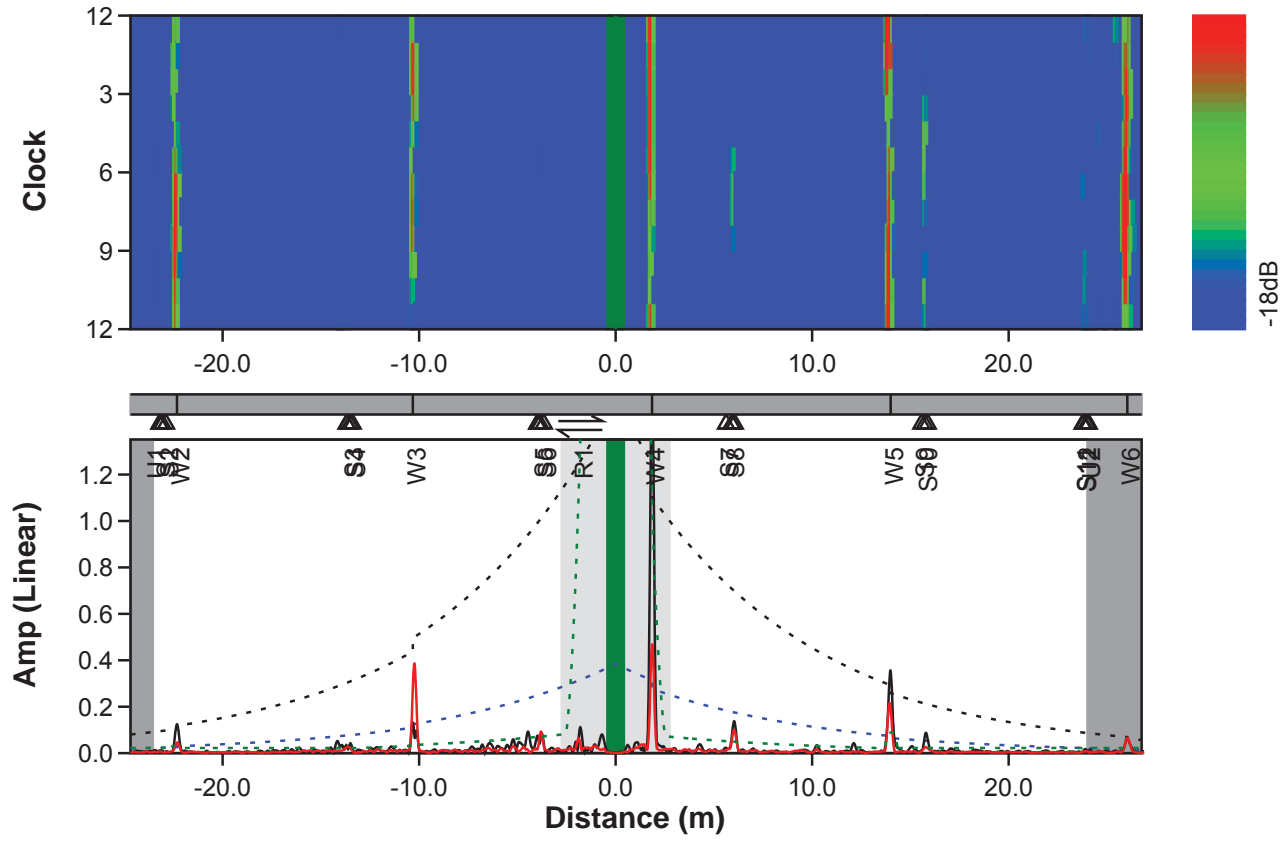
General Notes: 24" RFO No.6 - Test Point No.: S5
Positive direction with product flow.
No corrosion above the reporting level observed in the tested section of the pipe and found satisfactory.
(refer class, note and location as table below).
Location of signals measuring from center of ring.
Thickness at ring position are (12 o'clock:9.25 mm), (3 o'clock:9.27 mm), (6 o'clock:9.31 mm), (9 o'clock: 9.19 mm)

Feature	Location	ECL	Length	Extent	Class	Notes
W1	-34.4	-	0	35	Weld	
U1	-23.55	-	~		End	
S1	-23.06	-	0.15	50	Clamp	
S2	-22.88	-	0.3	45	Support	
W2	-22.32	25	0	60	Weld	
S3	-13.5	-	0.15	40	Clamp	
S4	-13.38	-	0.3	60	Support	
W3	-10.31	6	0	0	Weld	
S5	-3.83	-	0.15	0	Clamp	
S6	-3.65	-	0.3	16	Support	
R1	-1.79	-	0	45	Mirror	False echo
W4	1.85	30	0	70	Weld	Datum of screening
S7	5.62	-	0.3	35	Support	
S8	5.91	-	0.15	25	Clamp	
W5	13.99	25	0	40	Weld	
S9	15.56	-	0	9	Support	
S10	15.72	-	0.15	70	Clamp	
S11	23.77	-	0.3	40	Support	
S12	23.82	-	0.15	50	Clamp	
U2	24.01	-	~		End	
W6	26.04	-	0	0	Weld

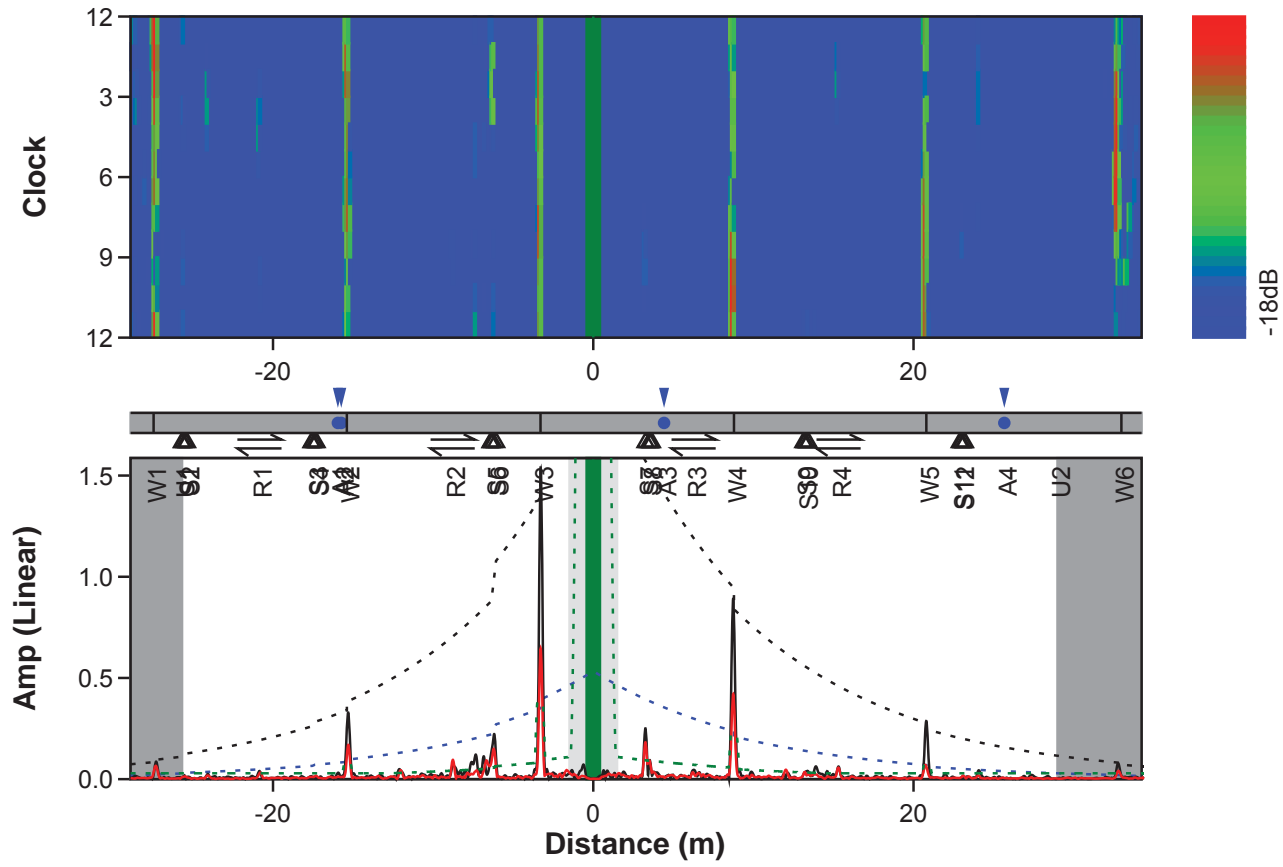
General Notes: 24" RFO-No.6 - Test Point No.: S6
 Positive direction with product flow.
 Found external localized corrosion at several corrosion (refer class, note and location as table below).
 Location of signals measuring from center of ring.
 Thickness at ring position are (12 o'clock:9.27 mm), (3 o'clock:9.26 mm), (6 o'clock:9.32 mm), (9 o'clock:9.28 mm)

Feature	Location	ECL	Length	Extent	Class	Notes
W1	-27.45	-	0	25	Weld	
U1	-25.68	-	~		End	
S1	-25.48	-	0.15	25	Clamp	
S2	-25.38	-	0.3	35	Support	
R1	-20.84	-	0	18	Mirror	False echo
S3	-17.39	-	0.15	0	Clamp	
S4	-17.29	-	0.3	0	Support	
A1	-15.95	2	0	60	Medium	Visually confirm external corrosion at 2H00 with max. pit depth is 0.10"@ 2.5 mm. UT reading adjacent to pit is 9.14 mm. Remaining wall thickness is 6.64 mm (27.4% wall loss)
A2	-15.74	1	0	30	Medium	Visually confirm external corrosion at 6H00 with max. pit depth is 0.10"@ 2.5 mm. UT reading adjacent to pit is 9.10 mm. Remaining wall thickness is 6.60 mm (27.5% wall loss)
W2	-15.38	20	0	50	Weld	
R2	-8.78	-	0	0	Mirror	False echo
S5	-6.25	-	0.15	35	Clamp	
S6	-6.07	-	0.3	50	Support	
W3	-3.29	-	0	60	Weld	Datum of screening
S7	3.27	-	0.3	25	Support	
S8	3.5	-	0.15	1	Clamp	
A3	4.42	0	0	0	Medium	Visually confirm isolated corrosion at 6H00 with max. pit depth is 0.12"@ 3.0 mm. UT reading adjacent to pit is 9.13 mm. Remaining wall thickness is 6.13 mm (32.9% wall loss)

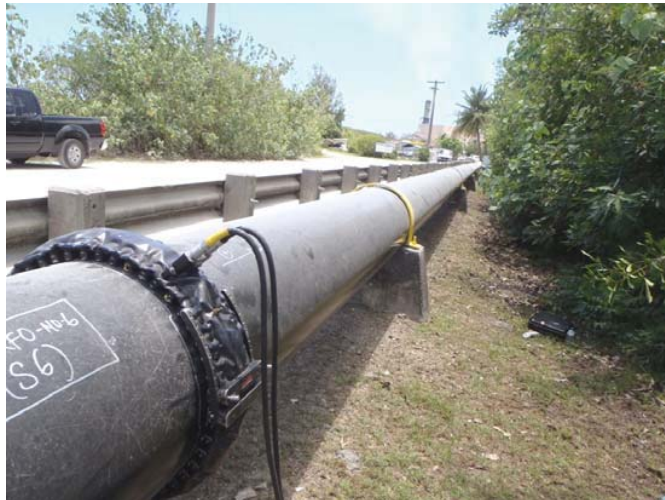
Positive direction

Feature	Location	ECL	Length	Extent	Class	Notes
W4	8.78	20	0	50	Weld	
S9	13.13	-	0.3	0	Support	
S10	13.23	-	0.15	0	Clamp	
R4	15.31	-	0	9	Mirror	False echo
W5	20.8	-	0	80	Weld	
S11	22.9	-	0.3	0	Support	
S12	23	-	0.15	0	Clamp	
A4	25.67	1	0	4	Medium	Visually confirm external corrosion at 6H00 with max. pit depth is 0.10" @ 2.5 mm. UT reading adjacent to pit is 9.27 mm. Remaining wall thickness is 6.77 mm (26.9% wall loss)
U2	28.99	-	~		End	
W6	32.98	-	0	50	Weld

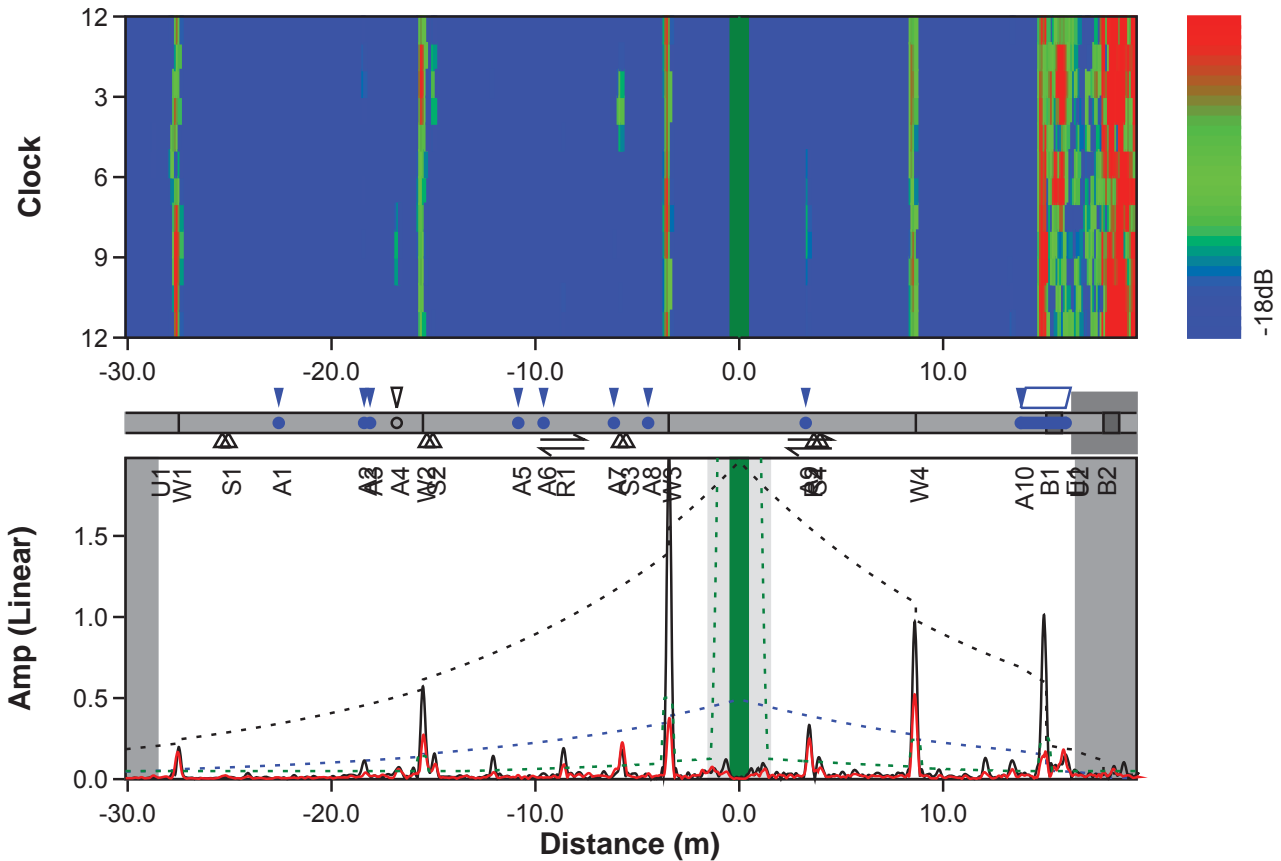
General Notes: 24" RFO-No.6 - Test Point No.: S7
 Positive direction with product flow.
 Found external corrosion at several corrosion (refer class, note and location as table below).
 Location of signals measuring from center of ring.
 Thickness at ring position are (12 o'clock:9.25 mm), (3 o'clock:9.24 mm), (6 o'clock:9.31 mm), (9 o'clock:9.28 mm)

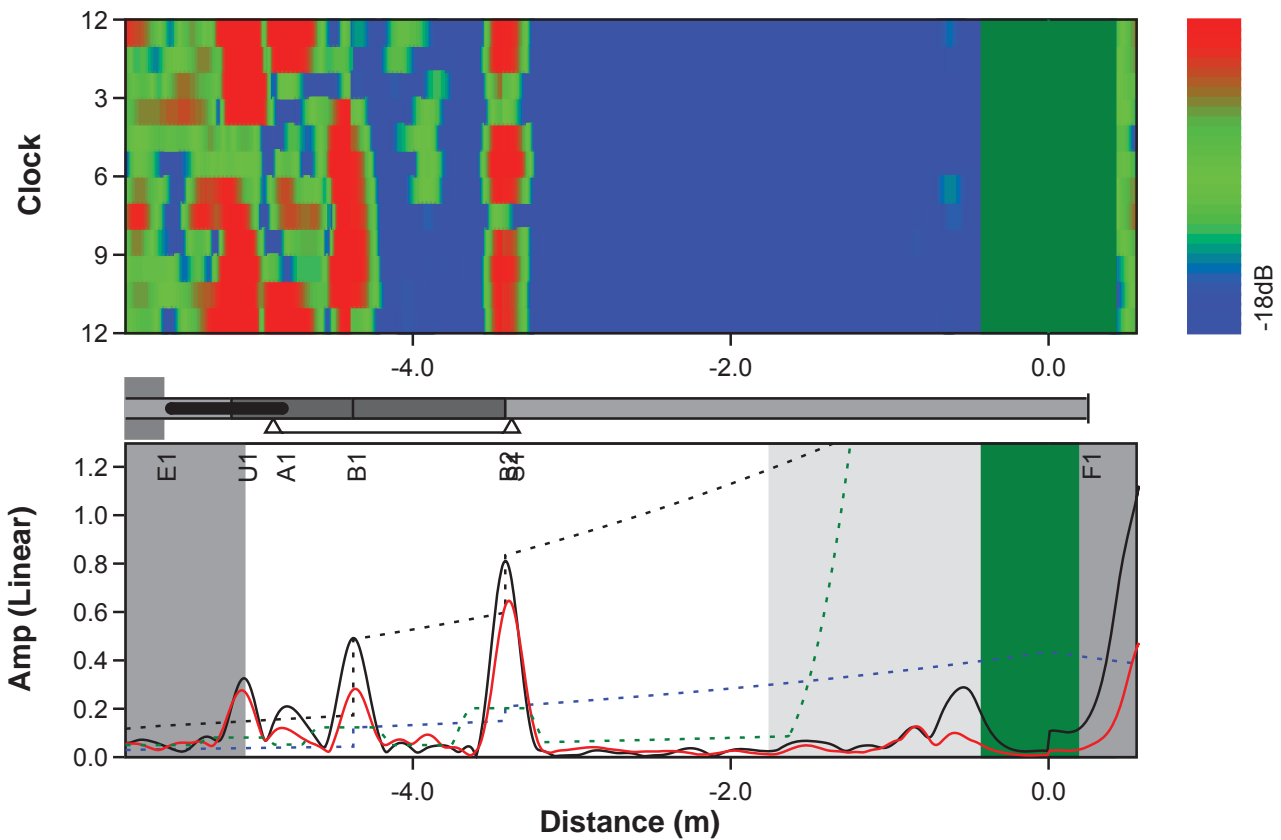
General Notes: 24" RFO-No.6 - Test Point No.: S8
Positive direction with product flow.
Found scattered external corrosion at soil to air interface closed to the pipe support.
(refer class, note and location as table below).
Location of signals measuring from center of ring.
Thickness at ring position are (12 o'clock:9.31 mm), (3 o'clock:9.41 mm),
(6 o'clock:9.27 mm), (9 o'clock: 9.41 mm)

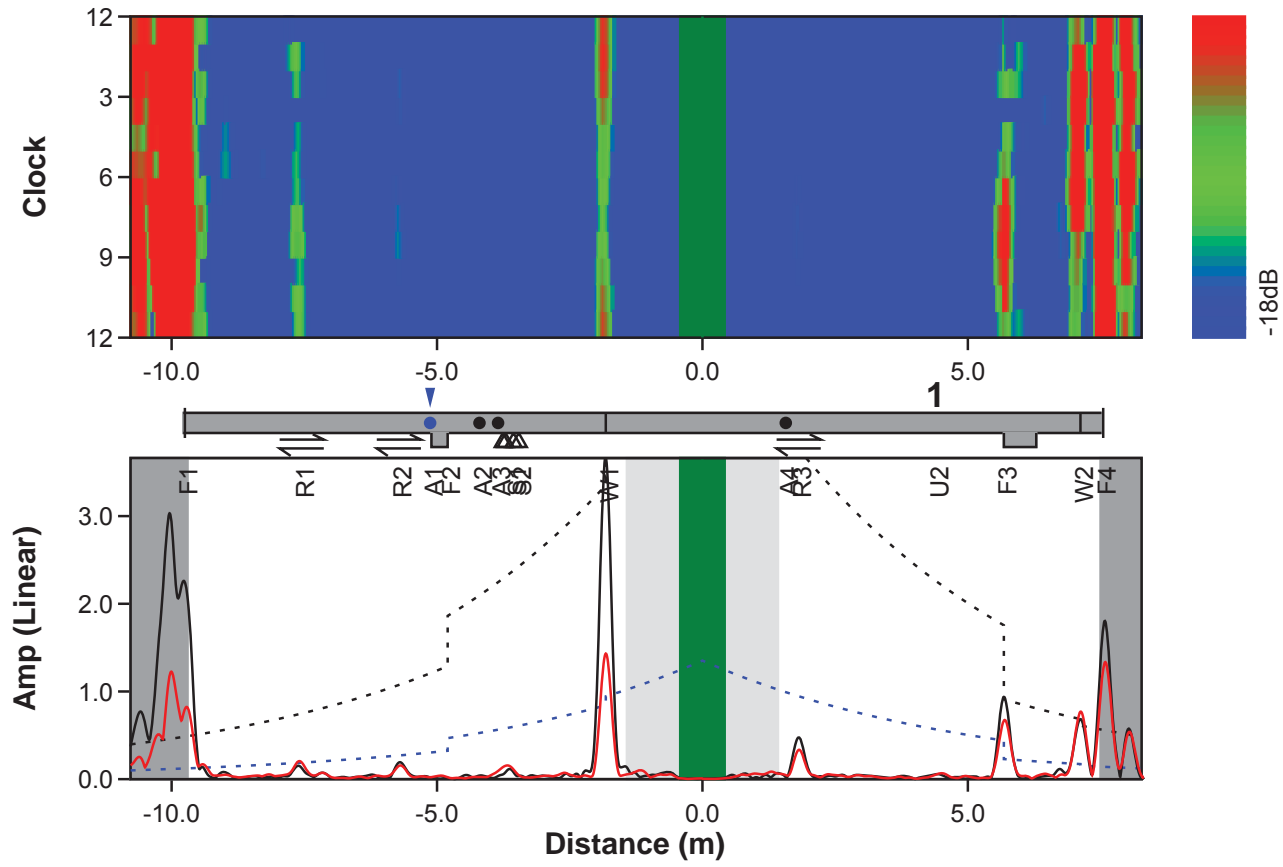
General Notes: 24" RFO-No.6 - Test Point No.: S9
 Positive direction with product flow.
 Found external localize corrosion at several location (refer class, note and location as table below).
 Location of signals measuring from center of ring.
 Thickness at ring position are (12 o'clock:9.51 mm), (3 o'clock:9.49 mm), (6 o'clock:9.48 mm), (9 o'clock: 9.40 mm)

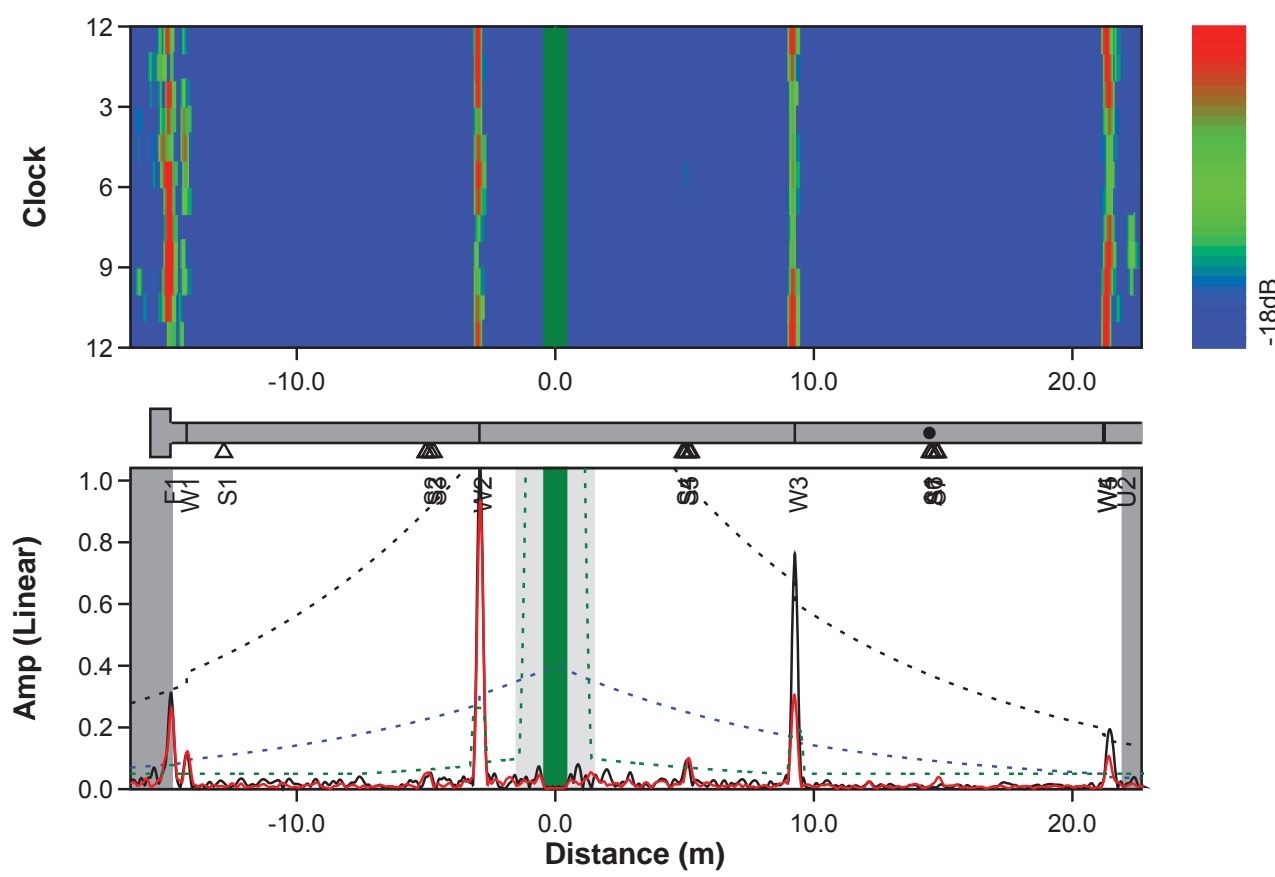
General Notes: 24" RFO-No.6 - Test Point No.: S10
Positive direction with product flow.
Found external localize corrosion close to the pipe support (refer class, note and location as table below).
Location of signals measuring from center of ring.
Thickness at ring position are (12 o'clock:9.58 mm), (3 o'clock:9.57 mm), (6 o'clock:9.49 mm), (9 o'clock: 9.25 mm)

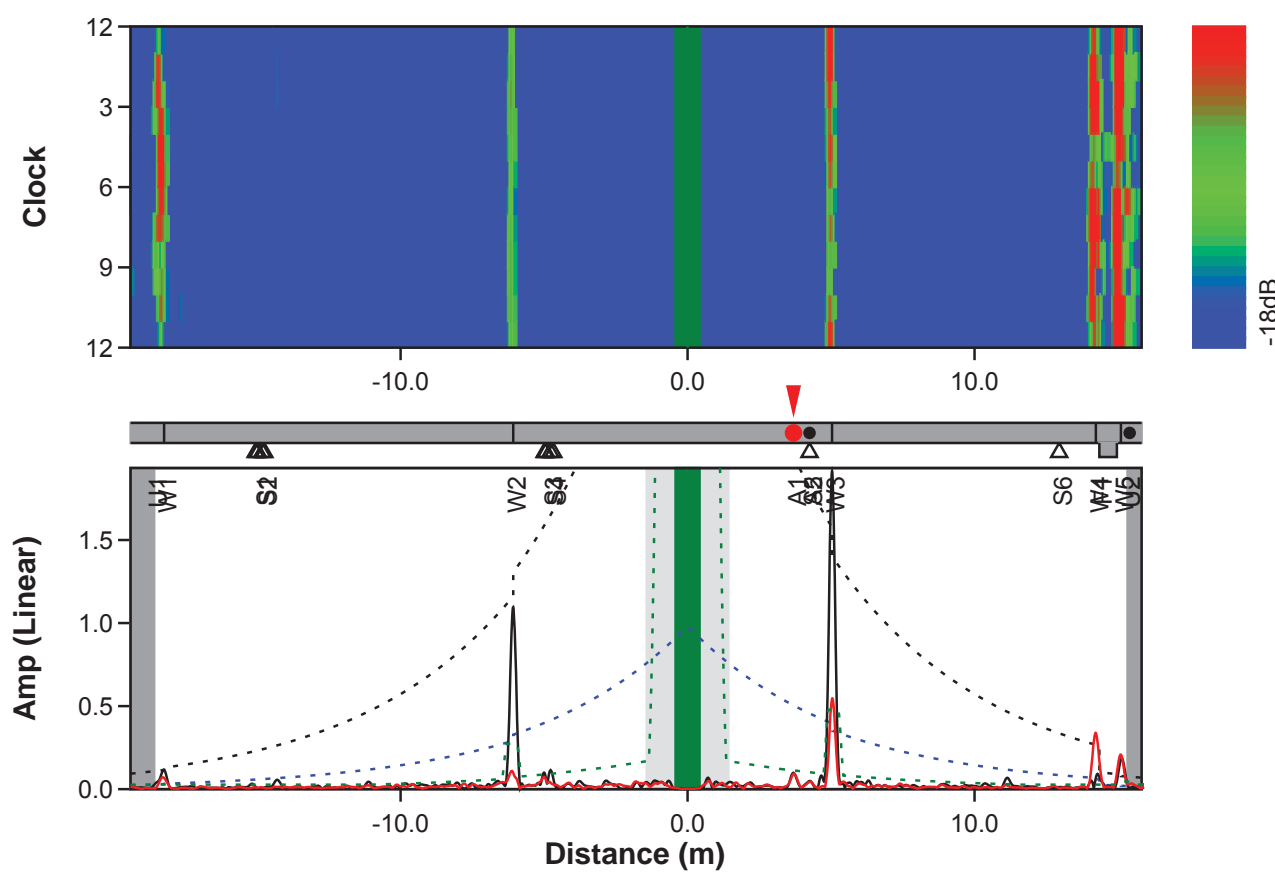
General Notes: 24" RFO-No.6 - Test Point No.: S11
Positive direction with product flow.
Found external localize corrosion at several location (refer class, note and location as table below).
Location of signals measuring from center of ring.
Thickness at ring position are (12 o'clock:9.23 mm), (3 o'clock:9.21 mm), (6 o'clock:9.60 mm), (9 o'clock: 9.60 mm)

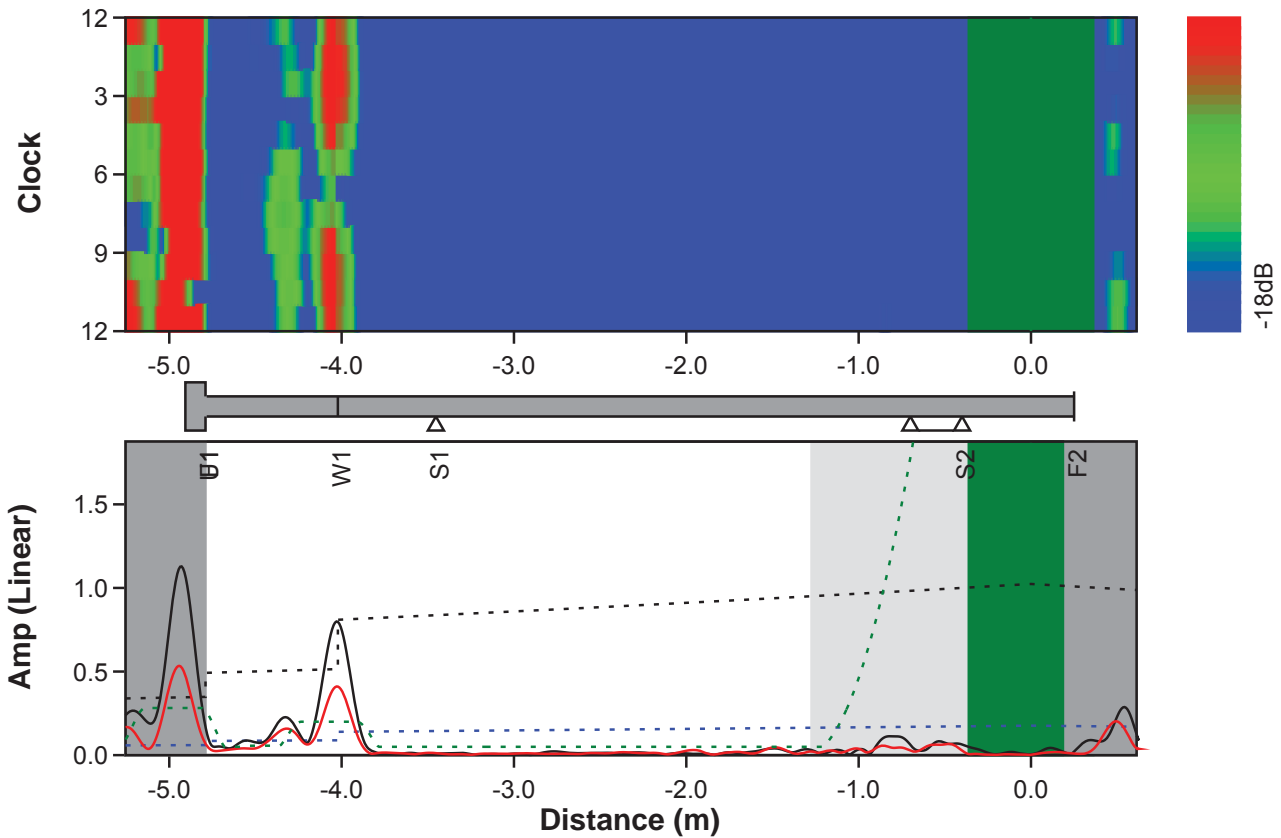
General Notes: 24" RFO-No.6 - Test Point No.: S12
Positive direction with product flow.
No corrosion above the reporting level observed in the tested section of the pipe and found satisfactory.
(refer class, note and location as table below).
Location of signals measuring from center of ring.
Thickness at ring position are (12 o'clock:9.62 mm), (3 o'clock:9.34 mm), (6 o'clock:9.61 mm), (9 o'clock: 9.46 mm)

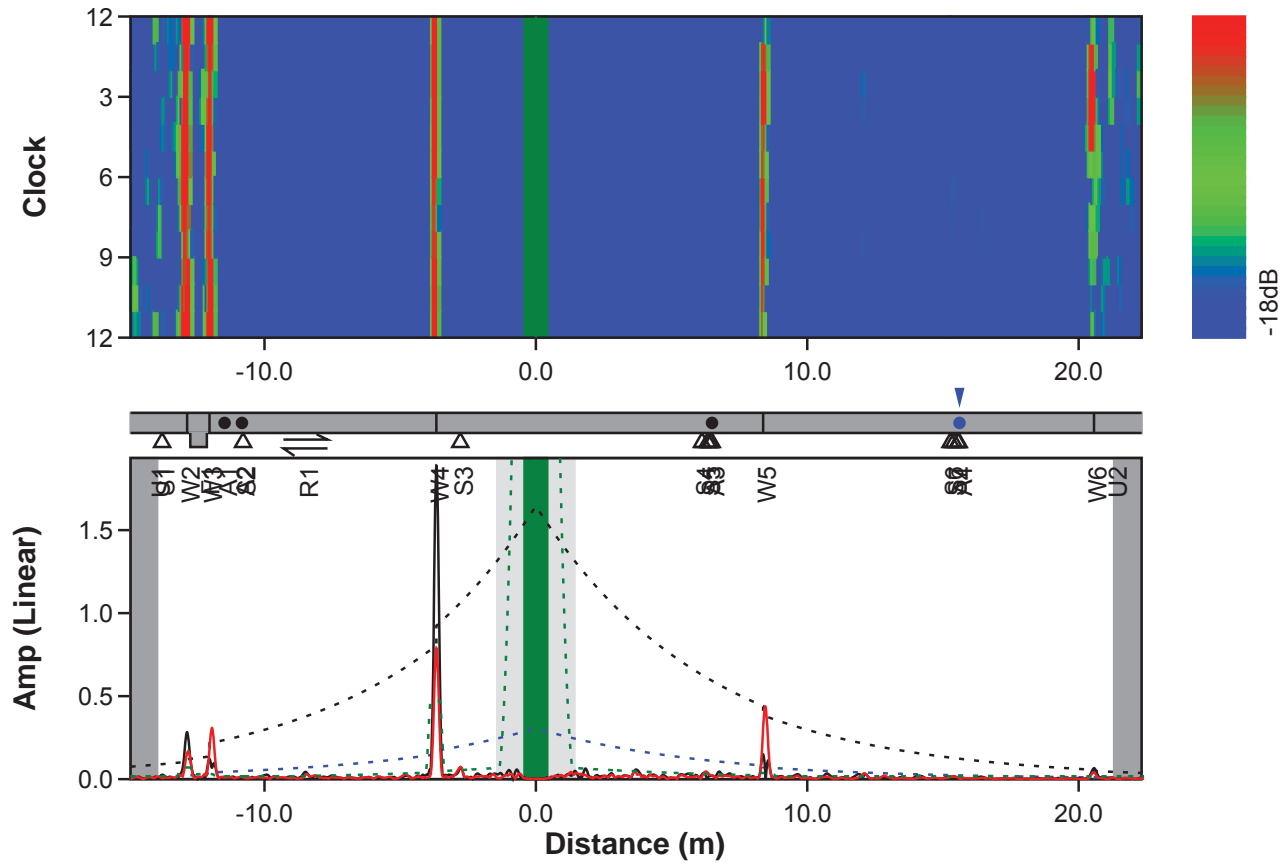
General Notes: 24" RFO-No.6 - Test Point No.: S13
 Positive direction with product flow.
 Found external localize corrosion at several location (refer class, note and location as table below).
 Location of signals measuring from center of ring.
 Thickness at ring position are (12 o'clock:9.57 mm), (3 o'clock:9.60 mm),
 (6 o'clock:9.07 mm), (9 o'clock: 9.60 mm)

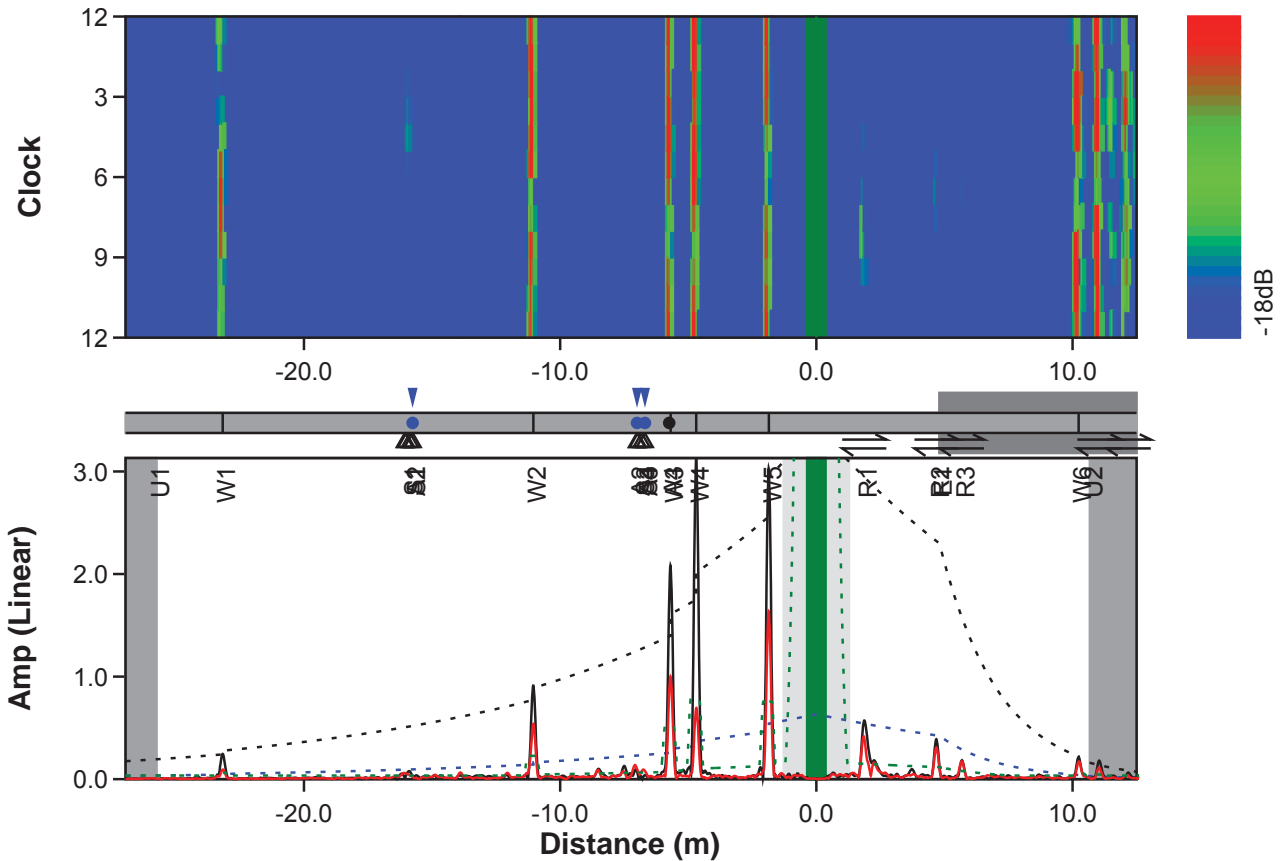
General Notes: 24" RFO-No.6 - Test Point No.: S14
 Positive direction with product flow.
 Found external localize corrosion at several location (refer class, note and location as table below).
 Location of signals measuring from center of ring.
 Thickness at ring position are (12 o'clock:9.59 mm), (3 o'clock:9.25 mm), (6 o'clock:9.57 mm), (9 o'clock: 9.29 mm)

Feature	Location	ECL	Length	Extent	Class	Notes
U1	-25.75	-	~		End	
W1	-23.17	-	0	60	Weld	
S1	-15.86	-	0.15	40	Clamp	
A1	-15.76	4	0	45	Medium	Visually confirm corrosion near the pipe support at 6H00 with max. pit depth is 0.11"@ 2.8 mm. UT reading adjacent to pit is 9.58 mm. Remaining wall thickness is 6.78 mm. (29.2% wall loss)
S2	-15.76	-	0.3	45	Support	
W2	-11.04	30	0	40	Weld	
A2	-7	2	0	0	Medium	Visually confirm corrosion near the pipe support at 4H00 and 6H00 with max. pit depth is 0.10"@ 2.5 mm. UT reading adjacent to pit is 9.43 mm. Remaining wall thickness is 6.93 mm. (26.5% wall loss)
S3	-6.82	-	0.15	0	Clamp	
S4	-6.7	-	0.3	0	Support	
A3	-6.69	1	0	0	Medium	Visually confirm corrosion near the pipe support at 7H00 with max. pit depth is 0.10"@ 2.5 mm. UT reading adjacent to pit is 9.30 mm. Remaining wall thickness is 6.80 mm (26.9% wall loss)
A4	-5.74	45	0	50	Minor	Visually confirm corrosion near the weld joint at 5H00 with max. pit depth is 0.06"@ 1.5 mm. UT reading adjacent to pit is 9.41 mm. Remaining wall thickness is 7.91 mm (15.9% wall loss)
