3.0 GUIDED WAVE REPORT

3.1 24"RESIDUAL FUEL OIL (RFO)

Test ID: G4-214#2203	Result: Minor Concern
Pipe: 14" RFO (S0)	Ring: R2B14(1525)
Site: Outside Terminal	Config: 8.2FR, T(0,1)
Location: Weld bend -0.23m	Calibration: Automatic (2935.84 mV)
Size: 14 inch (6.35mm)	Version: 3.103, Wavemaker G4-214
	GPS: 13°27.4223'N, 144°40.9832'E
Tested: 12 Jun 2014 12:45	Client: Vital Energy
Tested by: Khairul Anuar Husain [SGS]	Procedure: WI-TM-065/Ver.00/27.04.2011
	DACs: Call=6%, Weld=23%

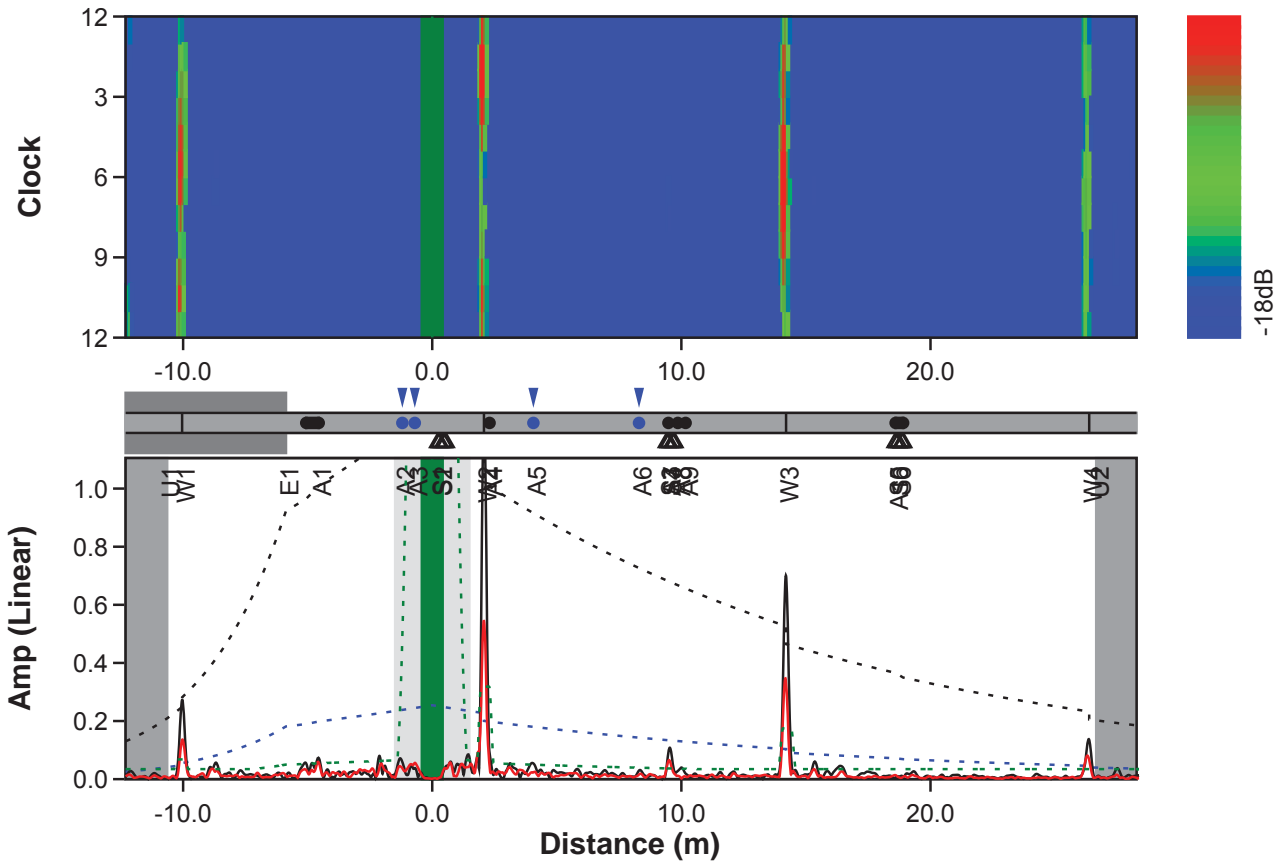
General Notes: 24" RFO-No.6 - Test Point No.: S15
 Positive direction with product flow.
 Found external localize corrosion at several location (refer class, note and location as table below).
 Location of signals measuring from center of ring.
 Thickness at ring position are (12 o'clock:9.71 mm), (3 o'clock:9.64 mm), (6 o'clock:9.69 mm), (9 o'clock: 9.70 mm)

Feature	Location	ECL	Length	Extent	Class	Notes
U1	-10.63	-	~		End	
W1	-10.03	30	0	50	Weld	
E1	-5.87	-	~	9	Earth	Bundwall crossing
A1	-4.55	2	0.5	19	Minor	Visually confirm general external corrosion under the wrapping section
A2	-1.2	2	0	40	Medium	Visually confirm isolated corrosion at 6H00 with max. pit depth is 0.12"@ 3.0 mm. UT reading adjacent to pit is 9.48 mm. Remaining wall thickness is 6.48 mm (31.6% wall loss)
A3	-0.7	1	0	0	Medium	Visually confirm isolated corrosion at 6H00 with max. pit depth is 0.12"@ 3.0 mm. UT reading adjacent to pit is 9.45 mm. Remaining wall thickness is 6.45 mm (31.7% wall loss)
S1	0.24	-	0.3	4	Support	
S2	0.3	-	0.15	0	Clamp	
W2	2.07	-	0	60	Weld	Datum of screening
A4	2.29	8	0	60	Minor	Visually confirm localized corrosion at 6H00 with max. pit depth is 0.05"@ 1.3 mm. UT reading adjacent to pit is 9.53 mm. Remaining wall thickness is 8.23 mm (13.6% wall loss)
A5	4.05	2	0	50	Medium	Visually confirm localized corrosion at 6H00 with max. pit depth is 0.12"@ 3.0 mm. UT reading adjacent to pit is 9.68 mm. Remaining wall thickness is 6.68 mm (31.0 % wall loss)

A6	8.3	1	0	40	Medium	Visually confirm corrosion at 6H00 with max. pit depth is 0.12"@ 3.0 mm. UT reading adjacent to pit is 9.48 mm. Remaining wall thickness is 6.48 mm (31.6% wall loss)

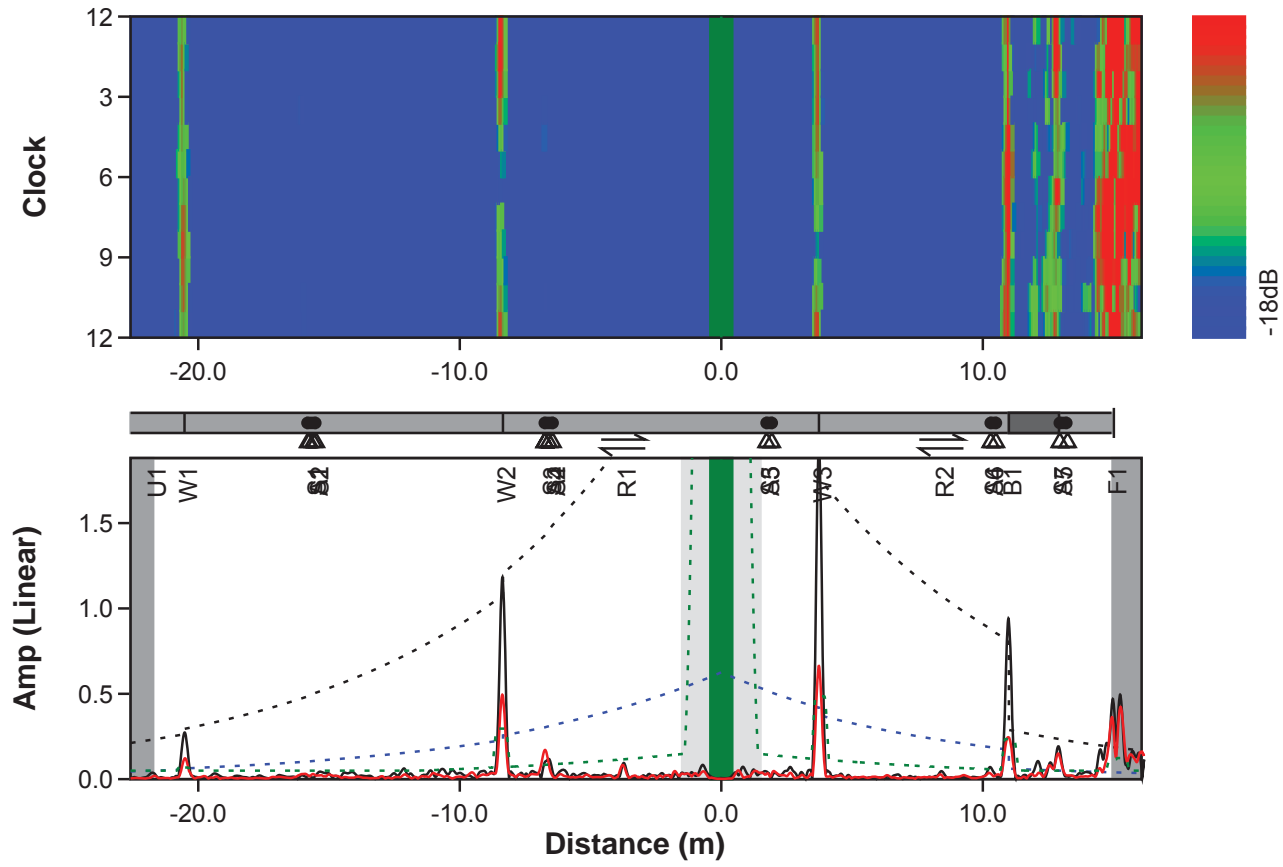
General Notes: 24" RFO no. 6 - Test Point No.: S16
 Positive direction with product flow.
 Found general external corrosion under pipe support (refer class, note and location as table below).
 Location of signals measuring from center of ring.
 Thickness at ring position are (12 o'clock:9.71 mm), (3 o'clock:9.69 mm),
 (6 o'clock:9.38 mm), (9 o'clock: 9.51 mm)

Feature	Location	ECL	Length	Extent	Class	Notes
U1	-21.72	-	~		End	
W1	-20.52	-	0	60	Weld	
S1	-15.6	-	0.15	0	Clamp	
A1	-15.52	2	0.3	6	Minor	Visually confirm general external corrosion under pipe support
S2	-15.5	-	0.3	25	Support	
W2	-8.34	25	0	60	Weld	
S3	-6.6	-	0.15	0	Clamp	
S4	-6.45	-	0.3	60	Support	
A2	-6.45	2	0.3	60	Minor	Visually confirm general external corrosion under pipe support
R1	-3.74	-	0	12	False Echo	Mirror signal
S5	1.73	-	0.2	25	Support	
A3	1.73	1	0.2	25	Minor	Visually confirm general external corrosion under pipe support
W3	3.73	-	0	70	Weld	Datum of screening
R2	8.41	-	0	40	False Echo	Mirror signal
S6	10.3	-	0.2	50	Support	
A4	10.3	2	0.2	50	Minor	Visually confirm general external corrosion under pipe support
B1	10.99	-	0	70	1D Bend	
S7	12.94	-	0.3	20	Support	
A5	12.94	20	0.25	20	Minor	Visually confirm general external corrosion under pipe support
F1	15.01	-	0	25	Flange

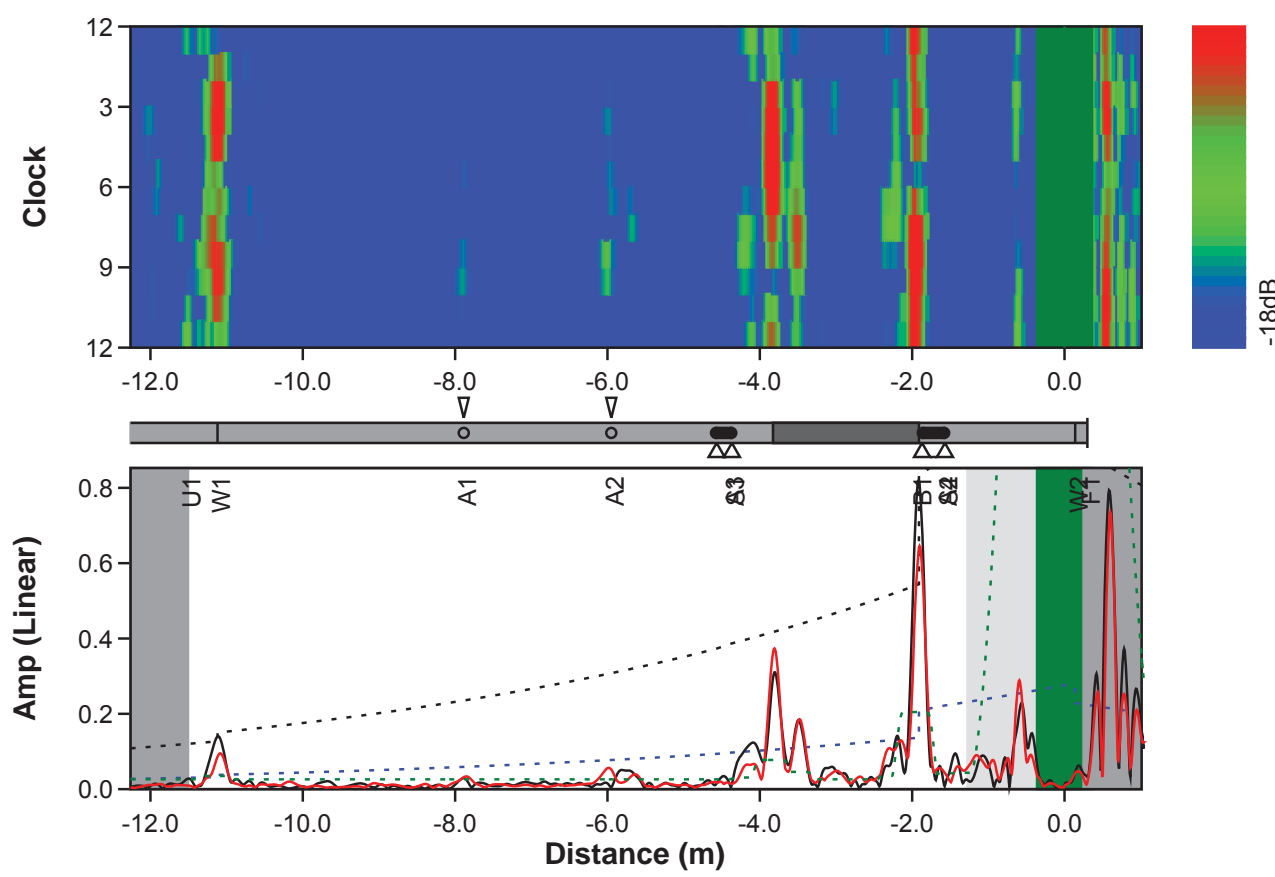
General Notes: 24" RFO-No.6 - Test Point No.: S17
Positive direction with product flow.
Found general external corrosion under pipe support (refer class, note and location as table below).
Location of signals measuring from center of ring.
Thickness at ring position are (12 o'clock:9.65 mm), (3 o'clock:9.62 mm), (6 o'clock:9.52 mm), (9 o'clock: 9.32 mm)

Feature	Location	ECL	Length	Extent	Class	Notes
U1	-11.5	-	~		End	
W1	-11.11	-	0	30	Weld	
A1	-7.88	4	0	0	Anomaly	UT confirm no significant finding. Minimum remaining wall thickness is 9.41 mm.
A2	-5.95	3	0	0	Anomaly	UT confirm no significant finding. Minimum remaining wall thickness is 9.35 mm.
A3	-4.37	5	0.2	70	Minor	Visually confirm general external corrosion under pipe support
S1	-4.36	-	0.2	70	Support	
B1	-1.91	-	0	20	1D Bend	
A4	-1.58	2	0.28	8	Minor	Visually confirm general external corrosion under pipe support
S2	-1.57	-	0.3	8	Support	
W2	0.14	-	0	25	Weld	Datum of screening
F1	0.3	-	0	25	Flange

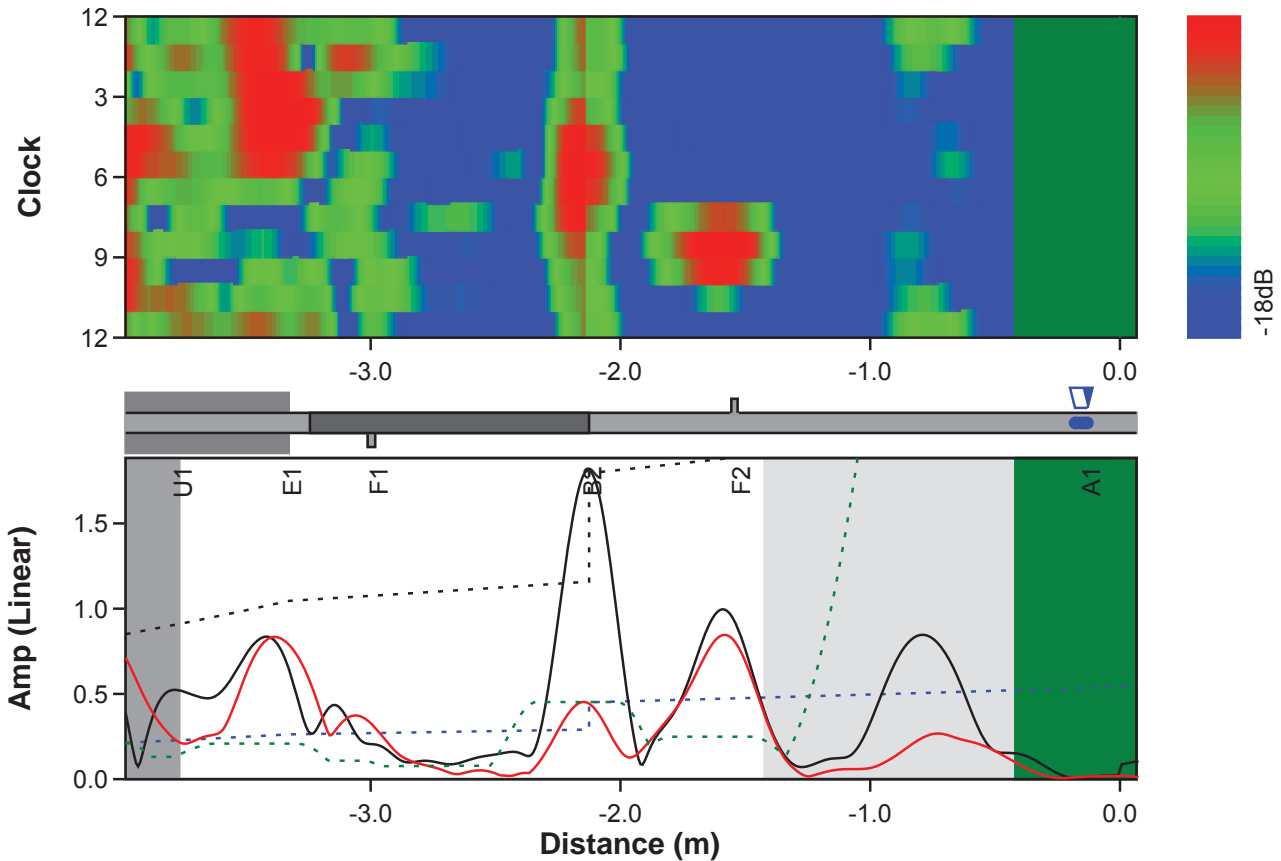
General Notes: 14" RFO-No.6 (bypass line) - Test Point No.: S1
 Positive direction with product flow.
 Found external localize corrosion at 6H00 (refer class, note and location as table below).
 Location of signals measuring from center of ring.
 Thickness at ring position are (12 o'clock:11.09 mm), (3 o'clock:11.85 mm), (6 o'clock:10.58 mm), (9 o'clock:11.32 mm)

Feature	Location	ECL	Length	Extent	Class	Notes
U1	-3.76	-	~		End	
E1	-3.32	-	~	0	Earth	Underground
F1	-2.98	-	0	0	Drain	
B2	-2.12	-	0	80	1D Bend	
F2	-1.53	-	0	15	Vent	
A1	-0.13	0	0.05	9	Medium	Visually confirm localized external corrosion at 6H00 with max. pit depth is 0.10"@ 2.5 mm. UT reading adjacent to pit is 10.58 mm. Remaining wall thickness is 8.03 mm (23.6% wall loss)
F3	0.23	-	0	80	Flange	Datum of screening

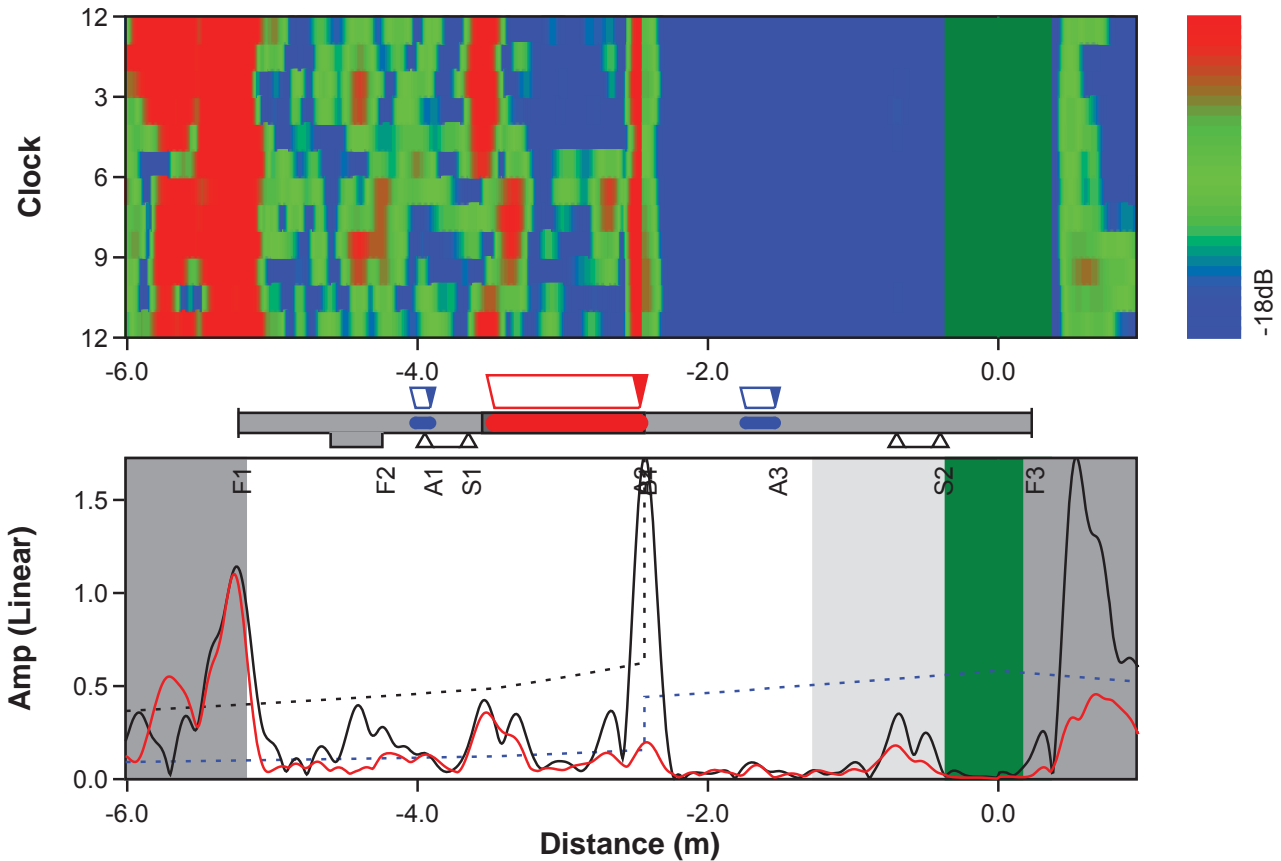
General Notes: 14" RFO-No.6 (bypass line)- Test Point No.: S2
 Positive direction with product flow.
 Found external localize corrosion at several location (refer class, note and location as table below).
 Location of signals measuring from center of ring.
 Thickness at ring position are (12 o'clock:11.28 mm), (3 o'clock:11.39 mm), (6 o'clock:11.40 mm), (9 o'clock: 11.23 mm)

Feature	Location	ECL	Length	Extent	Class	Notes
F1	-5.23	-	0	4	Flange	
F2	-4.24	-	0	50	Y	
A1	-3.91	7	0.1	6	Medium	Visually confirm external corrosion at 6H00 with max. pit depth is 0.13"@ 3.3 mm. UT reading adjacent to pit is 11.58 mm. Remaining wall thickness is 8.28 mm (28.5% wall loss)
S1	-3.65	-	0.3	19	Support	
A2	-2.47	60	1	90	Severe	Visually confirm external corrosion at the bend (6H00 position) with max. pit depth is 0.27"@ 6.8 mm. UT reading adjacent to pit is 10.76 mm. Remaining wall thickness is 3.84 mm (63.2% wall loss)
B1	-2.43	-	0	90	1D Bend	
A3	-1.54	1	0.2	5	Medium	Visually confirm external corrosion at 6H00 with max. pit depth is 0.13"@ 3.3 mm. UT reading adjacent to pit is 11.58 mm. Remaining wall thickness is 8.28 mm (28.5% wall loss)
S2	-0.4	-	0.3	70	Support	
F3	0.23	-	0	80	Flange	Datum of screening

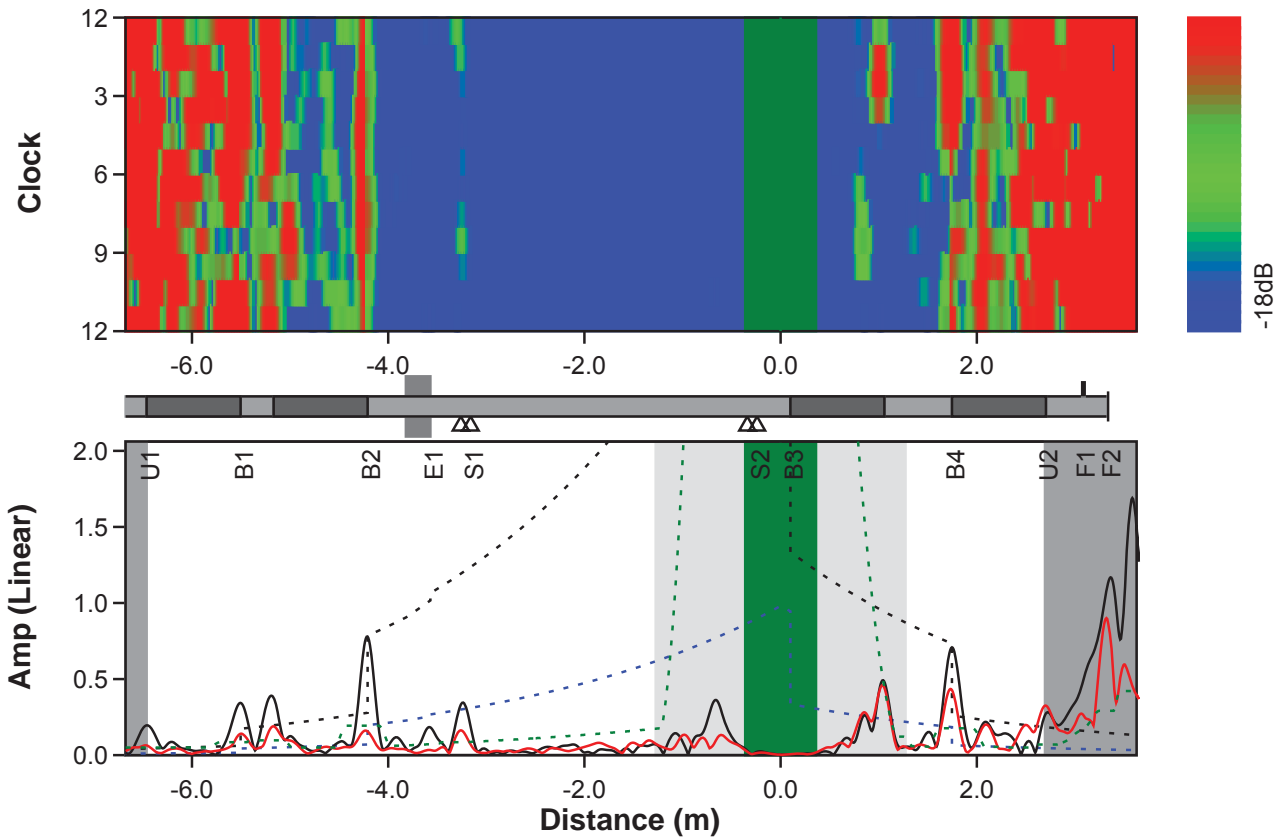
General Notes: 12" RFO-No.6 (bypass line) - Test Point No.: S4A
 Positive direction with product flow.
 No corrosion above the reporting level observed in the tested section of the pipe and found satisfactory.
 (refer class, note and location as table below).
 Location of signals measuring from center of ring.
 Thickness at ring position are (12 o'clock:9.64 mm), (3 o'clock:9.32 mm), (6 o'clock:9.58 mm), (9 o'clock: 9.66 mm)

Feature	Location	ECL	Length	Extent	Class	Notes
U1	-6.46	-	~		End	
B1	-5.5	-	0	60	1D Bend	
B2	-4.21	-	0	80	1D Bend	
E1	-3.57	-	0.25	80	Wall	Building wall
S1	-3.16	-	0.1	60	Clamp	
S2	-0.24	-	0.1	35	Clamp	
B3	0.1	-	0	0	1D Bend	Datum of screening
B4	1.74	-	0	40	1D Bend	
U2	2.69	-	~		End	
F1	3.07	-	0	50	Vent	Gauge meter
F2	3.33	-	0	25	Flange

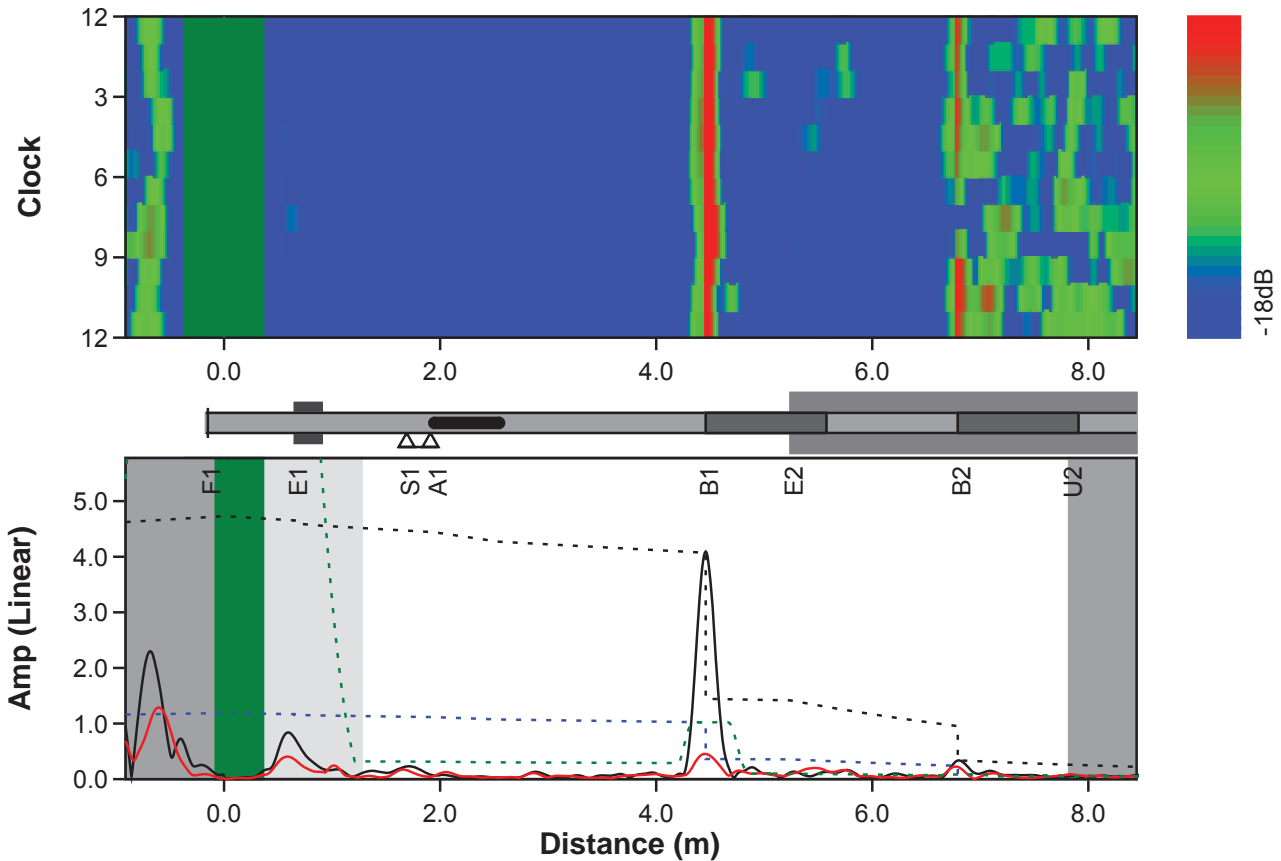
General Notes: 16" RFO-No.6 (bypass line) - Test Point No.: S5
Positive direction with product flow.
Found external corrosion at 6H00 closed to the pipe support. (refer class, note and location as table below).
Location of signals measuring from center of ring.
Thickness at ring position are (12 o'clock:6.59 mm), (3 o'clock:6.68 mm), (6 o'clock:6.88 mm), (9 o'clock: 6.65 mm)

Feature	Location	ECL	Length	Extent	Class	Notes
F1	-0.15	-	0	60	Flange	Datum of screening
E1	0.65	-	0.25	50	Wall	Building wall
S1	1.69	-	0.22	0	Support	
A1	1.94	1	0.6	0	Minor	Visually confirm external corrosion closed to support at 6H00 with max. pit depth is 0.06" @ 1.5 mm. UT reading adjacent to pit is 6.54 mm. Remaining wall thickness is 5.04 mm (22.9% wall loss)
B1	4.45	-	0	90	1D Bend	
E2	5.24	-	~	12	Earth	Underground
B2	6.79	-	0	35	1D Bend	
U2	7.82	-	~		End

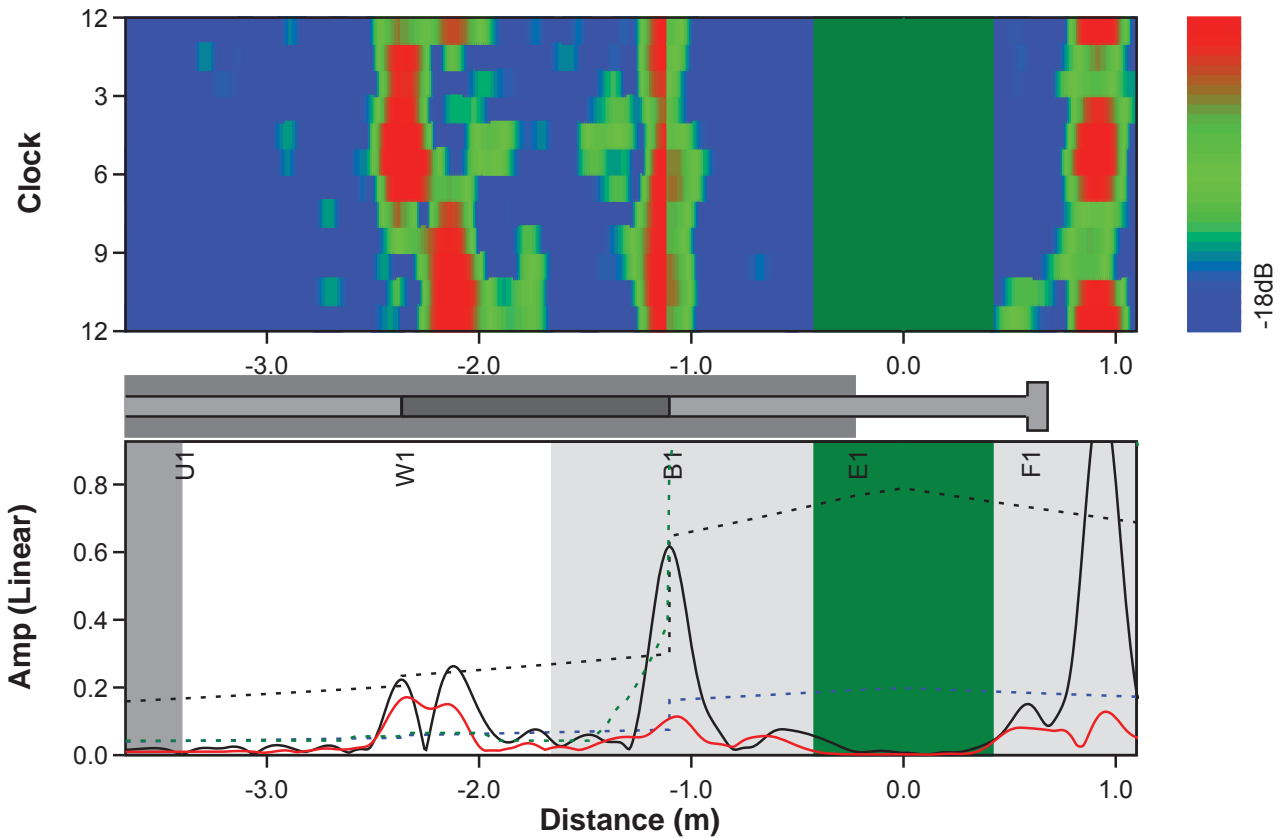
General Notes: 16" RFO-No.6 (bypass line) - Test Point No.: S6
Positive direction with product flow.
No corrosion above the reporting level observed in the tested section of the pipe and found satisfactory.
(refer class, note and location as table below).
Location of signals measuring from center of ring.
Thickness at ring position are (12 o'clock:12.32 mm), (3 o'clock:12.59 mm), (6 o'clock:12.32 mm), (9 o'clock:12.59 mm)

Feature	Location	ECL	Length	Extent	Class	Notes
U1	-3.4	-	~		End	
W1	-2.36	-	0	25	Weld	
B1	-1.1	-	1.26	80	Bend	
E1	-0.23	-	~	90	Earth	Underground
F1	0.58	-	0	45	T	Datum of screening

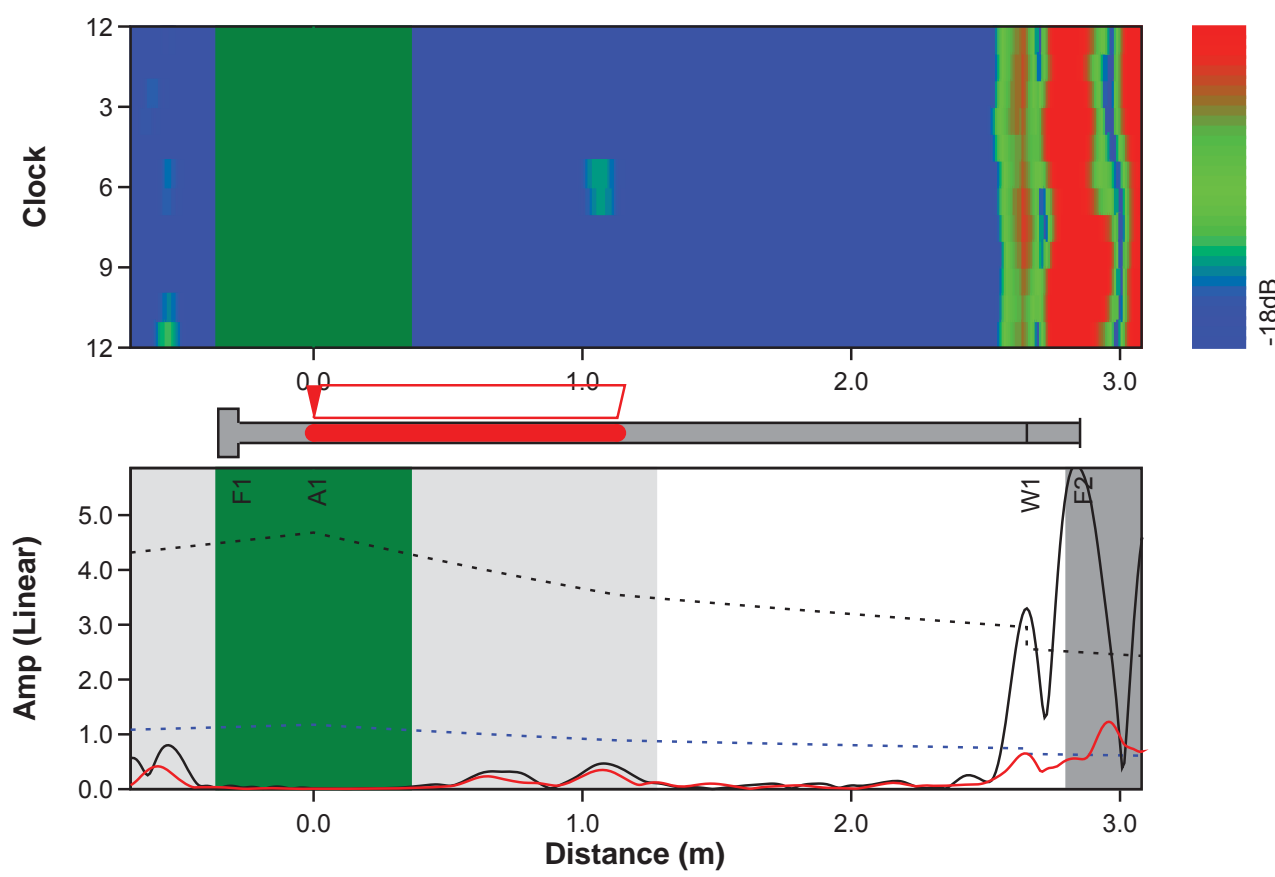
General Notes: 14" RFO-No.6 - Test Point No.: S1
 Positive direction with product flow.
 Found external corrosion at 6H00 position (refer class, note and location as table below).
 Location of signals measuring from center of ring.
 Thickness at ring position are (12 o'clock:9.63 mm), (3 o'clock:9.22 mm), (6 o'clock:10.20 mm), (9 o'clock:10.15 mm)

Feature	Location	ECL	Length	Extent	Class	Notes
F1	-0.28	-	0	60	T	Datum of screening
A1	0	0	1.13	35	Severe	Visually confirm external corrosion at 6H00 with max. pit depth is 0.21"@ 5.3 mm. UT reading adjacent to pit is 9.80 mm. Remaining wall thickness is 4.50 mm (54.1% wall loss)
W1	2.65	-	0	80	Weld	
F2	2.85	-	0	90	Flange

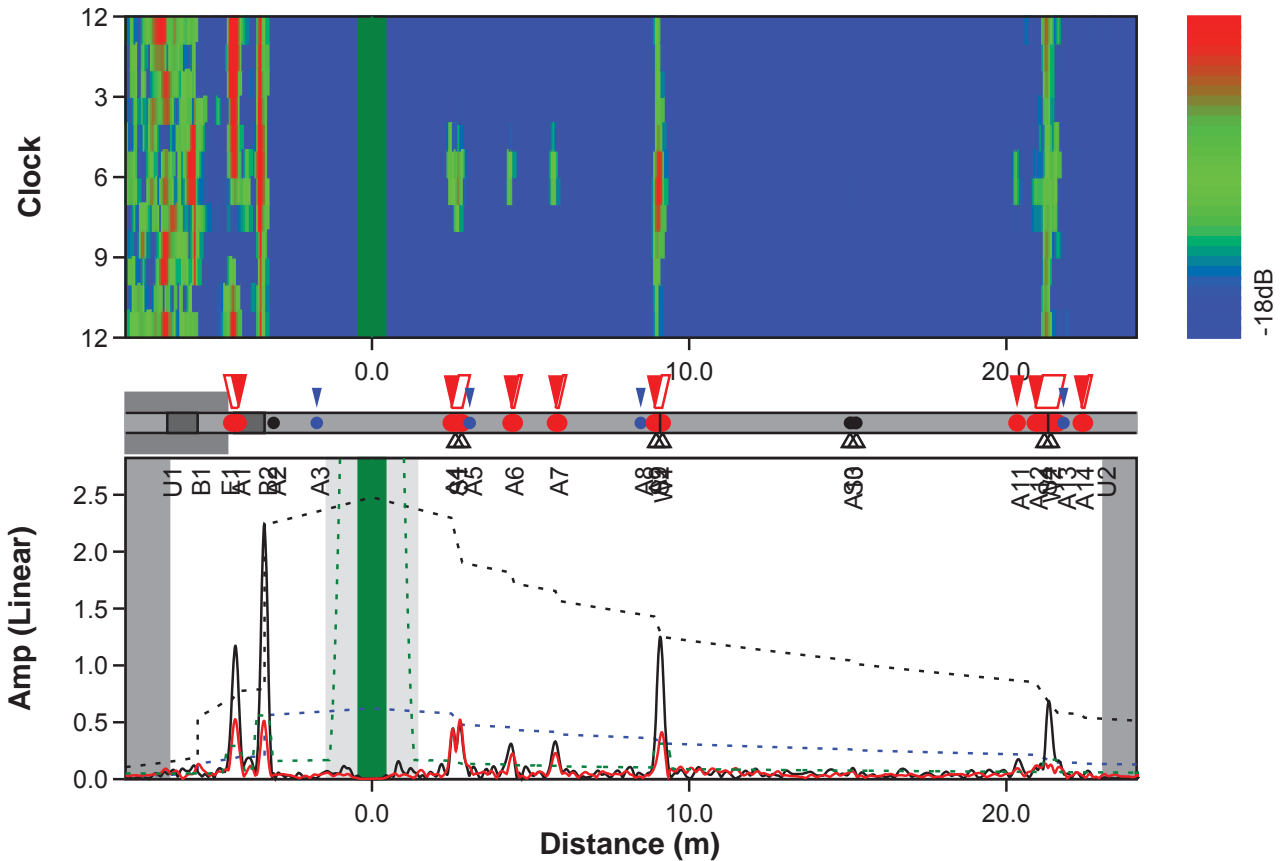
General Notes: 14" RFO-No.6 - Test Point No.: S2
 Positive direction with product flow.
 Found external corrosion mostly concentrate at bottom side (refer class, note and location as table below).
 Location of signals measuring from center of ring.
 Thickness at ring position are (12 o'clock:9.67 mm), (3 o'clock:9.57 mm), (6 o'clock:9.83 mm), (9 o'clock:9.88 mm)

Feature	Location	ECL	Length	Extent	Class	Notes
U1	-6.39	-	~		End	
B1	-5.49	-	0	0	1D Bend	
E1	-4.56	-	~	60	Earth	Underground
A1	-4.22	18	0.2	60	Severe	Visually confirm external corrosion at soil to air section with max. pit depth is 0.2"@ 5.0 mm. UT reading adjacent to pit is 9.95 mm. Remaining wall thickness is 4.95 mm (50.2% wall loss)
B2	-3.38	-	0	80	1D Bend	Datum of screening
A2	-3.1	1	0	25	Minor	Visually confirm external corrosion at 6H00 with max. pit depth is 0.06"@ 1.5 mm. UT reading adjacent to pit is 9.76 mm. Remaining wall thickness is 8.26 mm (15.3% wall loss)
A3	-1.74	0	0	0	Medium	Visually confirm external corrosion at 3-4H00 with max. pit depth is 0.12"@ 3.0 mm. UT reading adjacent to pit is 9.45 mm. Remaining wall thickness is 6.45 mm (31.7% wall loss)
A4	2.5	5	0.35	1	Severe	Visually confirm external corrosion at 6H00 with max. pit depth is 0.24"@ 6.0 mm. UT reading adjacent to pit is 9.70 mm. Remaining wall thickness is 3.70 mm (61.8% wall loss)

S1	2.63	-	0.2	5	Support	
A5	3.08	1	0	0	Medium	Visually confirm localized external corrosion at 6H00 with max. pit depth is 0.13"@ 3.3 mm. UT reading adjacent to pit is 9.73 mm. Remaining wall thickness is 6.43 mm (33.9% wall loss)
A6	4.38	4	0.1	30	Severe	Visually confirm localized external corrosion at 6H00 with max. pit depth is 0.20"@ 5.0 mm. UT reading adjacent to pit is 9.95 mm. Remaining wall thickness is 4.95 mm (50.2% wall loss)

Feature	Location	ECL	Length	Extent	Class	Notes
A7	5.78	5	0.1	30	Severe	Visually confirm localized external corrosion at 6H00 with max. pit depth is 0.20"@ 5.0 mm. UT reading adjacent to pit is 9.96 mm. Remaining wall thickness is 4.96 mm (50.0% wall loss)
A8	8.47	1	0	60	Medium	Visually confirm localized external corrosion at 6H00 with max. pit depth is 0.10"@ 2.5 mm. UT reading adjacent to pit is 10.15 mm. Remaining wall thickness is 7.65 mm (24.6% wall loss)
A9	8.9	10	0.25	70	Severe	Visually confirm external corrosion under pipe support at 6H00 with max. pit depth is 0.25"@ 6.3 mm. UT reading adjacent to pit is 10.03 mm. Remaining wall thickness is 3.68 mm (62.8% wall loss)
S2	8.96	-	0.2	80	Support	
W1	9.08	20	0	70	Weld	
S3	15.07	-	0.2	25	Support	
A10	15.07	2	0.2	25	Minor	Visually confirm external corrosion under pipe support (6H00) with max. pit depth is 0.06"@ 1.5 mm. UT reading adjacent to pit is 9.42 mm. Remaining wall thickness is 7.92 mm (15.9% wall loss)

A11	20.33	5	0	45	Severe	Visually confirm localized external corrosion at 6H00 with max. pit depth is 0.18"@ 4.5 mm. UT reading adjacent to pit is 9.18 mm. Remaining wall thickness is 4.68 mm (49.0% wall loss)
A12	20.91	3	0.7	0	Severe	Visually confirm external corrosion under pipe support (6H00) with max. pit depth is 0.22"@ 5.5 mm. UT reading adjacent to pit is 9.82 mm. Remaining wall thickness is 4.32 mm (56.0% wall loss)

Feature	Location	ECL	Length	Extent	Class	Notes
S4	21.2	-	0.2	70	Support	
W2	21.31	25	0	80	Weld	
A13	21.8	4	0	11	Medium	Visually confirm external corrosion at 6H00 with max. pit depth is 0.13"@ 3.3 mm. UT reading adjacent to pit is 9.93 mm. Remaining wall thickness is 6.63 mm (33.2% wall loss)
A14	22.36	2	0.1	0	Severe	Visually confirm localized external corrosion at 6H00 with max. pit depth is 0.18"@ 4.5 mm. UT reading adjacent to pit is 9.57 mm. Remaining wall thickness is 5.07 mm (47.0% wall loss)
U2	23.05	-	~		End

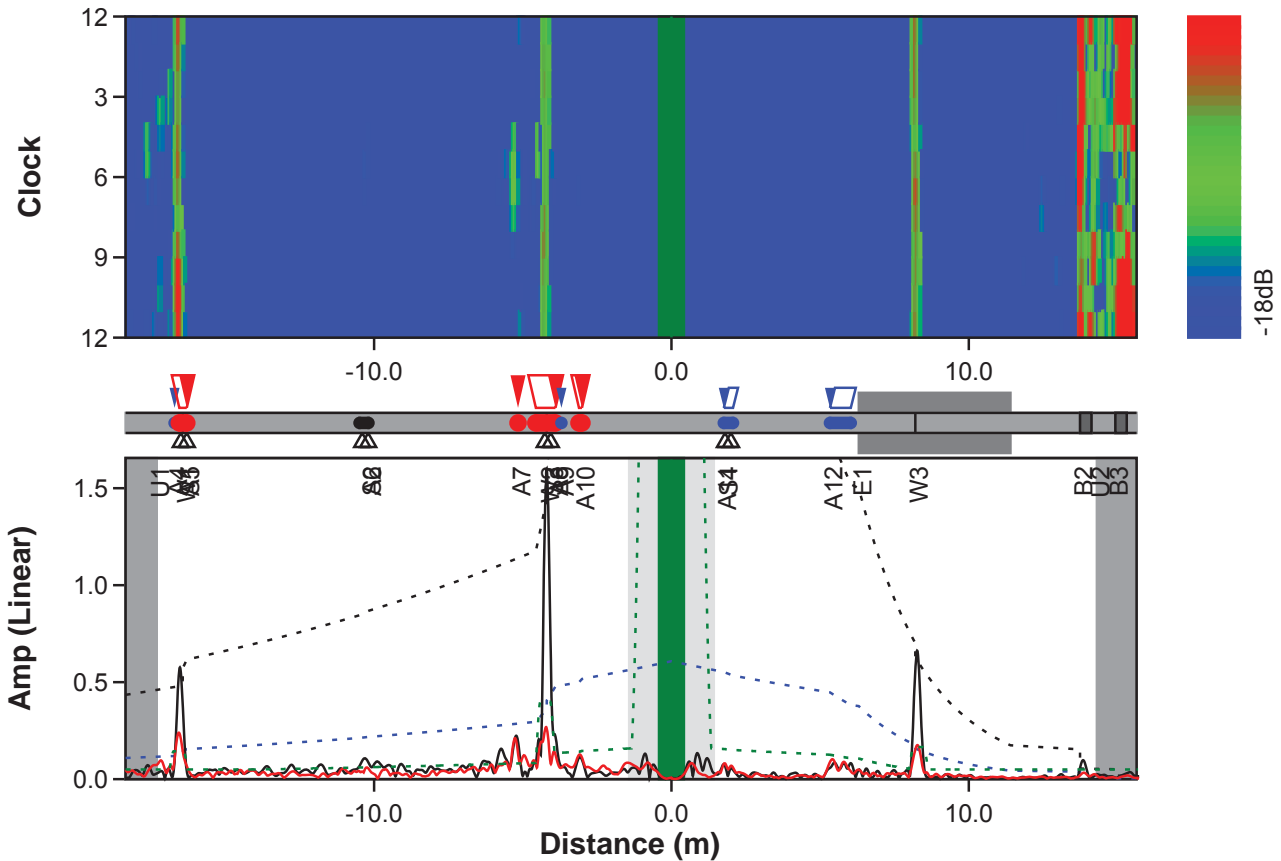
General Notes: 14" RFO-No.6 - Test Point No.: S3
Positive direction with product flow.
Found external corrosion concentrate at bottom side (refer class, note and location as table below).
Location of signals measuring from center of ring.
Thickness at ring position are (12 o'clock:9.91 mm), (3 o'clock:10.07 mm), (6 o'clock:9.72 mm), (9 o'clock:9.55 mm)

Feature	Location	ECL	Length	Extent	Class	Notes
U1	-17.3	-	~		End	
A4	-16.71	2	0	0	Medium	Visually confirm localized external corrosion at 6H00 with max. pit depth is 0.10"@ 2.5 mm. UT reading adjacent to pit is 10.15 mm. Remaining wall thickness is 7.65 mm (24.6% wall loss)
W1	-16.43	25	0	60	Weld	
S1	-16.3	-	0.2	60	Support	
A5	-16.3	16	0.25	60	Severe	Visually confirm external corrosion under pipe support at 6H00 with max. pit depth is 0.25"@ 6.3 mm. UT reading adjacent to pit is 10.03 mm. Remaining wall thickness is 3.68 mm (62.8% wall loss)
S2	-10.19	-	0.2	45	Support	
A6	-10.19	3	0.3	45	Minor	Visually confirm external corrosion at 6H00 with max. pit depth is 0.06"@ 1.5 mm. UT reading adjacent to pit is 9.76 mm. Remaining wall thickness is 8.26 mm (15.3% wall loss)
A7	-5.16	5	0	6	Severe	Visually confirm localized external corrosion at 6H00 with max. pit depth is 0.18"@ 4.5 mm. UT reading adjacent to pit is 9.18 mm. Remaining wall thickness is 4.68 mm (49.0% wall loss)

W2	-4.19	20	0	80	Weld	Datum of screening
S3	-4.05	-	0.2	90	Support	
A8	-3.9	3	0.66	40	Severe	Visually confirm external corrosion under pipe support (6H00) with max. pit depth is 0.22"@ 5.5 mm. UT reading adjacent to pit is 9.82 mm. Remaining wall thickness is 4.32 mm (56.0% wall loss)

Feature	Location	ECL	Length	Extent	Class	Notes
A9	-3.7	1	0	30	Medium	Visually confirm external corrosion at 6H00 with max. pit depth is 0.13"@ 3.3 mm. UT reading adjacent to pit is 9.93 mm. Remaining wall thickness is 6.63 mm (33.2% wall loss)
A10	-3.01	1	0.1	0	Severe	Visually confirm localized external corrosion at 6H00 with max. pit depth is 0.18"@ 4.5 mm. UT reading adjacent to pit is 9.57 mm. Remaining wall thickness is 5.07 mm (47.0% wall loss)
A11	1.76	1	0.31	0	Medium	Visually confirm localized external corrosion under pipe support (6H00) with max. pit depth is 0.10"@ 2.5 mm. UT reading adjacent to pit is 9.45mm. Remaining wall thickness is 7.95 mm (24.6% wall loss)
S4	1.8	-	0.2	0	Support	
A12	5.33	1	0.7	0	Medium	Visually confirm localized external corrosion at 6H00 with max. pit depth is 0.08"@ 2.0 mm. UT reading adjacent to pit is 9.12 mm. Remaining wall thickness is 7.12 mm (24.6% wall loss)

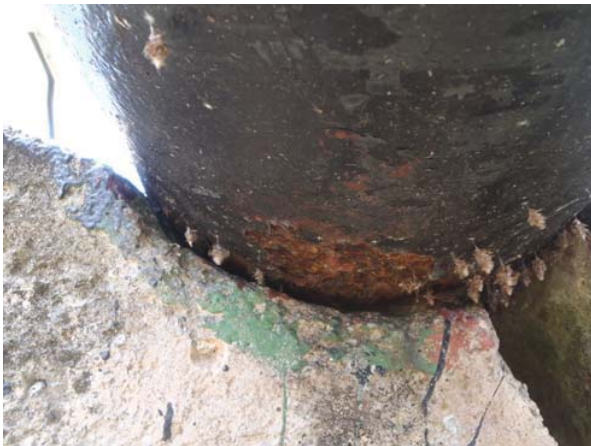
Closed view of corrosion

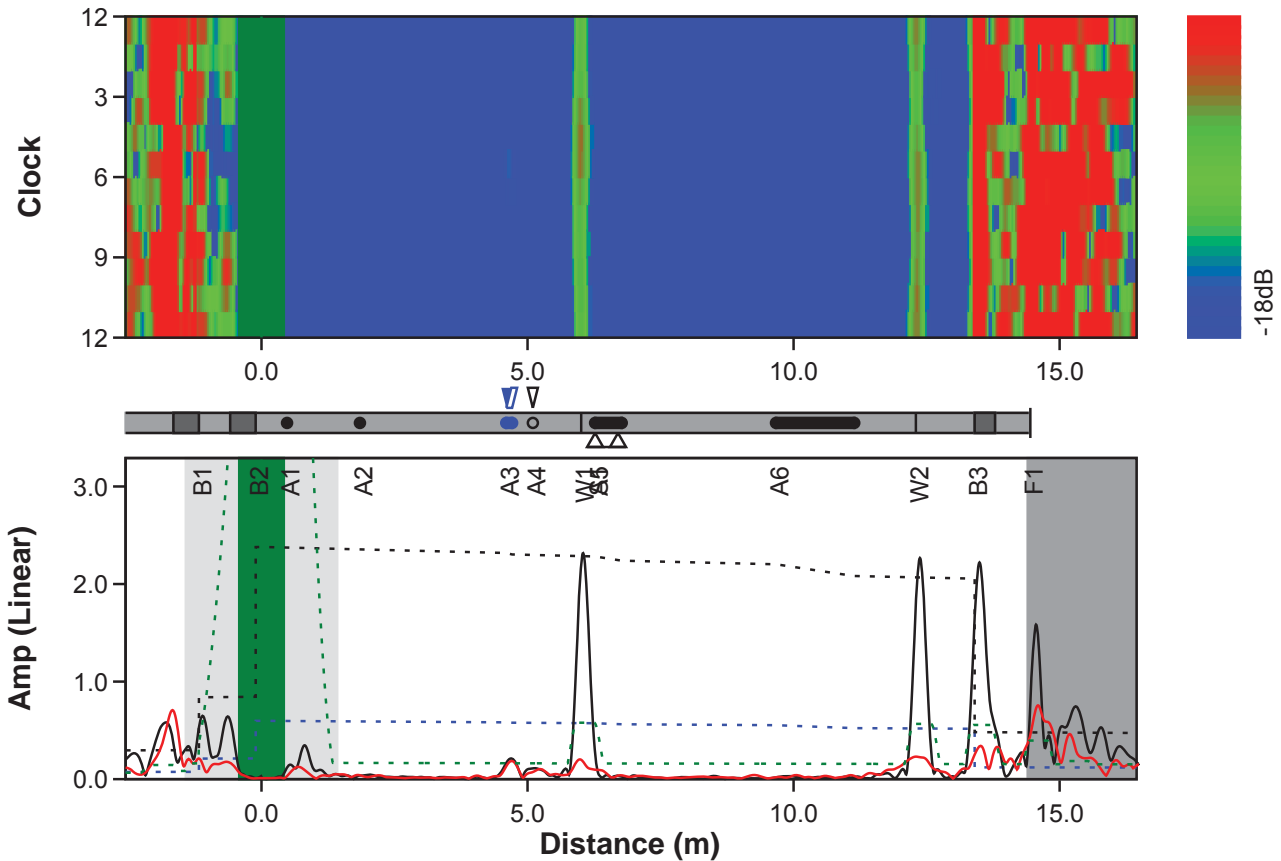
General Notes: 14" RFO-No.6 - Test Point No.: S4
Positive direction with product flow.
Found external corrosion concentrate at bottom side (refer class, note and location as table below).
Location of signals measuring from center of ring.
Thickness at ring position are (12 o'clock:9.87 mm), (3 o'clock:9.89 mm), (6 o'clock:9.94 mm), (9 o'clock:9.95 mm)

Feature	Location	ECL	Length	Extent	Class	Notes
B1	-1.17	-	0	70	45 deg Bend	
B2	-0.11	-	0	45	45 deg Bend	Datum of screening
A1	0.48	1	0	50	Minor	Visually confirm external corrosion at 7H00 with max. pit depth is 0.05"@ 1.3 mm. UT reading adjacent to pit is 9.91 mm. Remaining wall thickness is 8.61 mm (13.1%wall loss)
A2	1.85	0	0	0	Minor	Visually confirm external corrosion at 4H00 with max. pit depth is 0.05"@ 1.3 mm. UT reading adjacent to pit is 9.89 mm. Remaining wall thickness is 8.59 mm (13.1% wall loss)
A3	4.59	2	0.11	13	Medium	Visually confirm external corrosion at 6H00 with max. pit depth is 0.16"@ 4.0 mm. UT reading adjacent to pit is 9.67 mm. Remaining wall thickness is 5.67 mm (41.4% wall loss)
A4	5.09	1	0	13	Anomaly	UT confirm no significant finding. Minimum thickness reading is 10.16 mm.
W1	6	25	0	90	Weld	
S1	6.27	-	0.43	90	Support	
A5	6.27	8	0.5	90	Minor	Visually confirm corrosion under pipe support (6H00) with max. pit depth is 0.06"@ 1.5 mm. UT reading adjacent to pit is 9.75 mm. Remaining wall thickness is 8.25 mm (15.4% wall loss)

A6	9.67	0	1.47	4	Minor	Visually confirm external corrosion at 6H00 with max. pit depth is 0.06"@ 1.5 mm. UT reading adjacent to pit is 9.67 mm. Remaining wall thickness is 8.17 mm (15.5% wall loss)
