Test ID: G4-214#2209	Result: Medium Concern
Pipe: 12" RFO (S4)	Ring: R2B12(1507)
Site: Inside Terminal	Config: 4.6FR, T(0,1)
Location: Weld bend -0.11m	Calibration: Automatic (1271.25 mV)
Size: 12 inch (10.3mm)	Version: 3.103, Wavemaker G4-214
	GPS: 13°27.6425'N, 144°41.1241'E
Tested: 16 Jun 2014 12:00	Client: Vital Energy
Tested by: Khairul Anuar Husain [SGS]	Procedure: WI-TM-065/Ver.00/27.04.2011
	DACs: Call=6%, Weld=23%

General Notes: 14" RFO-No.6 - Test Point No.: S5
Positive direction with product flow.
Found external corrosion concentrate at bottom side (refer class, note and location as table below).
Location of signals measuring from center of ring.
Thickness at ring position are (12 o'clock:10.26 mm), (3 o'clock:10.31 mm), (6 o'clock:10.40 mm), (9 o'clock:10.41 mm)

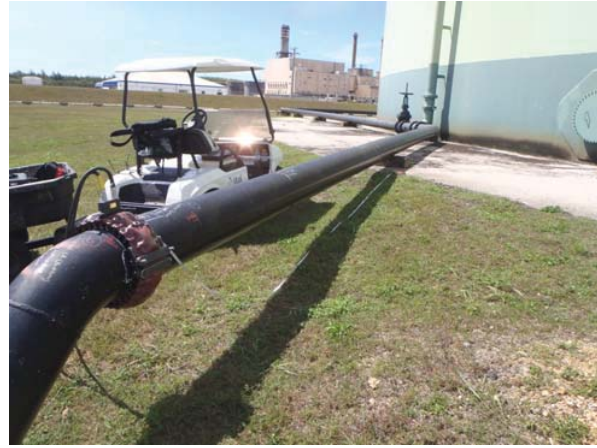
Positive direction

Feature	Location	ECL	Length	Extent	Class	Notes
W2	12.29	25	0	90	Weld	
B3	13.4	-	0	80	45 deg Bend	
F1	14.44	-	0	50	Flange

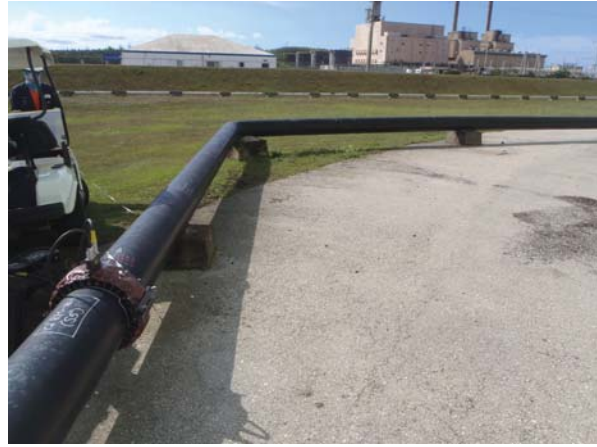
Positive direction

Feature	Location	ECL	Length	Extent	Class	Notes
F1	-14.96	-	0	90	Flange	
A1	-8.9	1	0.5	20	Minor	Visually confirm external corrosion under pipe support. No access to confirm corrosion depth.
S1	-8.89	-	0.44	20	Support	
W1	-8.63	19	0	60	Weld	
S2	-3.78	-	0.44	0	Support	
W2	-2.71	17	0	70	Weld	Datum of screening
S3	1.39	-	0.42	35	Support	
W3	3.46	25	0	90	Weld	
A2	3.8	1	4.15	25	Severe	Visually confirm external corrosion at 6H00 with max. pit depth is 0.32"@ 8.1 mm. UT reading adjacent to pit is 9.47 mm. Remaining wall thickness is 1.37 mm (85.5% wall loss)
B1	6.98	-	0	60	1D Bend	
A3	8.11	16	0.2	35	Severe	Visually confirm external corrosion at 6H00 with max. pit depth is 0.23"@ 5.8 mm. UT reading adjacent to pit is 9.42 mm. Remaining wall thickness is 3.62 mm (61.5% wall loss)
W4	8.25	-	0	10	Weld

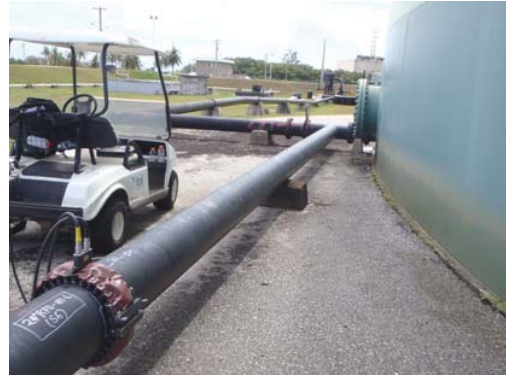
Positive direction

Feature	Location	ECL	Length	Extent	Class	Notes
U1	-13.11	-	~		End	
B1	-12.46	-	0	70	1D Bend	
A1	-12.25	15	4	50	Severe	Visually confirm external corrosion at 6H00 with max. pit depth is 0.32"@ 8.1 mm. UT reading adjacent to pit is 9.47 mm. Remaining wall thickness is 1.37 mm (85.5% wall loss)
W1	-11.83	25	0	80	Weld	
A2	-11.71	20	0.28	80	Severe	Visually confirm external corrosion at 6H00 with max. pit depth is 0.23"@ 5.8 mm. UT reading adjacent to pit is 9.42 mm. Remaining wall thickness is 3.62 mm (61.5% wall loss)
A3	-10.57	1	0.97	35	Severe	Visually confirm localized corrosion at 6H00 with max. pit depth is 0.21"@ 5.3 mm. UT reading adjacent to pit is 9.41 mm. Remaining wall thickness is 4.11 mm (56.3% wall loss)
A4	-8.22	25	0.2	90	Severe	Visually confirm localized corrosion at 6H00 with max. pit depth is 0.20"@ 5.0 mm. UT reading adjacent to pit is 9.78 mm. Remaining wall thickness is 4.78 mm (51.1% wall loss)

W2	-8.11	25	0	90	Weld	
S1	-7.14	-	0.43	6	Support	
W3	-2.2	12	0	70	Weld	Datum of screening
S2	-1.27	-	0.43	70	Support	
A5	-1.2	2	0.64	17	Minor	Visually confirm corrosion under pipe support (6H00) with max. pit depth is 0.07"@ 1.8 mm. UT reading adjacent to pit is 9.67 mm. Remaining wall thickness is 7.87 mm (18.6% wall loss)

Feature	Location	ECL	Length	Extent	Class	Notes
A6	1.65	0	0	0	Minor	Visually confirm external corrosion at 12H00 with max. pit depth is 0.06"@ 1.5 mm. UT reading adjacent to pit is 9.40 mm. Remaining wall thickness is 7.90 mm (15.9% wall loss)
A7	2.16	1	0	0	Minor	Visually confirm external corrosion at 6H00 with max. pit depth is 0.08"@ 2.0 mm. UT reading adjacent to pit is 9.40 mm. Remaining wall thickness is 7.40 mm (21.3% wall loss)
W4	3.92	25	0	90	Weld	
S3	4.21	-	0.43	80	Support	
A8	10.03	20	0.2	90	Minor	Visually confirm external corrosion at 6H00 with max. pit depth is 0.05"@ 1.30 mm. UT reading adjacent to pit is 9.54 mm. Remaining wall thickness is 8.24 mm (13.6% wall loss)
W5	10.03	20	0	90	Weld	
W6	10.56	-	0	70	Weld	
F1	10.76	-	0	70	T	
U2	10.96	-	~		End

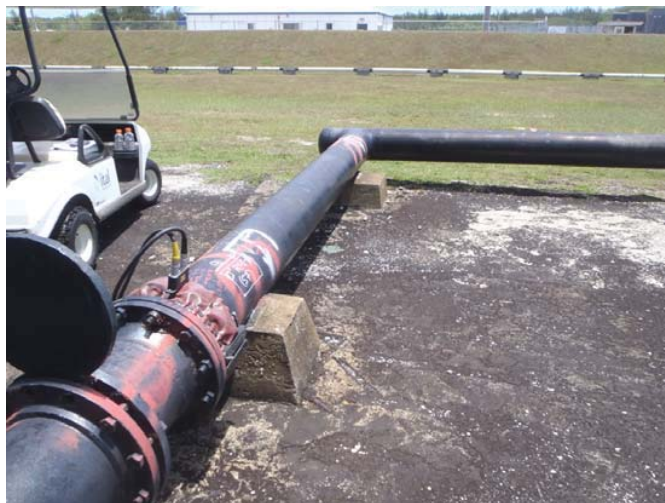
Positive direction

Feature	Location	ECL	Length	Extent	Class	Notes
F1	-0.17	-	0	50	Flange	Datum of screening
A1	0.27	1	0.54	40	Medium	Visually confirm external corrosion under pipe support (6H00) with max. pit depth is 0.1" @ 2.5 mm. UT reading adjacent to pit is 6.35 mm. Remaining wall thickness is 3.85 mm (39.4 % wall loss)
S1	0.28	-	0.42	40	Support	
S2	3.05	-	0.42	0	Support	
A2	3.05	0	0.6	0	Minor	Visually confirm external corrosion under pipe support. No access to confirm corrosion depth.
W1	3.87	-	0	80	Weld	
F2	4.18	-	0	60	T	
U2	4.4	-	~		End

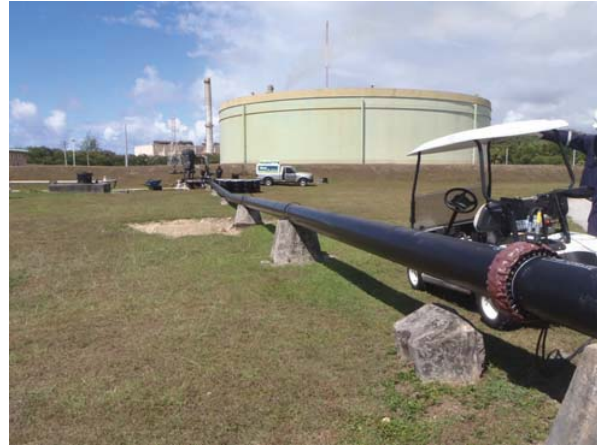
Positive direction

Feature	Location	ECL	Length	Extent	Class	Notes
W5	1.72	25	0	90	Weld	Datum of screening
A6	5.7	1	0.38	60	Minor	Visually confirm external corrosion under pipe support. No access to confirm corrosion depth.
S5	5.75	-	0.3	70	Support	
W6	7.33	20	0	90	Weld	
S6	12.04	-	0.78	70	Saddle	Patch plate
S7	12.2	-	0.3	70	Support	
W7	12.93	-	0	80	Weld	
A7	17.85	5	0	60	Anomaly	UT confirm no significant finding. Minimum thickness reading is 5.97 mm.
W8	18.53	-	0	70	Weld	
W9	19.31	-	0	70	Weld	
S8	19.48	-	0.3	60	Support	
U3	19.49	-	~		End	
W10	24.92	-	0	80	Weld

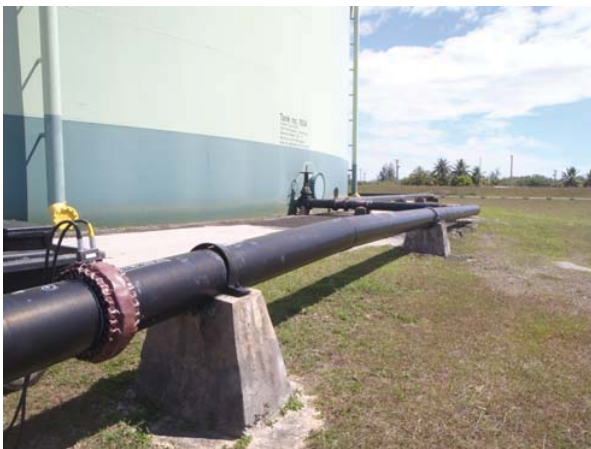
Negative direction

Feature	Location	ECL	Length	Extent	Class	Notes
F1	-15.18	-	0	70	End	
A1	-15.01	13	0	50	Medium	Visually confirm external corrosion at 5H00 with max. pit depth is 0.18"@ 4.5 mm. UT reading adjacent to pit is 12.73 mm. Remaining wall thickness is 8.23 mm (35.3% wall loss)
W1	-14.87	-	0	0	Weld	
F2	-14.5	-	0	80	Y	
W2	-14.42	-	0	90	Weld	
A2	-12.87	3	0	60	Minor	UT confirm internal corrosion with maximum wall thickness is 5.36 mm (15.6% wall loss)
A3	-11.96	5	0	25	Anomaly	UT confirm no significant finding. Minimum thickness reading is 5.72 mm.
W3	-8.79	15	0	80	Weld	
U2	-8.3	-	0	5	User1	Insert weld patch (0.08 x 0.08m) - see attached picture
S1	-7.26	-	0.3	20	Support	
S2	-7.23	-	0.4	16	Saddle	Patch plate at 3 to 10H00
A4	-4.64	0	0	0	Severe	Visually confirm external corrosion at 6H00 with max. pit depth is 0.14"@ 3.5 mm. UT reading adjacent to pit is 6.36 mm. Remaining wall thickness is 2.86 mm (55.0% wall loss)

W4	-3.18	20	0	60	Weld	
S3	-3	-	0.27	50	Saddle	Patch plate at 6H00
A5	-0.75	1	0.27	40	Minor	Visually confirm external corrosion under pipe support. No access to confirm corrosion depth.
S4	-0.7	-	0.3	40	Support

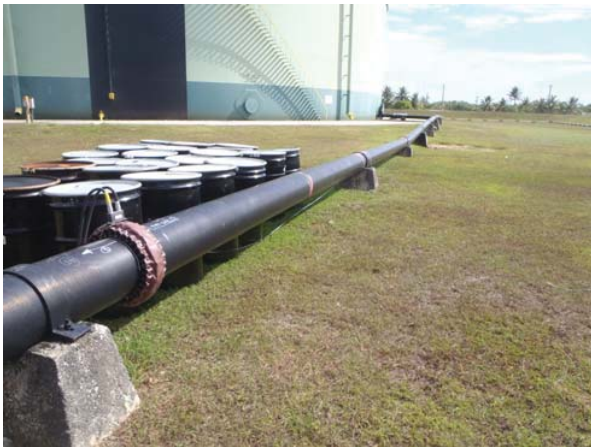
Negative direction

Feature	Location	ECL	Length	Extent	Class	Notes
U1	-15.36	-	~		End	
W2	-15.05	40	0	80	Weld	
W3	-14.28	20	0	90	Weld	
S2	-13.56	-	0.3	25	Support	
A1	-13.49	1	0.3	30	Minor	Visually confirm external corrosion under pipe support. No access to confirm corrosion depth.
W4	-8.66	20	0	90	Weld	
S3	-6.43	-	0	0	Clamp	
S4	-6.33	-	0.3	0	Support	
A2	-6.3	4	0.35	0	Severe	Visually confirm external corrosion at 6H00 under pipe support with max. pit depth is 0.16" @ 3.8 mm. UT reading adjacent to pit is 6.16 mm. Remaining wall thickness is 2.36 mm (61.7% wall loss)
W5	-3.06	25	0	90	Weld	
A3	0.6	2	0.3	13	Minor	Visually confirm external corrosion under pipe support. No access to confirm corrosion depth.
S5	0.63	-	0.3	11	Support	
W6	2.54	20	0	80	Weld	Datum of screening
F1	4.37	-	0	40	Y	
F2	4.96	-	0	30	Flange

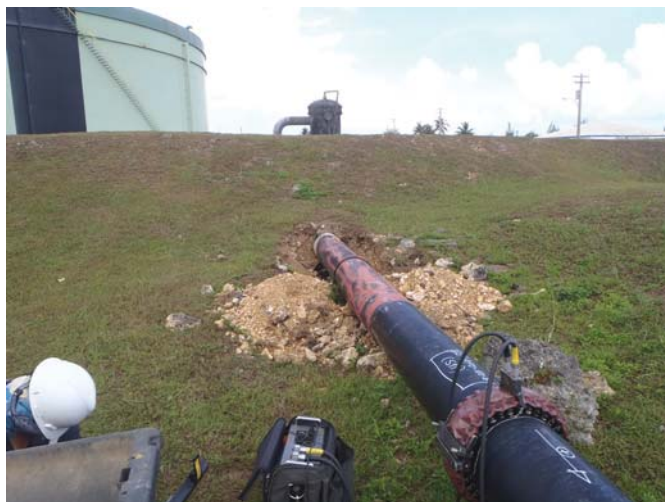
Negative direction

Feature	Location	ECL	Length	Extent	Class	Notes
U1	-6.14	-	~		End	
E1	-4.9	-	~	0	Earth	underground
W1	-4.02	-	0	0	Weld	
A1	-3.4	2	1	15	Medium	Visually confirm external corrosion at 6H00 with max. pit depth is 0.12"@ 3.0 mm. UT reading adjacent to pit is 6.35 mm. Remaining wall thickness is 3.35 mm (47.2% wall loss)
S1	-2.96	-	0.15	40	Clamp	
S2	-2.89	-	0.3	40	Support	
A2	-1.56	25	0.85	30	Medium	Visually confirm external corrosion at 1 - 3H00 with max. pit depth is 0.12"@ 3.0 mm. UT reading adjacent to pit is 6.20 mm. Remaining wall thickness is 3.20 mm. (48.4% wall loss)
S3	-1.5	-	1.1	30	Saddle	Patch plate
W2	1.53	-	0	80	Weld	Datum of screening
S4	2.45	-	0.3	60	Support	
S5	2.56	-	0.15	70	Clamp	
W3	7.11	-	0	60	Weld	
S6	8.44	-	0.3	0	Support	
S7	8.58	-	0.15	30	Clamp	
W4	12.65	-	0	80	Weld	
S8	14.53	-	0.3	30	Support	
S9	14.66	-	0.15	60	Clamp	
F1	15.59	-	0	45	Branch	
U2	16.16	-	~		End

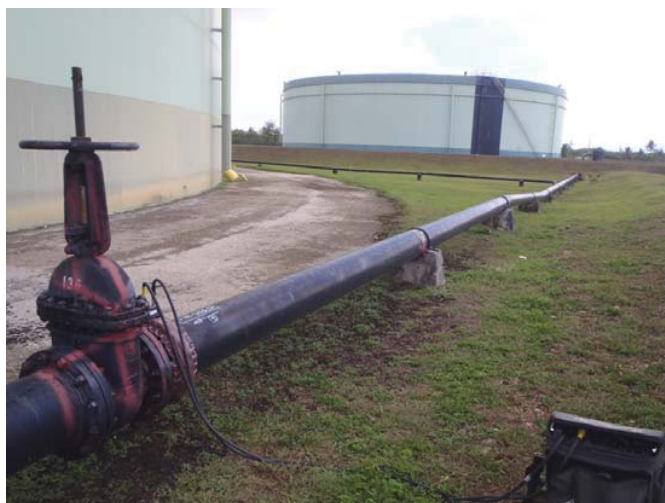
Negative direction

Feature	Location	ECL	Length	Extent	Class	Notes
U1	-12.38	-	~		End	
W2	-11.86	-	0	70	Weld	
S1	-10.88	-	0.6	60	Saddle	
W3	-9.86	-	0	90	Weld	
S2	-4.46	-	0.15	50	Clamp	
S3	-4.36	-	0.3	80	Support	
A1	-4.34	25	0.31	80	Severe	Visually confirm external corrosion under pipe support (6H00) with max. pit depth is 0.15"@ 3.8 mm. UT reading adjacent to pit is 6.27 mm. Remaining wall thickness is 2.47 mm (60.6% wall loss)
W4	-4.24	-	0	90	Weld	
F1	0.18	-	0	80	Flange	Datum of screening

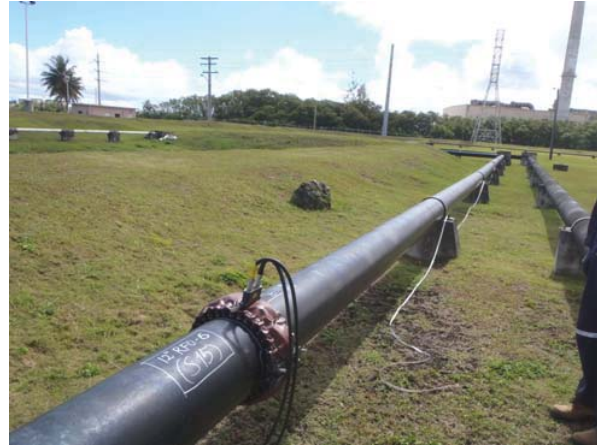
Positive direction

Feature	Location	ECL	Length	Extent	Class	Notes
F1	-11.3	-	0	50	Flange	
W1	-10.46	-	0	45	Weld	
F2	-10.05	-	0	70	Y	Branch
W2	-9.94	-	0	70	Weld	
W3	-7.35	25	0	80	Weld	
S1	-2.38	-	0.15	60	Clamp	
S2	-2.28	-	0.3	70	Support	
W4	-1.73	20	0	80	Weld	Datum of screening
W5	3.89	25	0	80	Weld	
A1	4.51	2	0.3	0	Minor	Visually confirm external corrosion under pipe support (6H00) with max. pit depth approximately 0.07" @ 1.3 mm. UT reading adjacent to pit is 6.29 mm. Remaining wall thickness approximately 4.99 mm (20.7% wall loss)
S3	4.53	-	0.3	0	Support	
S4	4.65	-	0.15	40	Clamp	
W6	9.47	-	0	70	Weld	
A2	11.6	2	0.3	1	Severe	Visually confirm external corrosion under pipe support (6H00) with max. pit depth approximately 0.17" @ 3.8 mm. UT reading adjacent to pit is 6.35 mm. Remaining wall thickness approximately 2.55 mm (59.8% wall loss)
S5	11.62	-	0.3	0	Support	
S6	11.76	-	0.15	0	Saddle	
W7	15.07	-	0	70	Weld	
U2	15.24	-	~		End

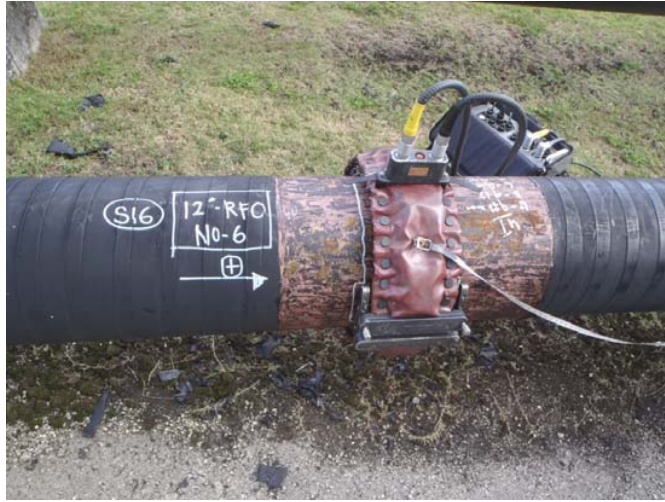
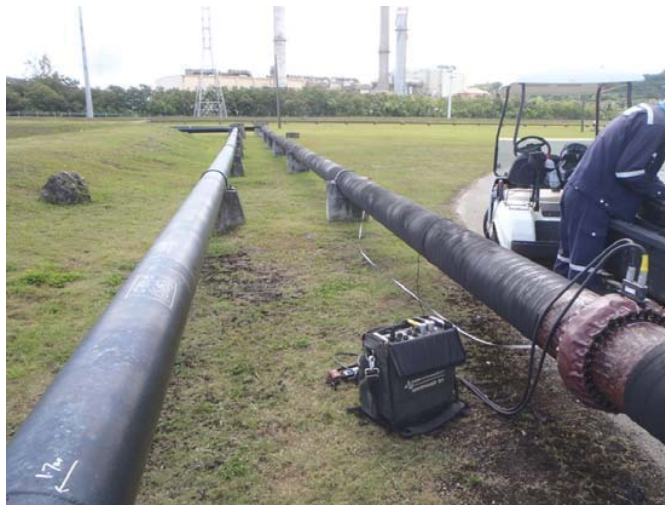
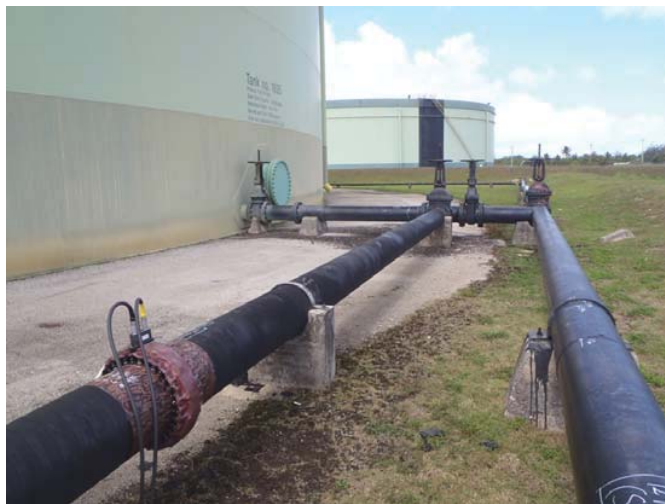
General Notes: 12" RFO-No.6 - Test Point No.: S16
Positive direction with product flow.
No corrosion above the reporting level observed in the tested section of the pipe and found satisfactory.
(refer class, note and location as table below).
Location of signals measuring from center of ring.
Thickness at ring position are (12 o'clock:9.83 mm), (3 o'clock:9.63 mm), (6 o'clock:9.48 mm), (9 o'clock: 9.85 mm)

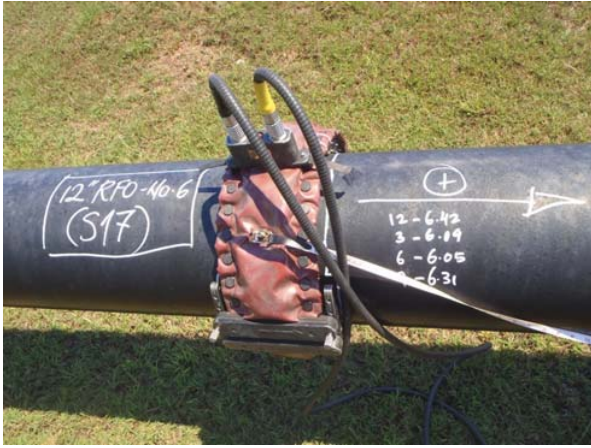
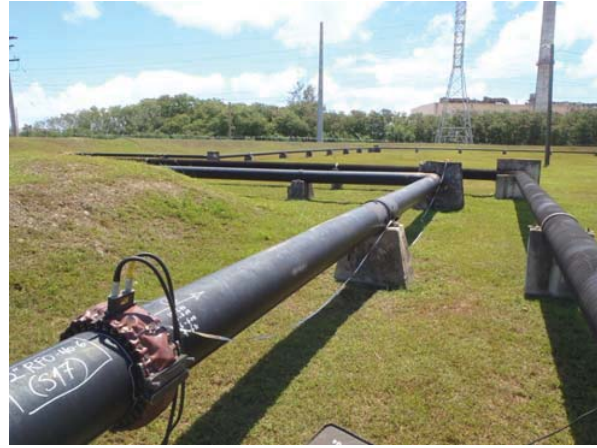
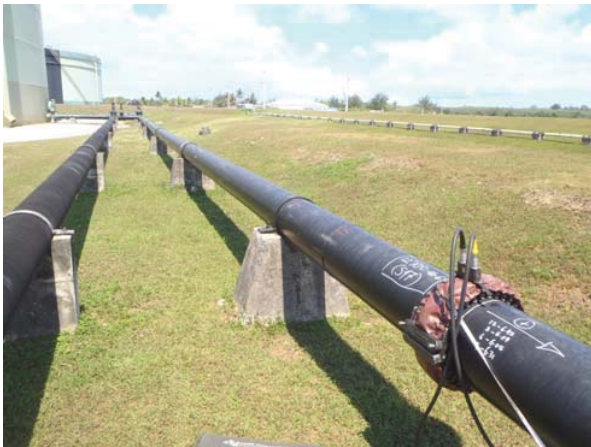
General Notes: 14" RFO-No.6 - Test Point No.: S17
 Positive direction with product flow.
 Found external corrosion at pipe support (refer class, note and location as table below).
 Location of signals measuring from center of ring.
 Thickness at ring position are (12 o'clock:6.42 mm), (3 o'clock:6.09 mm), (6 o'clock:6.05 mm), (9 o'clock:6.31 mm)

Feature	Location	ECL	Length	Extent	Class	Notes
W1	-12.35	-	0	25	Weld	
U1	-11.27	-	~		End	
R1	-8.63	-	0	35	Reverb.	False echo
S1	-7.87	-	0.15	30	Clamp	
S2	-7.84	-	0.3	35	Support	
A1	-7.75	3	0.35	40	Severe	Visually confirm external corrosion under pipe support (6H00) with max. pit depth approximately 0.20" @ 5.0 mm. UT reading adjacent to pit is 6.18 mm. Remaining wall thickness approximately 1.18 mm(80.9%wall loss)
W2	-6.72	-	0	80	Weld	
S3	-1.97	-	0.15	50	Clamp	
S4	-1.85	-	0.3	60	Support	
W3	-1.1	20	0	80	Weld	Datum of screening
E1	3.54	-	1	50	Wrapping	
S5	3.81	-	0.48	50	Saddle	
R2	4.8	-	0	25	Trailing Echoes	False echo
R3	8.84	-	0	60	Reverb.	False echo
S6	9.96	-	0.1	1	Saddle	
S7	10.02	-	1	12	Support	
B1	10.06	-	0	12	1D Bend	
A2	10.15	60	0.9	16	Minor	Visually confirm general corrosion under pipe support.
U2	10.23	-	~		End

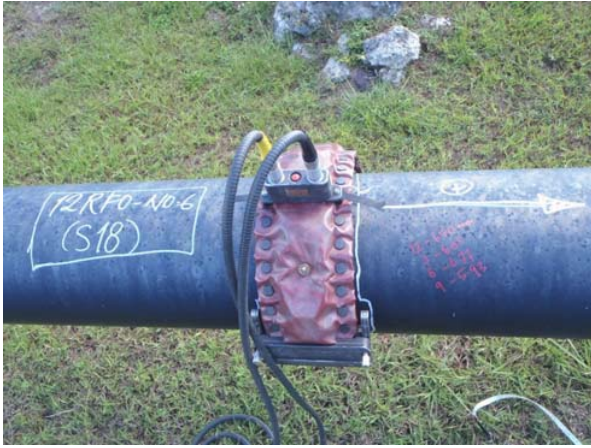
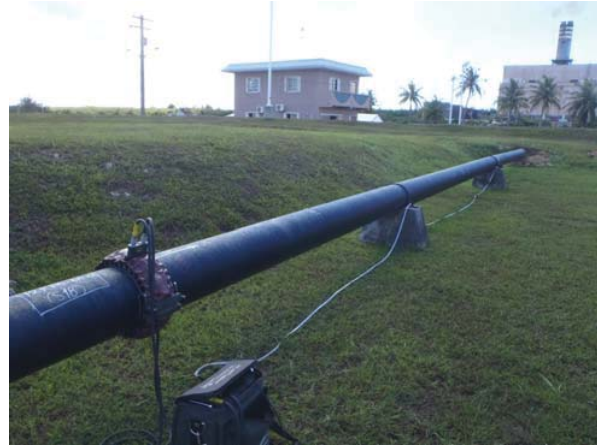
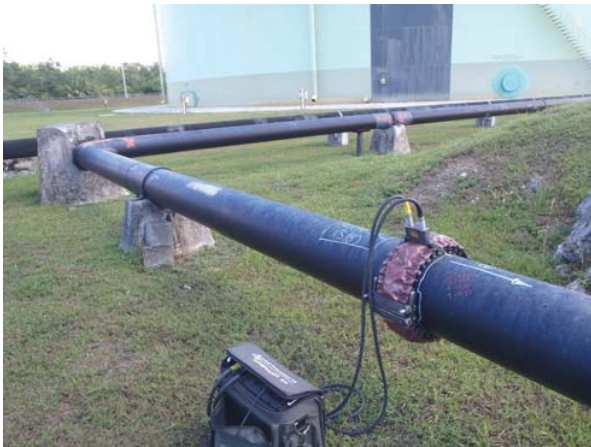
General Notes: 14" RFO-No.6 - Test Point No.: S18
Positive direction with product flow.
Found external corrosion at pipe support (refer class, note and location as table below).
Location of signals measuring from center of ring.
Thickness at ring position are (12 o'clock:6.50 mm), (3 o'clock:6.03 mm), (6 o'clock:6.77 mm), (9 o'clock:5.93 mm)

Feature	Location	ECL	Length	Extent	Class	Notes
U1	-7.43	-	~		End	
S1	-7.11	-	0.1	50	Saddle	Patch plate (0.1x0.1)m at bottom side
A1	-6.15	50	1	80	Minor	General corrosion under pipe support
B1	-6.12	-	0	80	1D Bend	
W1	-3.68	-	0	70	Weld	
S2	-3.1	-	0.15	50	Clamp	
S3	-3	-	0.3	50	Support	
W2	1.9	-	0	70	Weld	Datum of screening
S4	3.86	-	0.3	14	Support	
S5	3.98	-	0.15	80	Clamp	
W3	7.51	-	0	70	Weld	
A2	10.91	3	0.35	0	Severe	Visually confirm external corrosion under pipe support (6 - 9H00) with max. pit depth approximately 0.20"@ 5.0 mm. UT reading adjacent to pit is 6.15 mm. Remaining wall thickness approximately 1.15 mm (81.3%wall loss)
S6	10.94	-	0.3	0	Saddle	
S7	11.07	-	0	0	Clamp	
W4	13.09	-	0	70	Weld	
U2	13.39	-	~		End

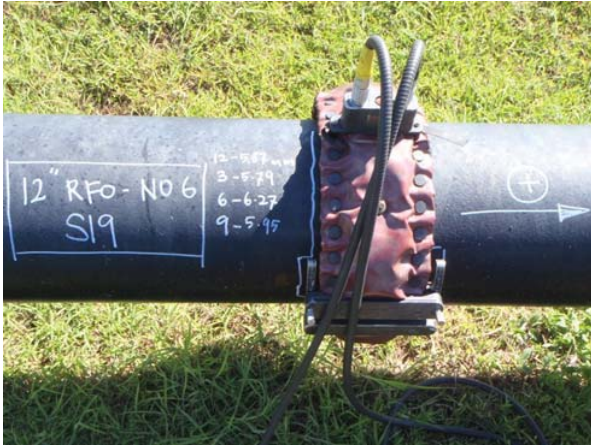
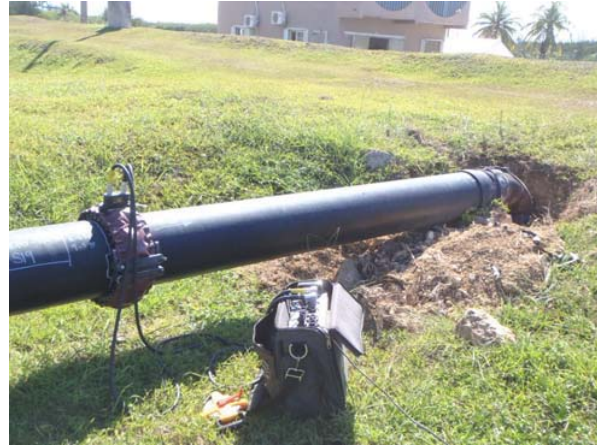
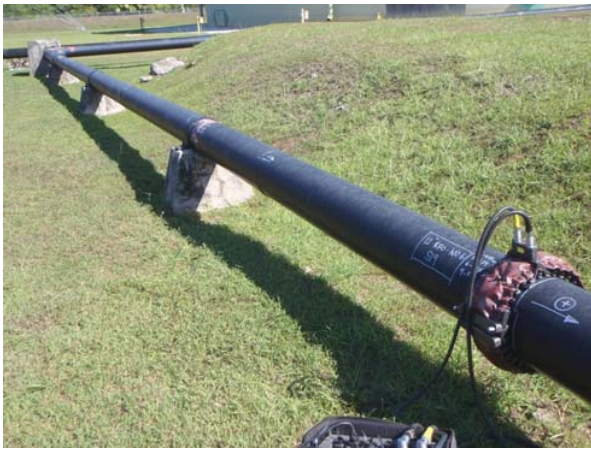
General Notes: 14" RFO-No.6 - Test Point No.: S19
Positive direction with product flow.
Found external corrosion at pipe support (refer class, note and location as table below).
Location of signals measuring from center of ring.
Thickness at ring position are (12 o'clock:5.87 mm), (3 o'clock:5.79 mm), (6 o'clock:6.27 mm), (9 o'clock:5.95 mm)

Feature	Location	ECL	Length	Extent	Class	Notes
W1	-13.7	-	0	90	Weld	
U1	-12.19	-	~		End	
S1	-11.3	-	0.15	0	Clamp	
S2	-11.2	-	0.3	35	Support	
W2	-8.1	-	0	90	Weld	
S3	-4.28	-	0.15	30	Clamp	
S4	-4.2	-	0.3	0	Support	
A1	-4.14	3	0.35	0	Severe	Visually confirm external corrosion under pipe support (6 - 9H00) with max. pit depth approximately 0.20" @ 5.0 mm. UT reading adjacent to pit is 6.15 mm. Remaining wall thickness approximately 1.15 mm. (81.3% wall loss)
W3	-2.51	-	0	70	Weld	Datum of screening
B1	3.06	-	0	60	45 deg Bend	
E1	3.66	-	~	30	Earth	
U2	5.13	-	~		End	
B2	5.38	-	0	50	45 deg Bend

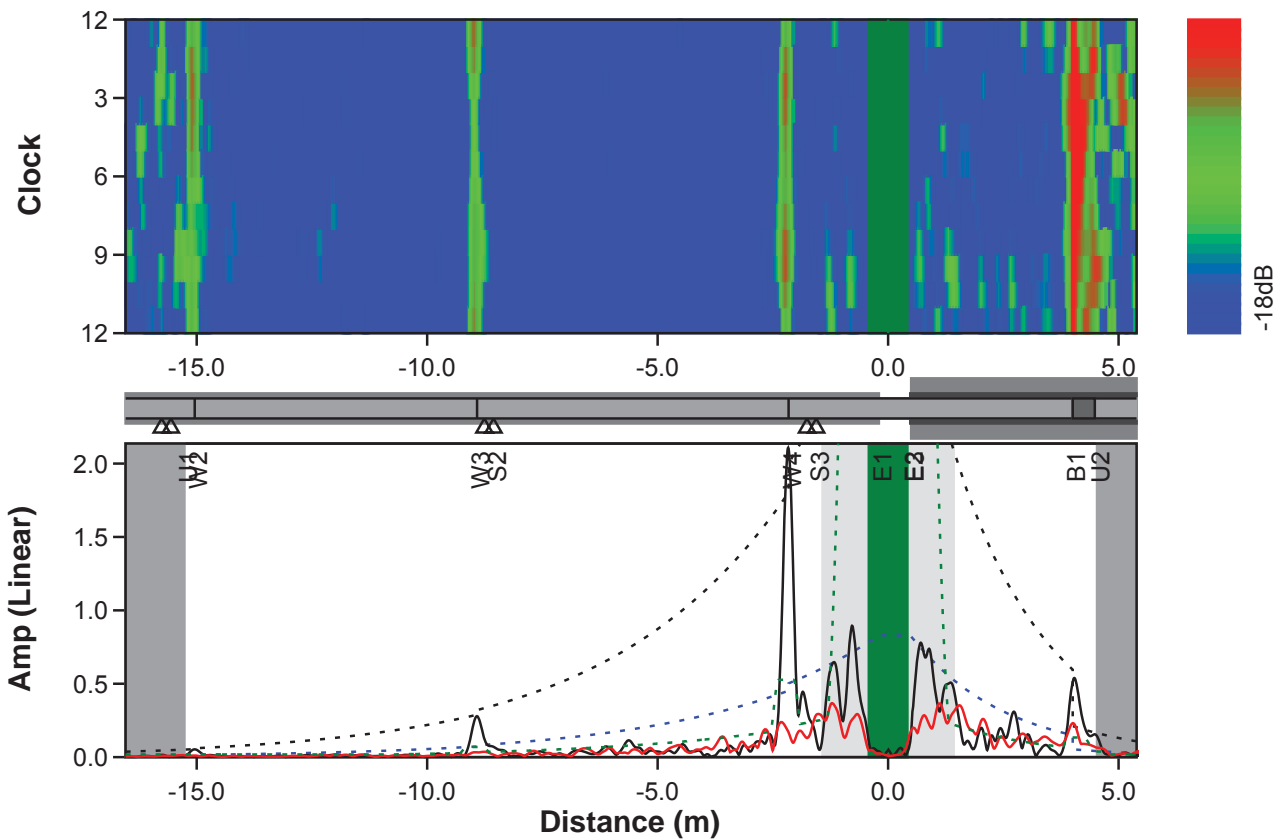
General Notes: 12" RFO-No.6 - Test Point No.: S20
Positive direction with product flow.
No corrosion above the reporting level observed in the tested section of the pipe and found satisfactory.
(refer class, note and location as table below).
Location of signals measuring from center of ring.
Thickness at ring position are (12 o'clock:10.28 mm), (3 o'clock:9.84 mm), (6 o'clock:10.35 mm), (9 o'clock: 10.47 mm)

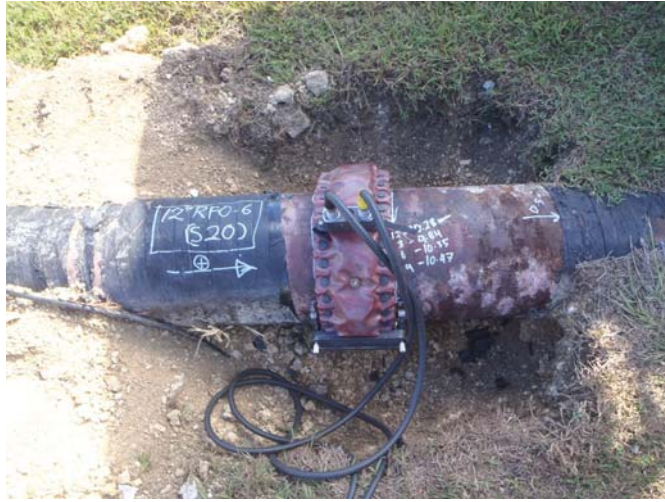
Ring location place at soil to air section

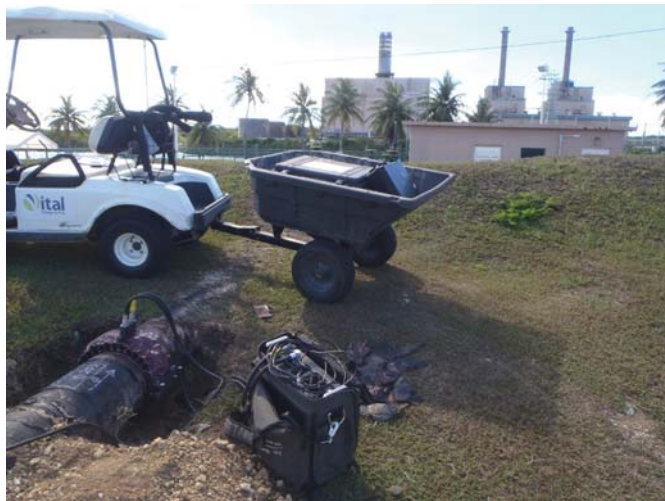
Positive direction towards pump area

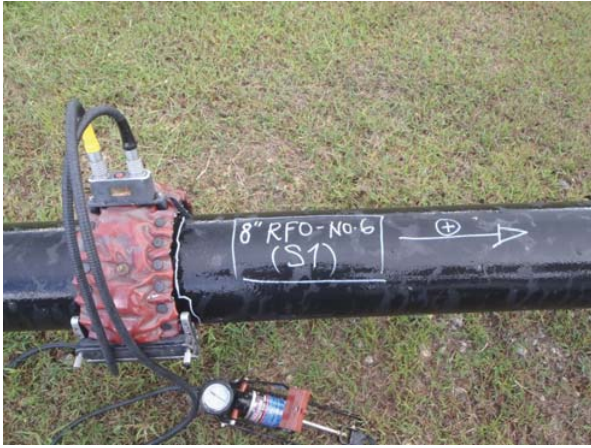
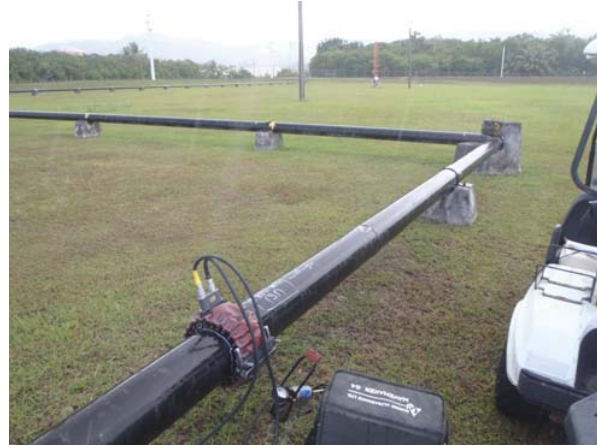
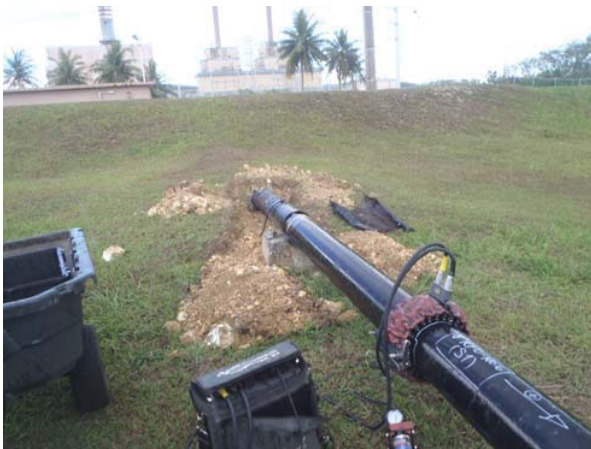
General Notes: 8" RFO-No.6 - Test Point No.: S1
 Positive direction with product flow.
 Found external corrosion at pipe support (refer class, note and location as table below).
 Location of signals measuring from center of ring.
 Thickness at ring position are (12 o'clock:7.29 mm), (3 o'clock:7.06 mm),
 (6 o'clock:7.07 mm), (9 o'clock:7.01 mm)

Feature	Location	ECL	Length	Extent	Class	Notes
U1	-3.73	-	~		End	
B1	-3.33	-	0	60	45 deg Bend	
W1	-2.57	-	0	45	Weld	
S1	-1.87	-	0.3	19	Support	
A1	-1.8	4	0.35	19	Medium	Visually confirm external corrosion under pipe support (6H00) with max. pit depth approximately 0.13"@ 3.3 mm. UT reading adjacent to pit is 7.25 mm. Remaining wall thickness approximately 3.95 mm (45.5% wall loss)
W2	1.47	-	0	90	Weld	Datum of screening
A2	3.53	11	0.38	25	Severe	Visually confirm external corrosion under pipe support (6H00) with max. pit depth approximately 0.20"@ 5.0 mm. UT reading adjacent to pit is 7.09 mm. Remaining wall thickness approximately 2.09 mm (70.5% wall loss)
S2	3.63	-	0.3	25	Support	
A3	6.86	3	1.1	0	Severe	Visually confirm external corrosion under pipe support (3-6H00) with max. pit depth approximately 0.22" @ 5.5 mm. UT reading adjacent to pit is 6.96 mm. Remaining wall thickness approximately 1.46 mm (79.0% wall loss)

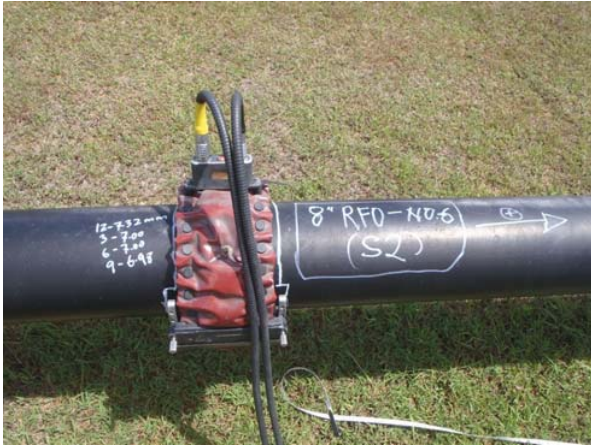
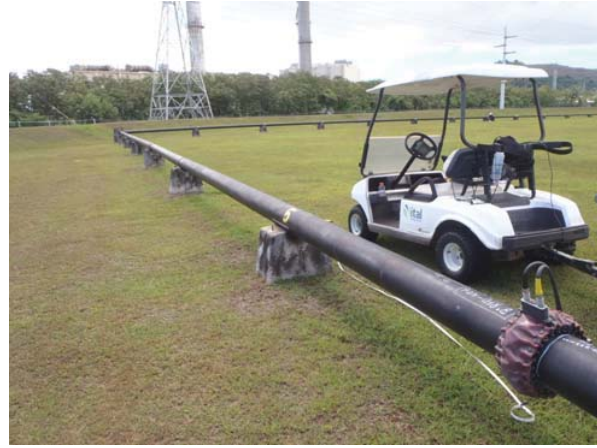
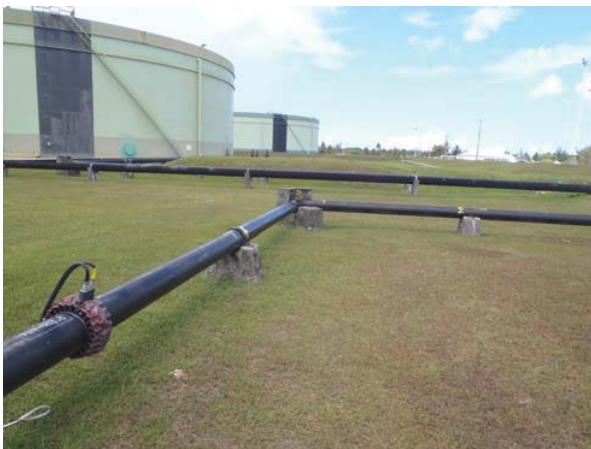
General Notes: 8" RFO-No.6 - Test Point No.: S2
Positive direction with product flow.
Found external corrosion at pipe support (refer class, note and location as table below).
Location of signals measuring from center of ring.
Thickness at ring position are (12 o'clock:7.32 mm), (3 o'clock:7.00 mm), (6 o'clock:7.00 mm), (9 o'clock:6.98 mm)

Feature	Location	ECL	Length	Extent	Class	Notes
U1	-8.43	-	~		End	
B1	-7.37	-	0	80	1D Bend	
S1	-7.23	-	1	80	Support	
A1	-7.22	11	1	80	Severe	Visually confirm external corrosion under pipe support (3-6H00) with max. pit depth approximately 0.22"@ 5.5 mm. UT reading adjacent to pit is 6.96 mm. Remaining wall thickness approximately 1.46 mm (79.0% wall loss)
S2	-3.06	-	0.15	12	Clamp	
S3	-2.94	-	0.3	13	Support	
A2	-2.91	18	0.35	13	Severe	Visually confirm external corrosion under pipe support (6H00) with max. pit depth approximately 0.20"@ 5.0 mm. UT reading adjacent to pit is 7.08 mm. Remaining wall thickness approximately 2.08 mm (70.6% wall loss)
W1	-1.82	-	0	80	Weld	Datum of screening
S4	2.48	-	0.4	10	Saddle	Patch plate at bottom side
W2	3.71	-	0	70	Weld	
S5	8.35	-	0.3	35	Support	
S6	8.5	-	0.15	70	Clamp	
W3	9.29	-	0	80	Weld	
S7	14.11	-	0.5	45	Saddle	Patch plate at bottom side
W4	14.88	-	0	70	Weld	
U2	15.08	-	~		End

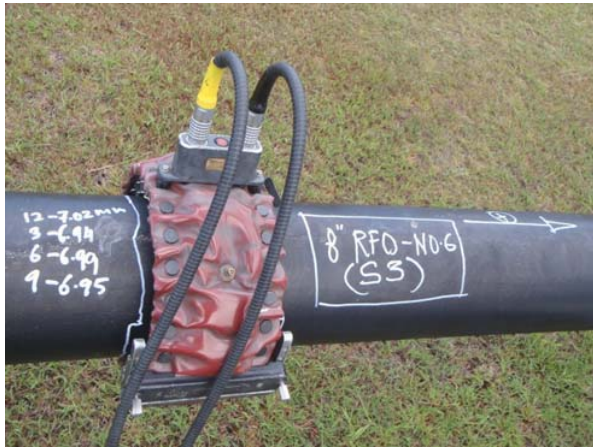
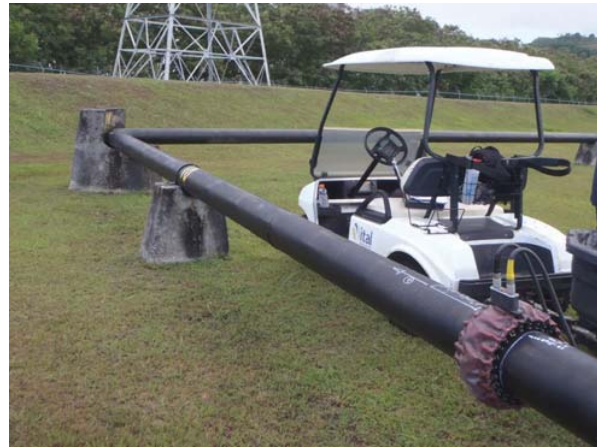
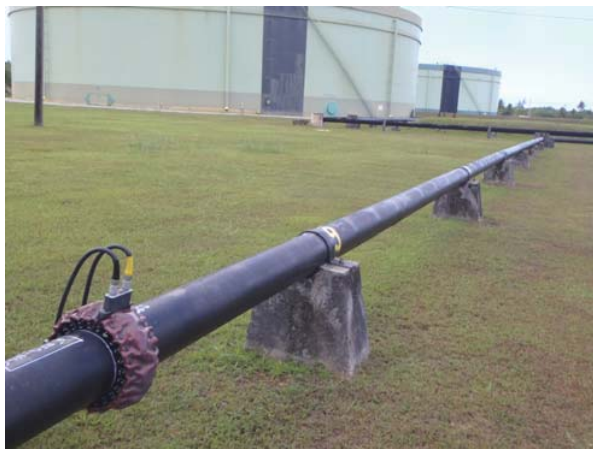
General Notes: 8" RFO-No.6 - Test Point No.: S3
Positive direction with product flow.
Found external corrosion at pipe support (refer class, note and location as table below).
Location of signals measuring from center of ring.
Thickness at ring position are (12 o'clock:7.02 mm), (3 o'clock:6.94 mm), (6 o'clock:6.99 mm), (9 o'clock:6.95 mm)

Feature	Location	ECL	Length	Extent	Class	Notes
U1	-14.91	-	~		End	
R1	-14.12	-	0	0	False Echo	Reverberation signals
S1	-13.36	-	0.5	70	Saddle	Patch plate at bottom side
W1	-13.13	-	0	90	Weld	
S2	-7.73	-	0.15	90	Clamp	
S3	-7.63	-	0.3	90	Support	
W2	-7.6	-	0	80	Weld	
W3	-3.68	-	0	80	Weld	
S4	-1.89	-	0.15	50	Clamp	
S5	-1.79	-	0.3	50	Support	
A1	-1.77	3	0.3	60	Medium	Visually confirm external corrosion under pipe support (3 - 6H00) with max. pit depth approximately 0.08"@ 2.0 mm. UT reading adjacent to pit is 7.21 mm. Remaining wall thickness approximately 5.21 mm (27.7% wall loss)
W4	1.85	-	0	70	Weld	Datum of screening
S6	3.74	-	0.3	25	Support	
A2	3.74	2	0.3	25	Medium	Visually confirm external corrosion under pipe support (6H00) with max. pit depth approximately 0.07"@ 1.8 mm. UT reading adjacent to pit is 7.35 mm. Remaining wall thickness approximately 5.55 mm (24.5% wall loss)
S7	3.88	-	0.15	25	Support	
A3	7.24	19	1	80	Medium	Visually confirm external corrosion under pipe support (6 - 9H00) with max. pit depth approximately 0.13"@ 3.3 mm. UT reading adjacent to pit is 7.35 mm. Remaining wall thickness approximately 4.05 mm (44.9% wall loss)
