GUAM POWER AUTHORITY

GUAM POWER AUTHORITY
MTM Pipeline Spill
February 23, 2005 THU

**GPA TOTO TANGUISSON PIPELINE
EMERGENCY RESPONSE AND CLEANUP SERVICES REPORT**

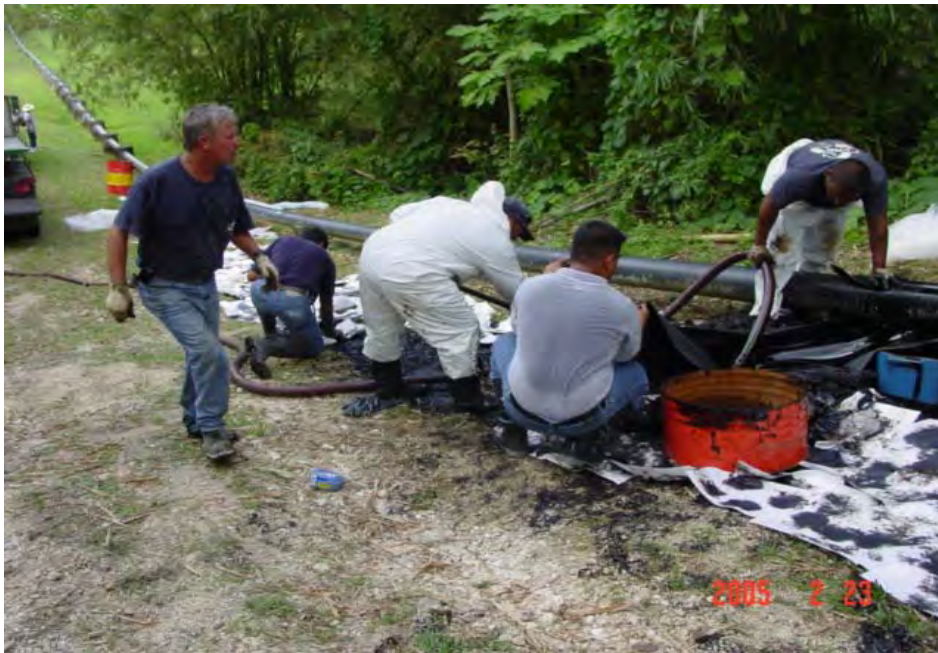
4652

Personnel removing contaminated pads and soil.

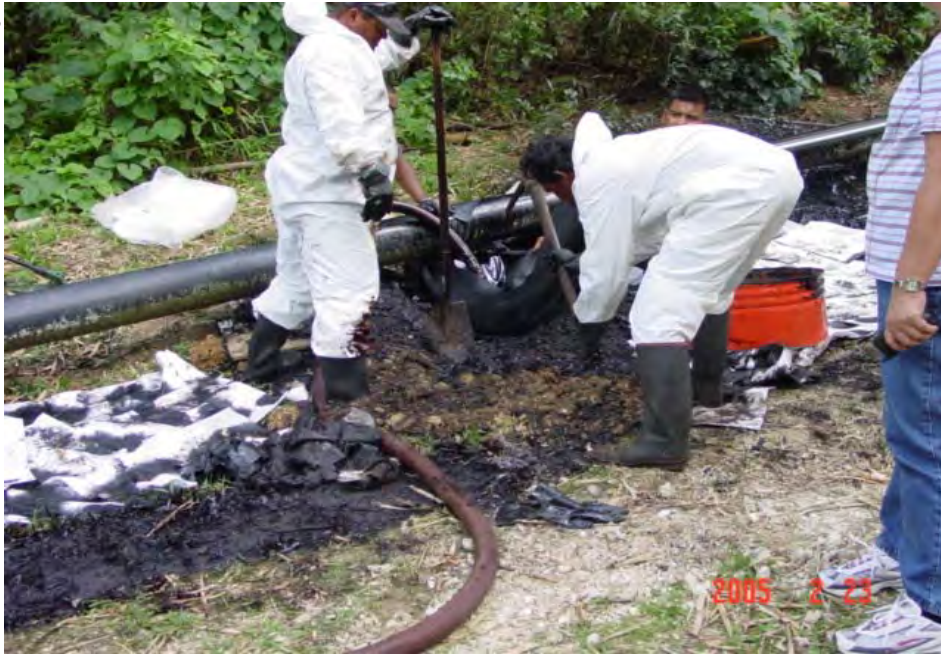
4653

Personnel removing contaminated pads and soil.

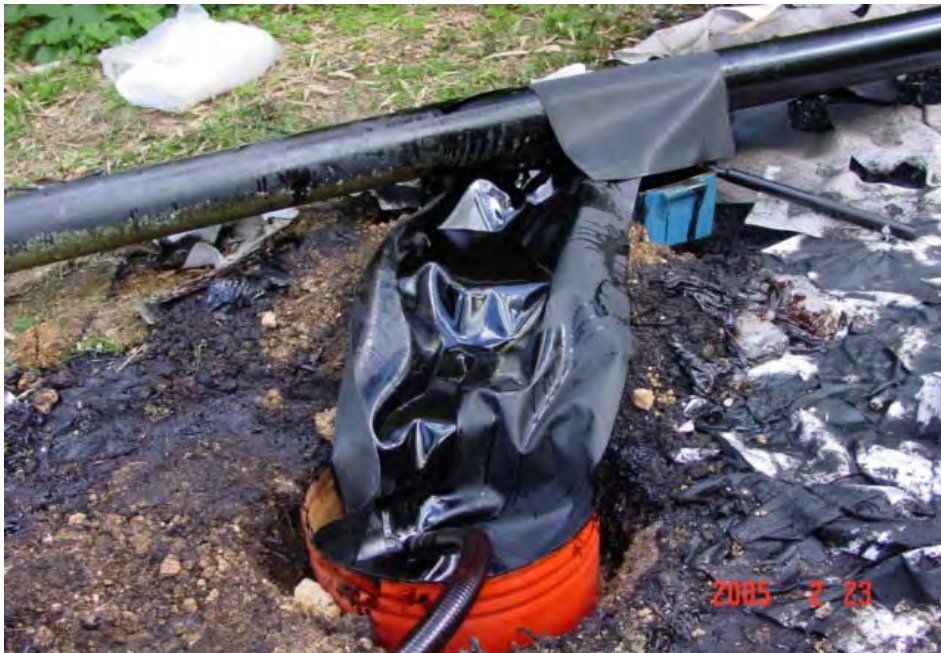
4655

Rubber mat used to direct flow inside a waiting drum. Vacuum truck pumped out oil collected in drum.

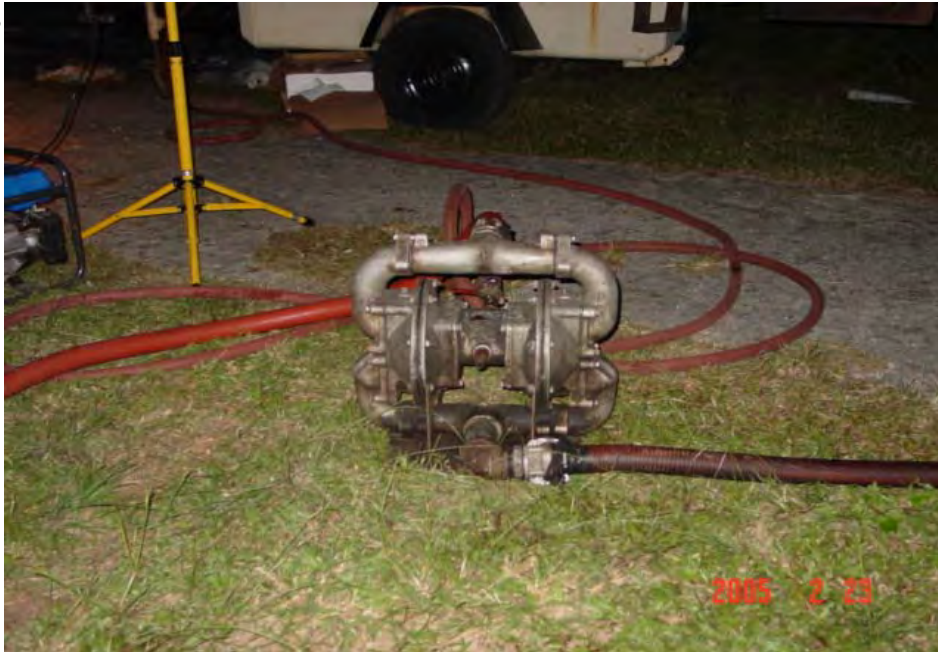
4663

Diaphragm pump transferring oil from Low Point Drain Valve to Tanker Truck.

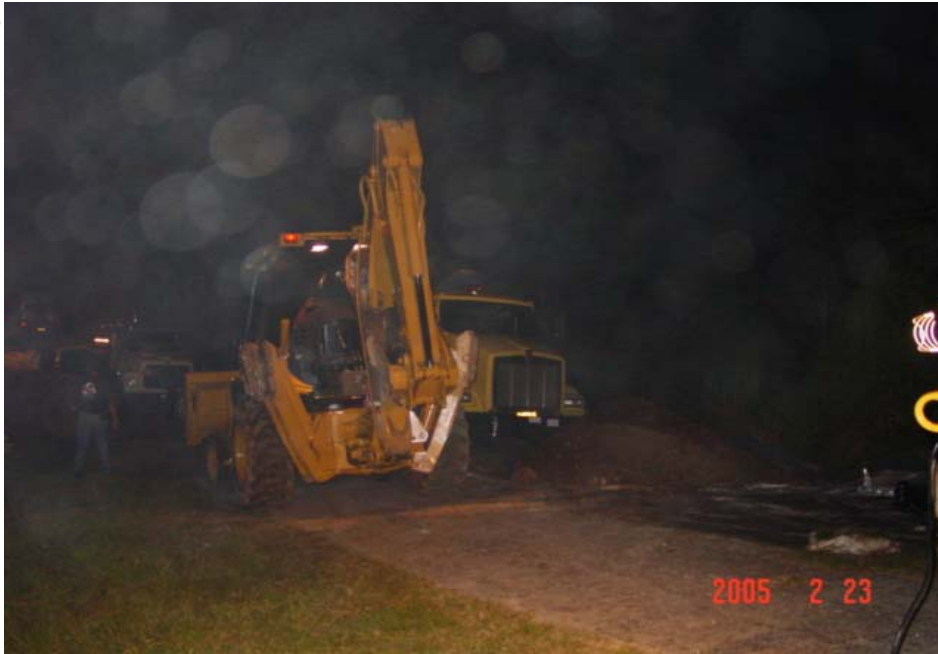
4665

Back hoe utilized in digging and transferring soil to stockpile area on right side.

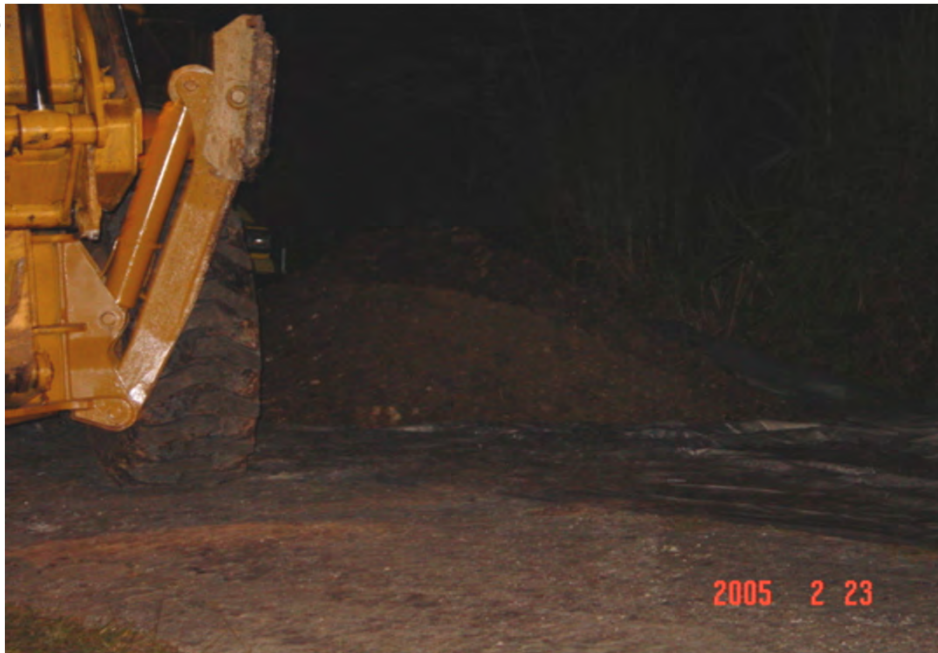
4666

Close-up of stockpiled soil. Plastic sheeting was laid on the ground prior to soil transfers.

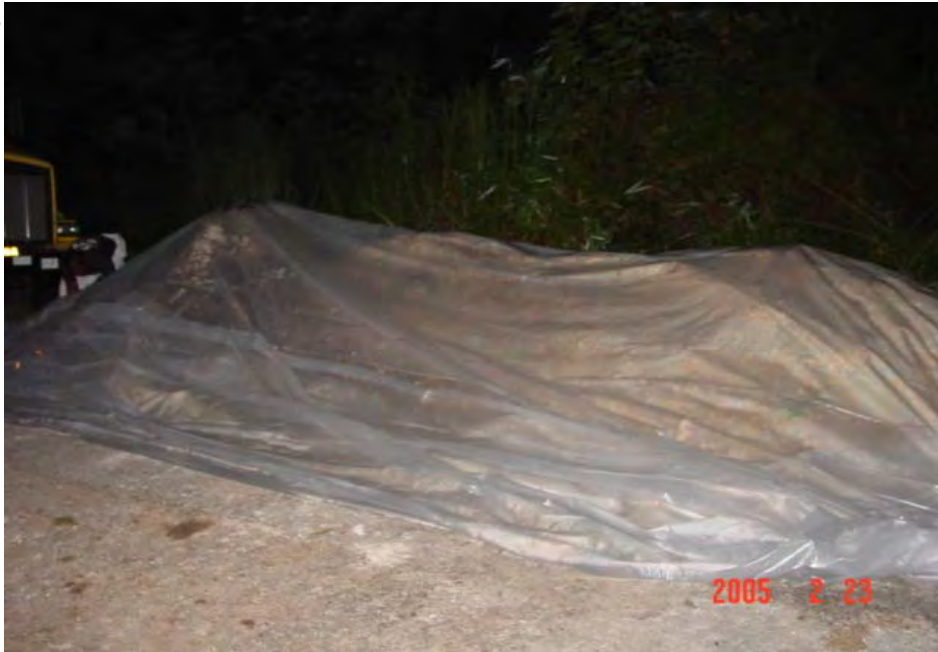
4668

Stockpiled soil covered with plastic sheeting. An estimated 1.5 - 2 dump truck loads of soil was removed.

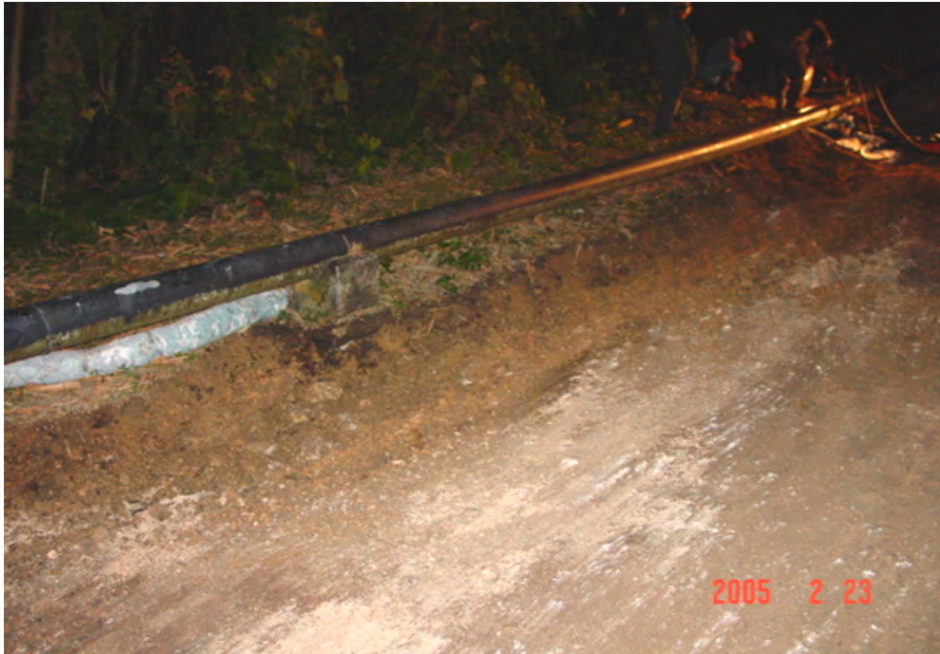
4672

Contaminated soil has been removed.

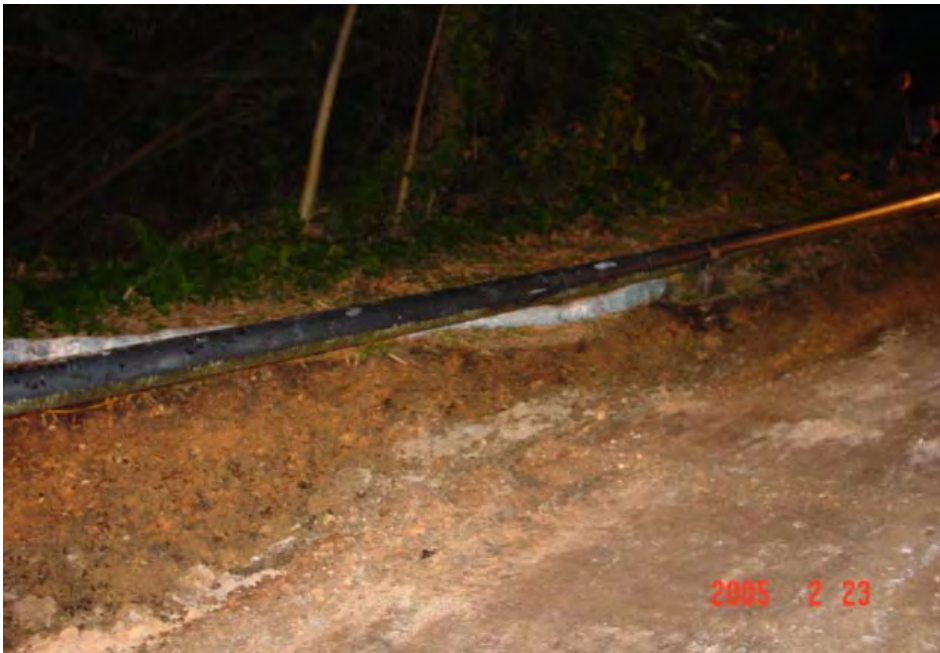
4671

Contaminated soil has been removed.

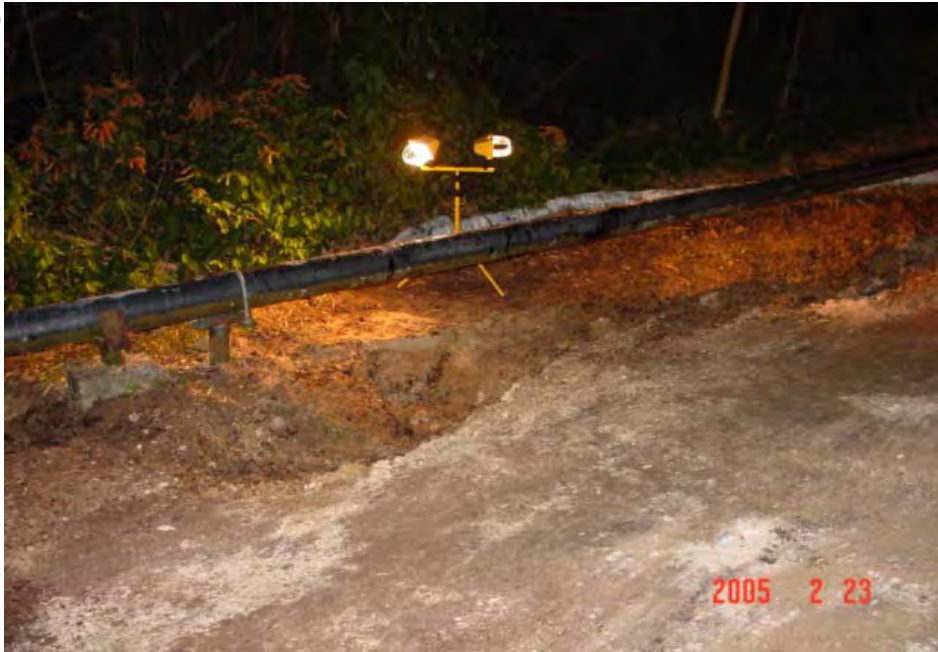
4670

Contaminated soil has been removed.

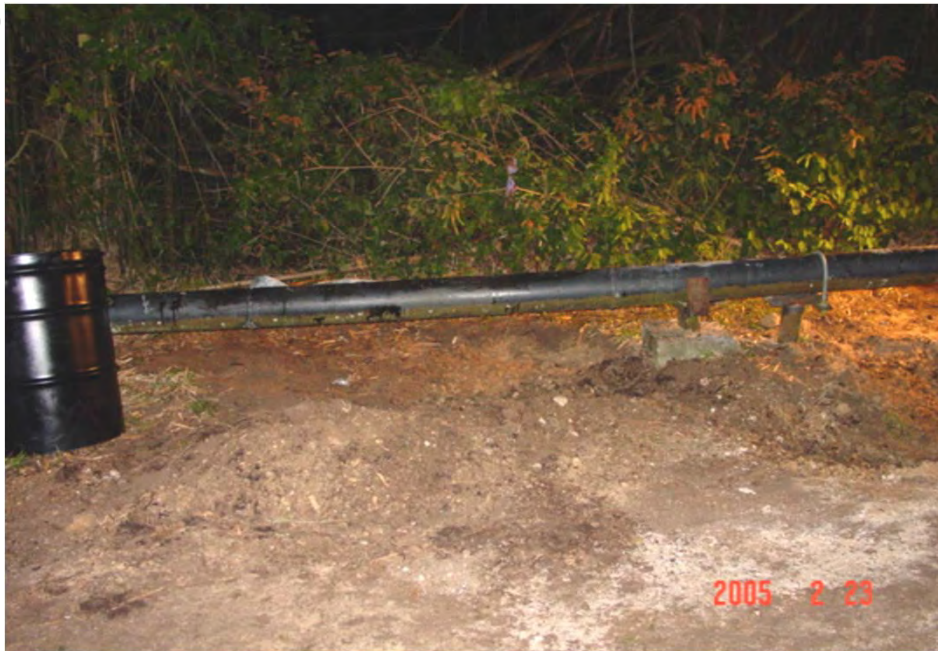
4669

Contaminated soil has been removed. This is the end point of the oil flow.

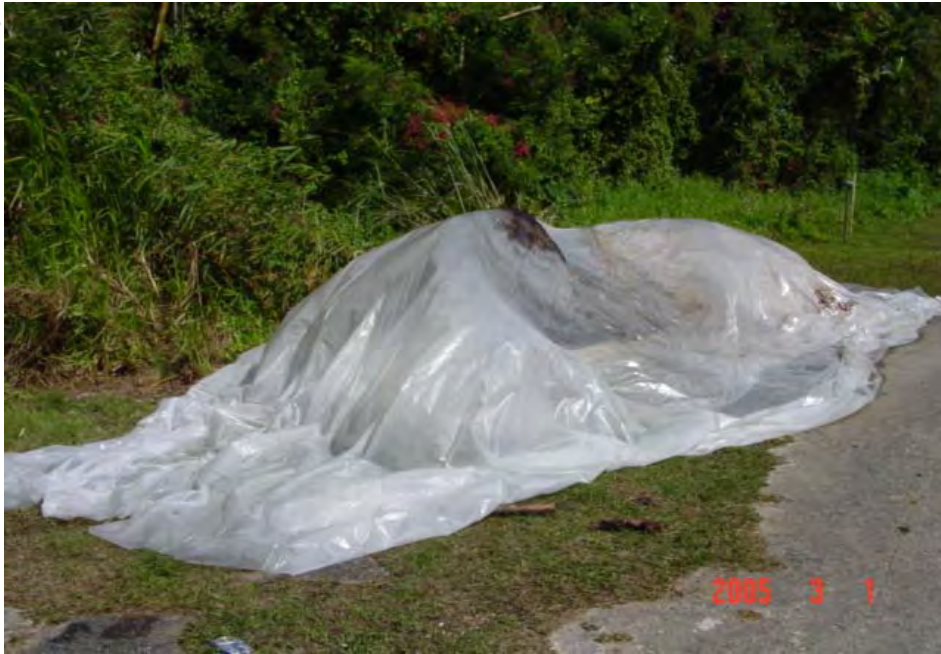
4698

Stockpiled contaminated soil.

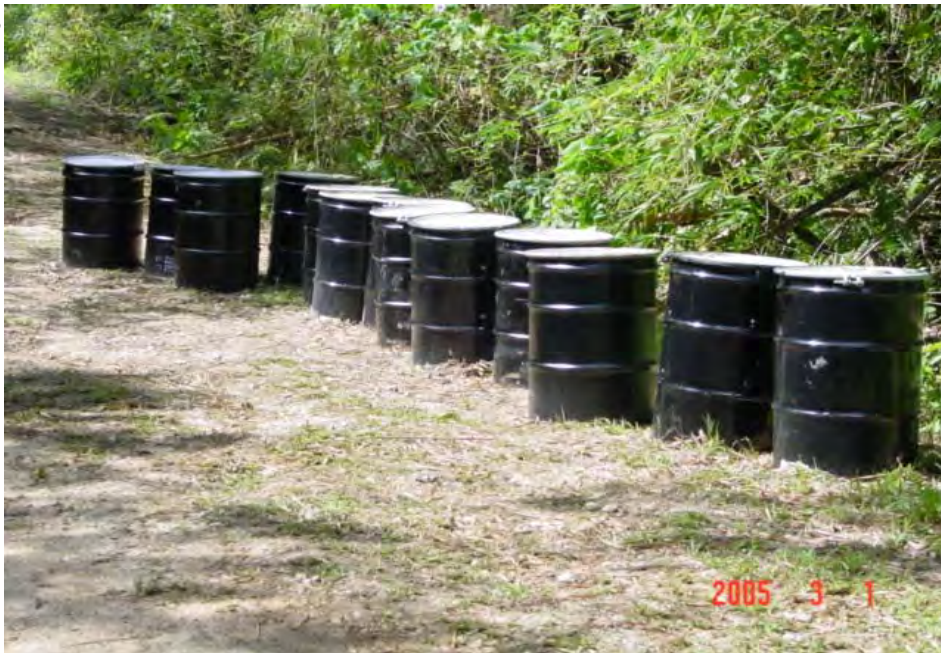
4703

Drums of contaminated pads, booms, and soil.

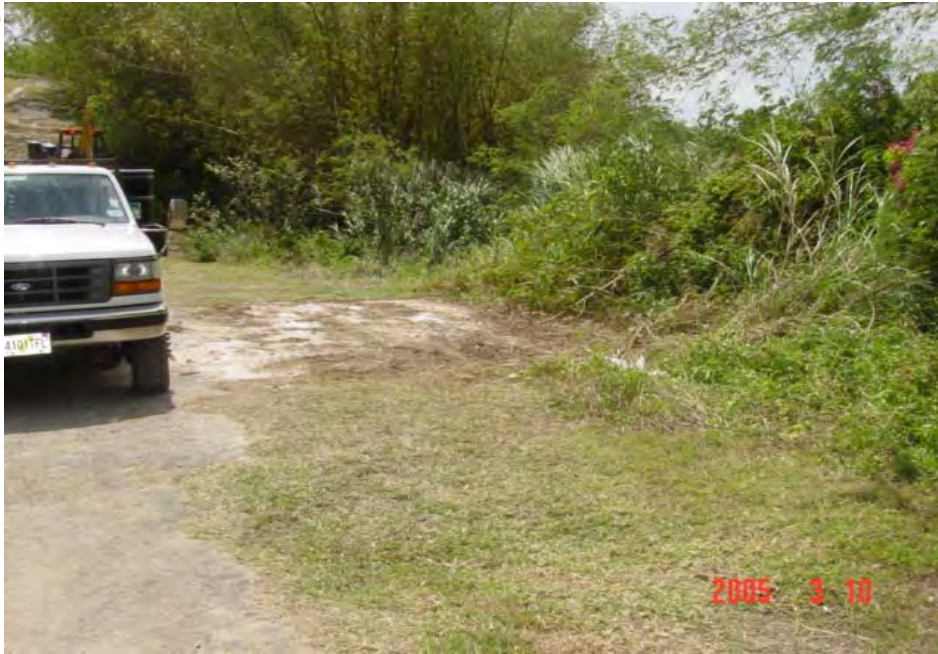
199

Stockpiled contaminated soil has been removed.

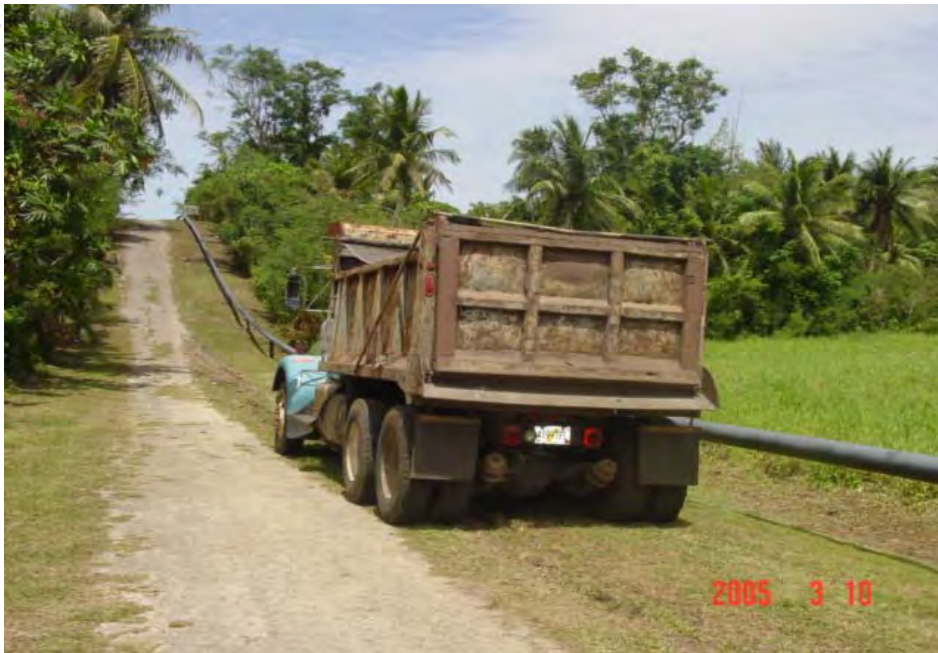
198

Contaminated soil transported in dump truck.

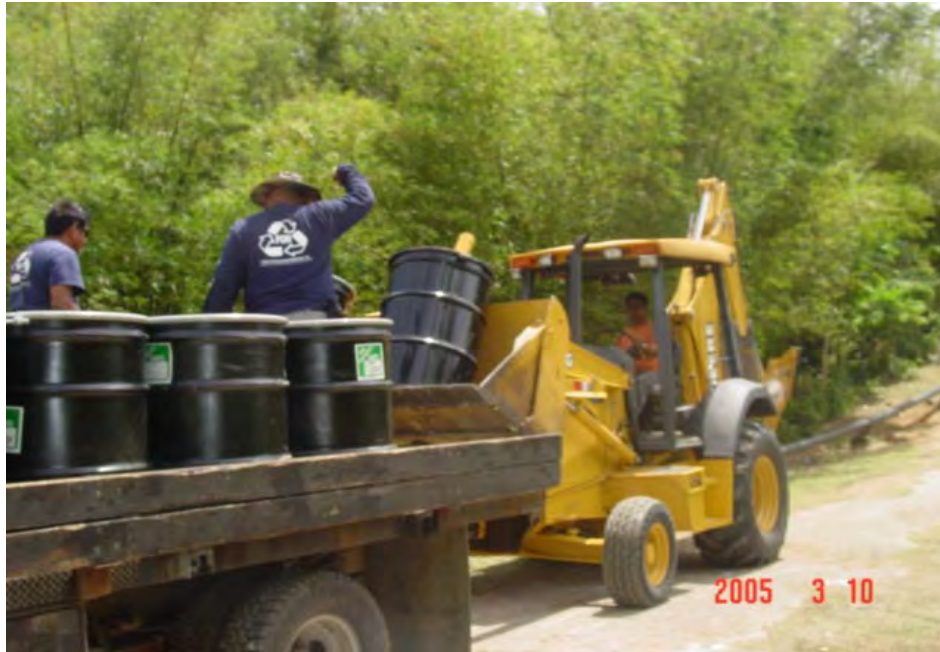
201

PERI workers loading drums of various waste onto Flatbed.

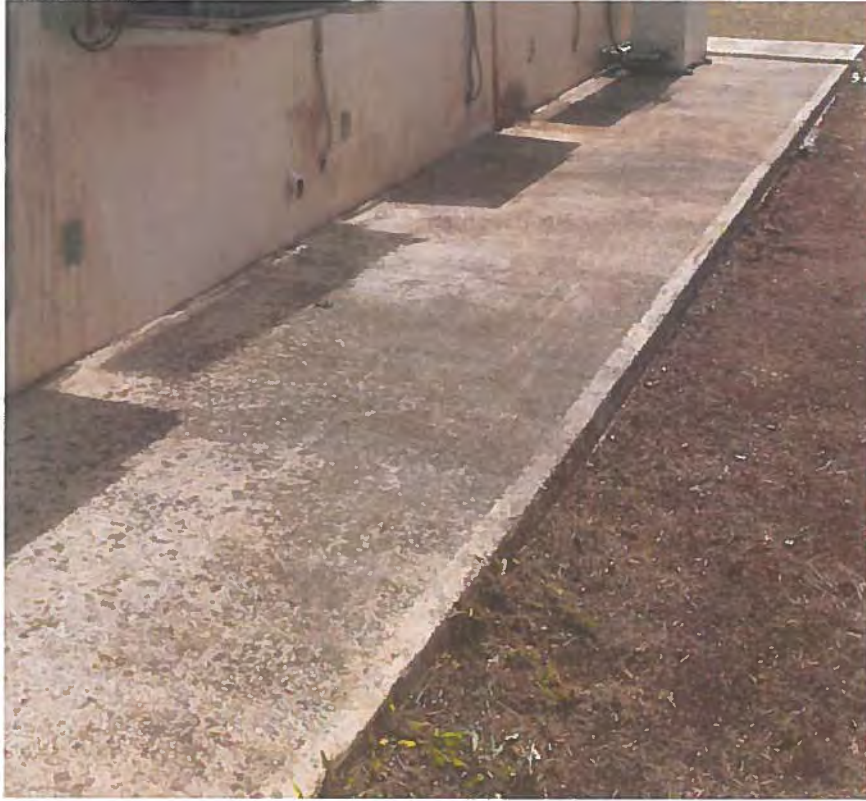
Photo 4 of 8

View of the northern wall of JS Store within the premises after the cleaning (western view)
