GUAM POWER AUTHORITY

GUAM POWER AUTHORITY
MTM Pipeline Spill
February 23, 2005 THU

**GPA TOTO TANGUISSON PIPELINE
EMERGENCY RESPONSE AND CLEANUP SERVICES REPORT**

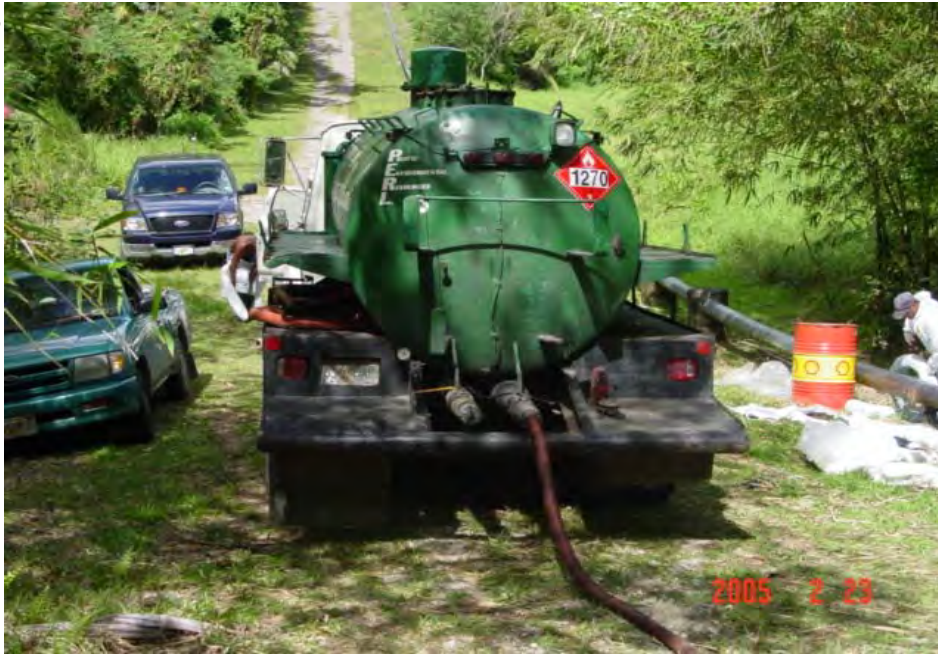
4648

2,000 gl. PERI Vacuum Truck.

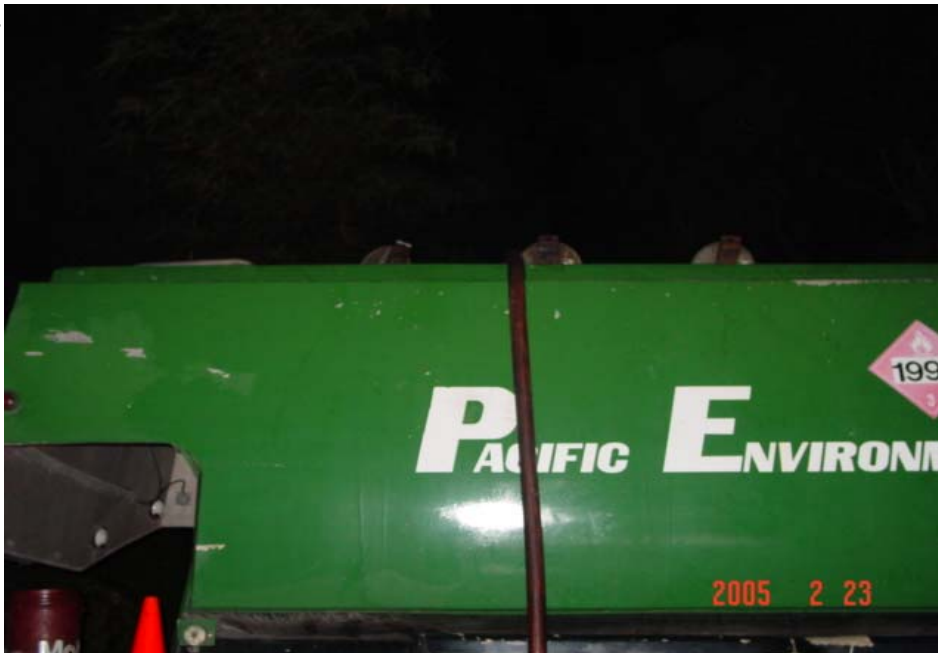
4664

4,000 gal PERI Tanker Truck.

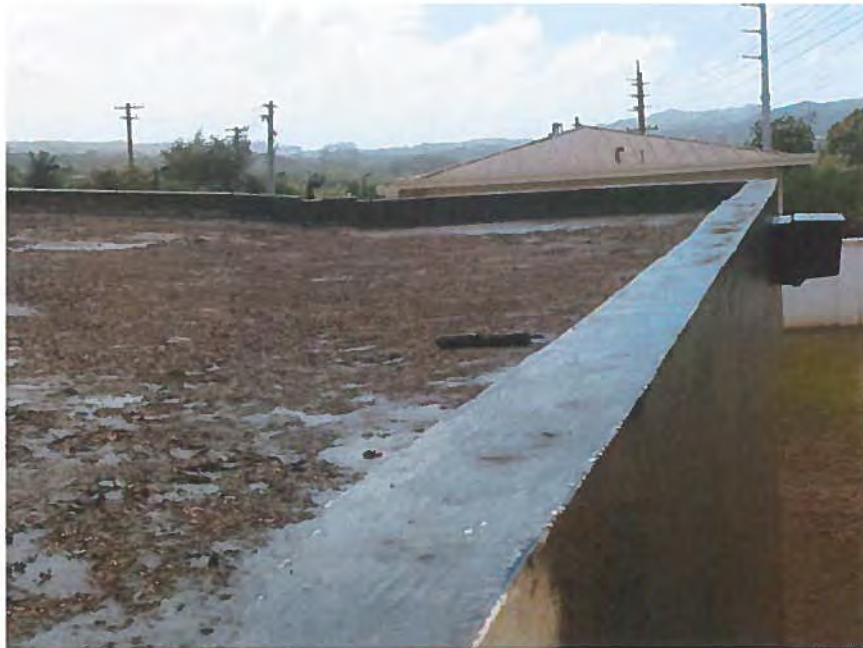
Photo 1 of 6

Photo taken during the initial response to the spill. Note the impact on the soil areas, the northern concrete enclosure wall of the facility as well as the northern wall of the store as shown on the picture.

(southwest view)

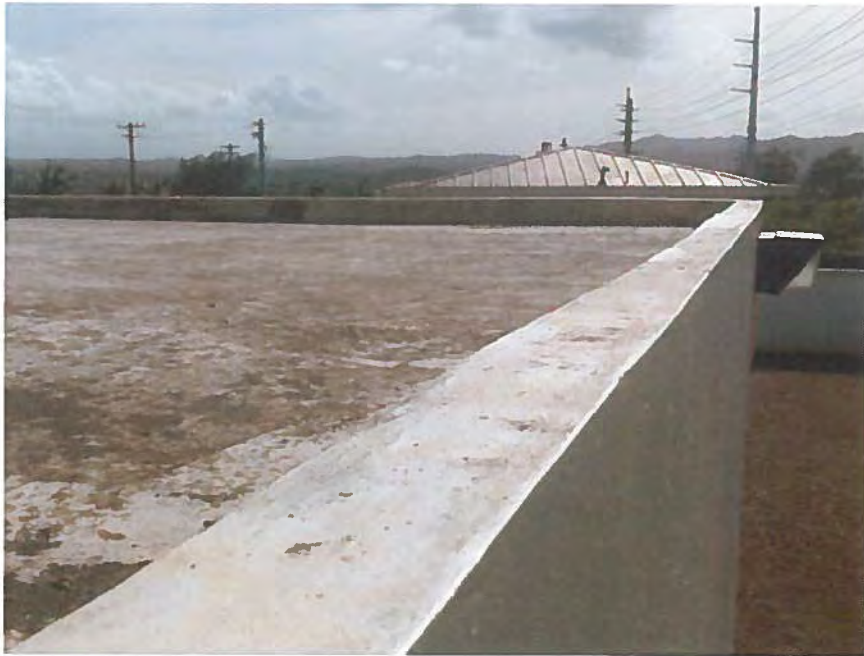
Photo 1 of 8
February 24 2015

Photo taken after the conclusion of clean up services outside the JS Store property along the pipeline's immediate area (southwest view)

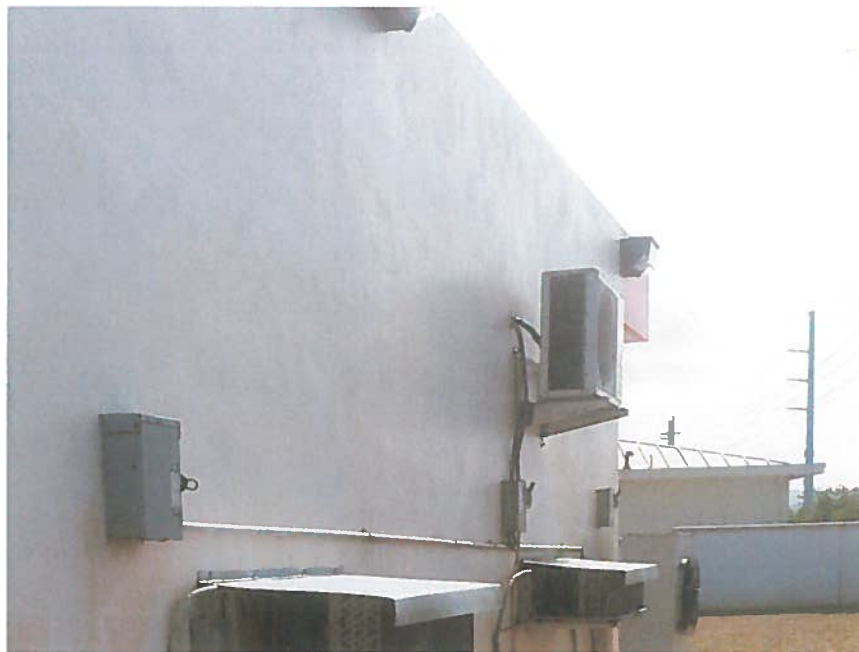
Photo 3 of 8

Closer view of the northern concrete wall of the store along with the concrete wall enclosure after clean up services.
